BALTIC PIPE, DANISH BALTIC SECTOR  
Screening of geophysical data and target inspection  
for the proposed Baltic Pipe gas pipeline  
- Anchor Corridor

VIR 2813

***SLKS 18/00033***

March 2022

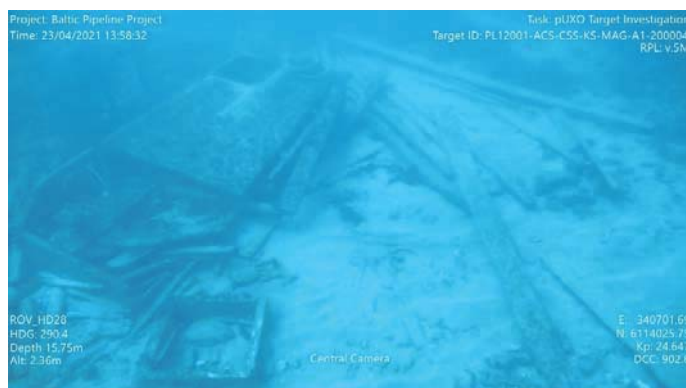
Archaeological sonar data screening is no guarantee that an area is clear of archaeological objects. After finalizing the archaeological screening, two objects of potential historical value were indeed discovered during the client's UXO survey: *PL12001-ACS-CSS-KS-MAG-A1-200004* and *PL12001-ACS-CSS-GS-GRAD-003014*. Both turned out to be wrecks, the former (*MAG-A1-200004*) was classified as modern after the UXO survey showed that the potential UXO was a pressure tank, possibly used for starting the engine or supplying the vessels stove.

**Figure 5. The actual wreck MAG-A1-200004. Image: CSS Subsea/ Saipem.**

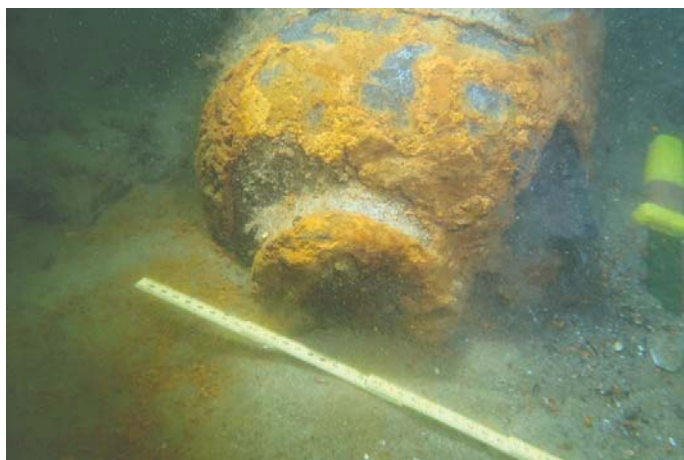
**Figure 7. Close up of the pressure tank. Image: CSS Subsea/ Saipem.**

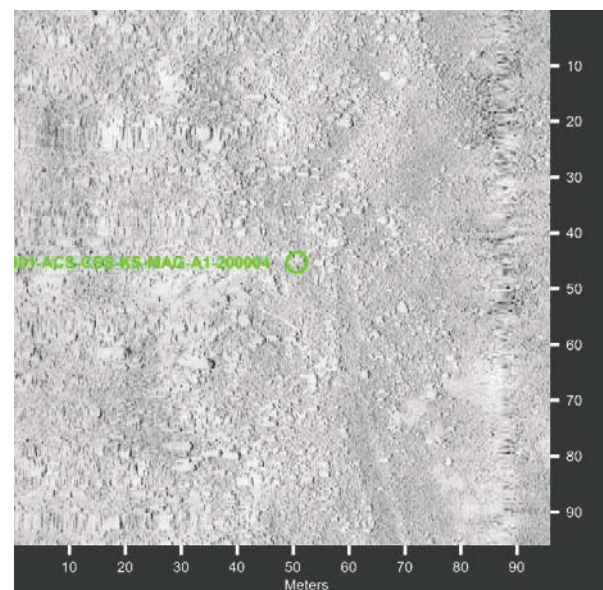
**Figure 6, Side scan sonar image from a target report created in retrospect using the coordinates found in the MAG-A1-200004 TIR shows no clear sign of a wreck. Side scan sonar image: Baltic Pipe project.**

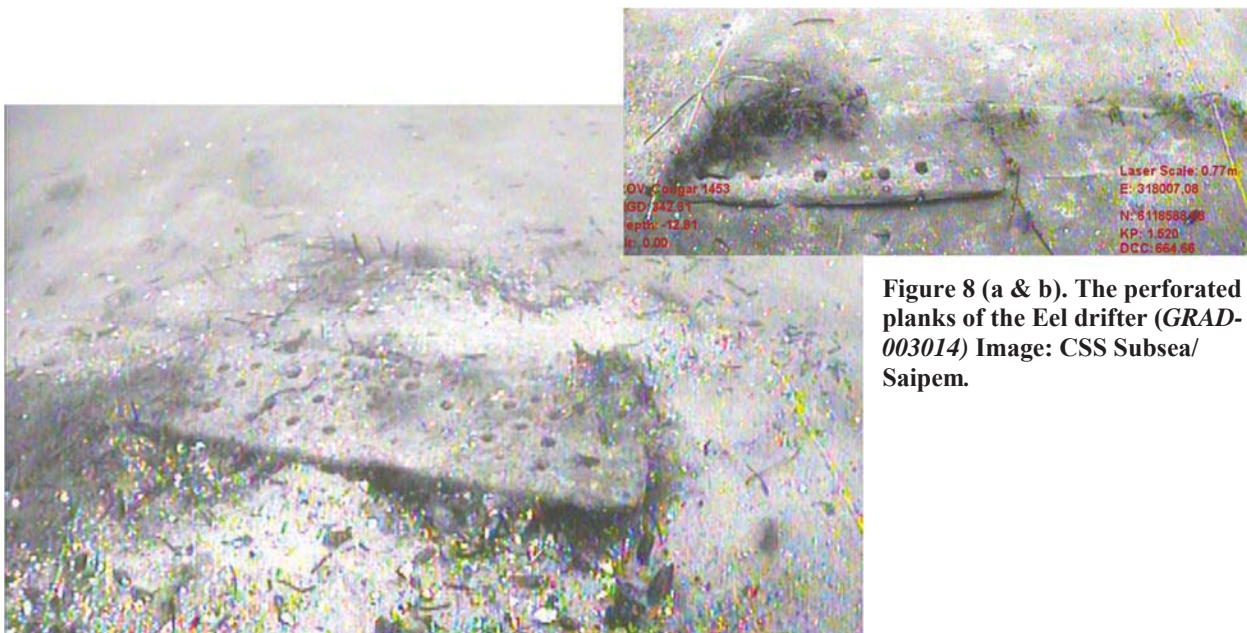
The latter, *PL12001-ACS-CSS-GS-GRAD-003014*, is thought to be the remains of an eel drifter, which would have foundered over 100 years ago, and thus protected by the museums act. This wreck was investigated using ROV with maritime archaeologist Mikkel Thomsen present May 30<sup>th</sup> 2022:

*A 50x50m area centered on the wreck was surveyed visually and using OAS. Furthermore, the four nearest re-evaluation sonar targets (2813-ChanceFind2-SSS0007, -0008, -0019 and -0036) were also inspected. Coherent wreck elements are preserved in a c. 7m long and 3m wide area. Loose elements are seen to the south and east hereof, meaning that the wreck occupies a roughly triangular area of seabed c. 12x13m. The wreck is thought to be the remains of a clinker-built eel drifter based on findings of the characteristic perforated planks from the fish well, the bulkhead that substitutes for a normal frame fore/aft of the fish well, and the small stem/stern knee. This along with the size – and the fact that eel drifters were indeed used in these waters – leads to the conclusion that we are indeed looking at such a vessel. Probably a good 100 years old. A large boulder c. 14 m west may be the cause of wreck during drift fishing.*

**Figure 8 (a & b). The perforated planks of the Eel drifter (*GRAD-003014*) Image: CSS Subsea/ Saipem.**

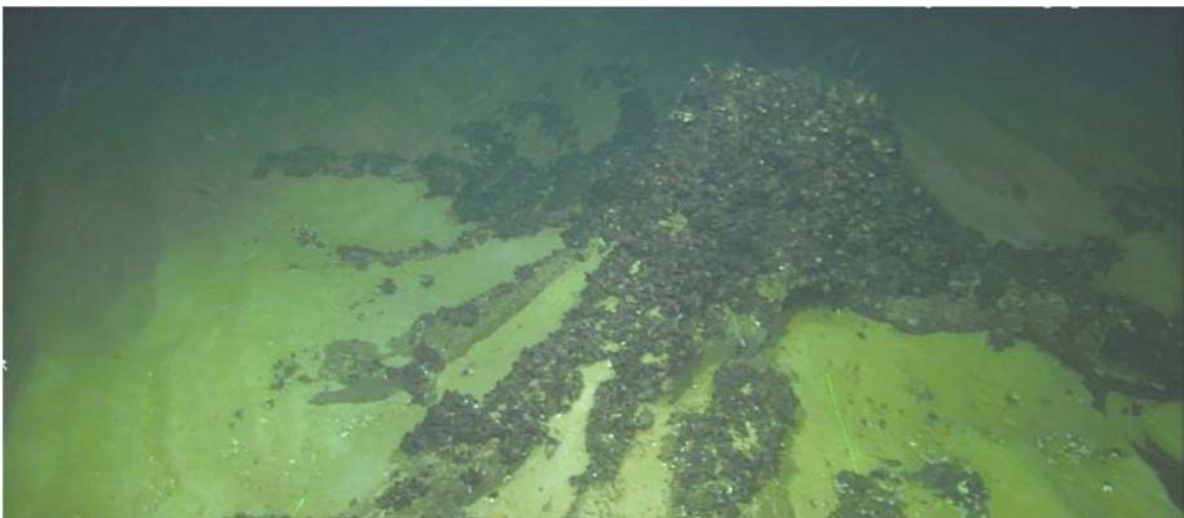
**Figure 9: Rooted tree stump at Rønne Banke off Bornholm (A3\_DK\_GAZ-1270). Image: CSS Subsea/Saipem.**

It should be noted that most of the 46 identified tree stumps/tree trunks are rooted stumps, i.e. remains of submerged forests *in situ*. A number the linear objects selected during the side scan sonar screening were found to be fallen tree trunks surrounded by roots and other debris from decomposing submerged forests during ROV investigation. Potentially these areas are more extensive than earlier estimated, see Figure 10, where the “rough patches” could be remains of the ancient forest off the Zealand coast.

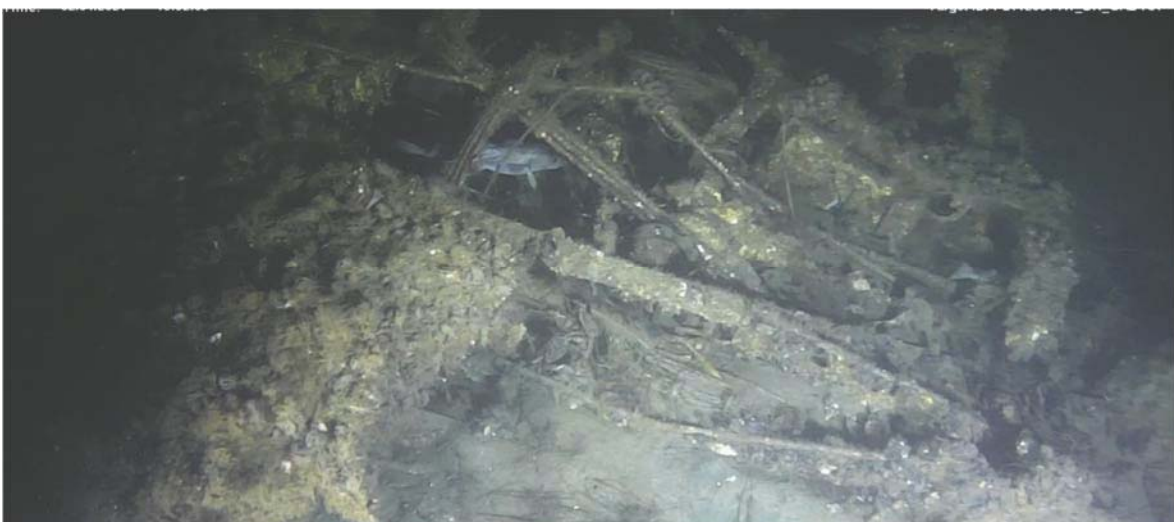
*No identifying marks were observed on the aircraft side or wing surfaces. Examination of the wreck shows that the port engine ... is entirely missing, but possible distorted components of the starboard engine remain. The ailerons are partly broken, but the flap mechanisms close to the fuselage appear to be intact. It is probable that extensive damage was caused when the aircraft impacted the water, either through loss of control or structural integrity, or as a result of a controlled ditching. The cockpit assembly is not visible due to the inverted position of the wreck, and the fuselage is collapsed. Remains of the tail assembly and tail plane are visible.*

**Figure 11: ROV video still image of PL112001-A1\_DK\_GAZ-781. Possible underside of nose. Image: CSS Subsea/Saipem**

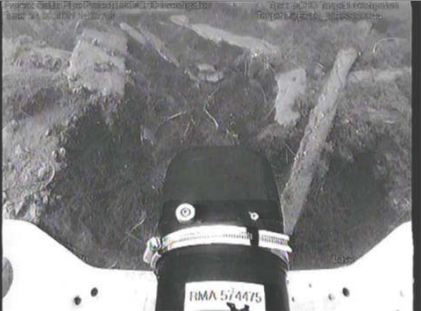
BP09_VIRSSS0023						489895,11	6083050,05	-39,58	182,076	potential CHO / linear object	Wooden construction	Video shows a wooden object, square cross section and just barely curved, with some hole visible. From one end there's a thinner beam sticking out, very poor visibility so hard to see any details. Pres wreck part, dating not possible.	Assumed	50	 
BP09_VIRSSS0041	Linear object					489152,67	6083952,79	-36,74	180,923	potential CHO / linear object	Wooden object, curved, square cross section. Ships frame?	Video shows a wooden object, square cross section, and slightly curved, pres. a ships frame element-futtock. Pres wreck part, dating not possible.	Assumed	50

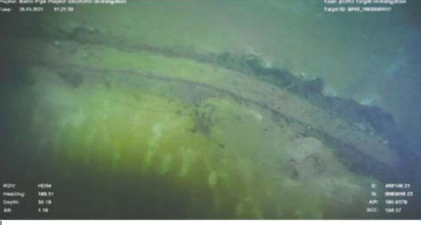
PL112001-A1_DK_GAZ-121	Long pile of something, cirka 11x4 meters. Size consistent with ballast pile. Visible in Bathymetry	Debris	12,24	4,12	0,00	319426,76	6119416,13		2,696	pCHO / cobbles / ballast pile	Wreck. Ballast stones and wooden boards visible. Dating by the provided images not possible.	Video shows a mound of cobbles covered in marine growth/mussels. A brick or cut stone can be seen, pres. a wreck. Dating not possible. PL112001-A1_DK_GAZ-123 is situated 75 meters away, possibly they are related.	Assumed	50 meters radius based on wreck perimeter

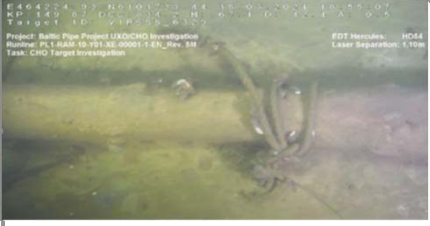
BP06_Li01	Log, slightly bended, diameter 0.2 m, length 3.5 m, orientation W-E, heavily covered by seabed biology.					336245,62	6115524,51		20,071	non-CHO / mound no height	Wooden beam, slightly curved. Ships frame? Check video.	From report: Pres. stempost or frame element; almost entirely overgrown.	Assumed	50

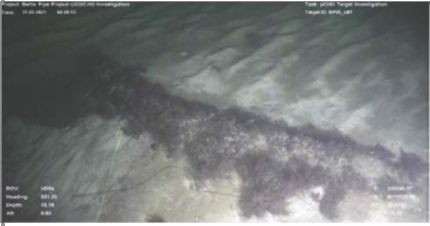
PL112001-A1_DK_GAZ-451	Linear plus boulder?	Linear object	12,06	0,20		340599,94	6115771,23		24,390	non-CHO / linear object / boulder	Wooden plank or pole. Check video	Video shows a wooden board/plank, with holes. Pres hull plank. Wreckpart	Assumed	50

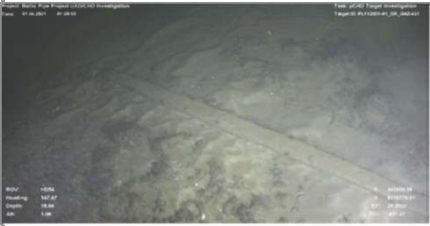
PL112001-A1_DK_GAZ-46	Liear object, 4 meters long. Visible in Bathymetry	Linear object	4,42	0,43	0,24	318142,70	6118893,81		1,589	Non-CHO / linear object / log	Wooden object. Seems square in images. P-CHO	Video shows a wooden object, beam or log, not completely straight but bent naturally or by hand. The size suggest it might be a wreck part, perhaps a futtock. The visibility is very poor, making it difficult to see details or get a good overview.	Assumed	50

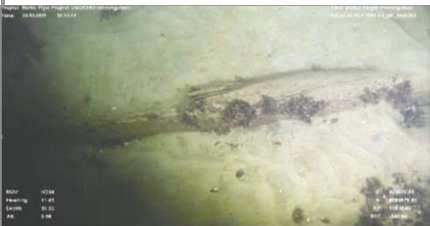
VIR_SSS_0201	Visible in Bathymetry	Linear object	8,73	0,44	1,99	327785,27	6117070,66		11,442	potential CHO / wooden debris	Wooden construction. Poss wreckparts. Check video	Same as BP01_VIRSSS0011. Video shows part of a wreck resembling BP01_VIRSSS0007. These are situated some 150 meters from each other, pres they are parts of the same wreck. Dive 189	Assumed	50 meters radius based on wreck perimeter

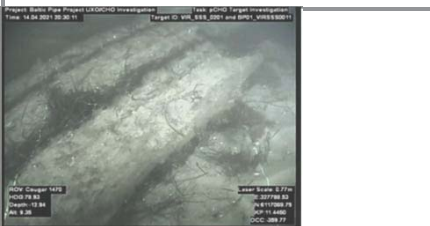
BP01_VIRSSS0011						327790,76	6117071,56	-12,64	11,447	potential CHO / wooden debris	Wooden construction. Poss wreckparts. Check video	Same as VIR_SSS_0201. Video shows part of a wreck resembling BP01_VIRSSS0007. These are situated some 150 meters from each other, pres they are parts of the same wreck. Dive 189-192	Assumed	50 meters radius based on wreck perimeter

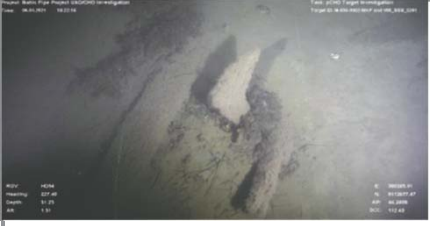
VIR_SSS_0361	Half hidden linear obejct, visible in Bathymetry.	Linear object	10,49	0,12		360288,98	6112976,00		44,250	potential CHO / debris / linear object	Same as M-806-0002-NHP		Assumed	25 meters radius based on wreck perimeter. Digital version provided (shapefile)

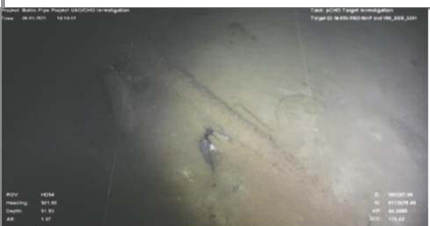
PL112001-A1_DK_GAZ-462	Visible in Bathymetry	Wreck	18,22	5,43		341296,46	6114489,76		25,198	21m long shipwreck, considerably broken up	Wooden wreck. Quite broken up, but many construction details still in place. Far between frames, inner planking, Brick cargo.	Video shows a wooden wreck, broken into two pieces. Ship seems carvel built. Stempost is standing up, but the planking has fallen out. Inner and outer planking visible. Far between frames (50cm?), frames are circa 15x15 cm, and poss double. The windlass seem to be sitting next to the wreck close to the stempost. There are anchors present. One of them seem to have an iron stock, but missing flukes. The other one looks smaller, and more shaped like a grapnel. The wreck is filled with yellow bricks; cargo. Its an considerable amount and underneath the wreck seem to be in good shape. There are wreck parts spread over the surveyed area. Perimeter is based mostly on ROV-Video, as the wreck is situated in a boulder field it is hard to make out wreck components in SSS and MBES images.	Assumed	50 meters radius based on wreck perimeter. Digital version provided (shapefile)

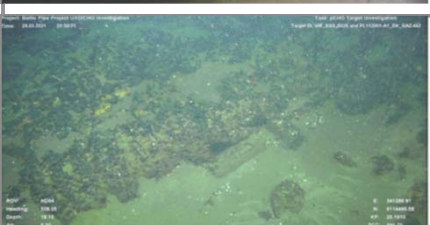
PL112001-A1_DK_GAZ-630	Well defined wreck. Some wreckparts are scattered around the wreck, otherwise, it seems pretty intact.	Wreck	27,29	6,23		357971,92	6113674,88		41,872	Wooden Wreck same as BP06_VIRSSS0116	Wreck. Check video.	Video shows a wreck in quite a good shape. Some chain and rope are spread out to the east of the wreck, and to the south and west there is wooden components. It is entangled in fishing nets. It is likely that the fishing nets are the reason for the degradation of the wreck. Perimeter is based on ROV-Video, SSS and MBES images.	Assumed	100 meters radius based on wreck perimeter. Digital version provided (shapefile)

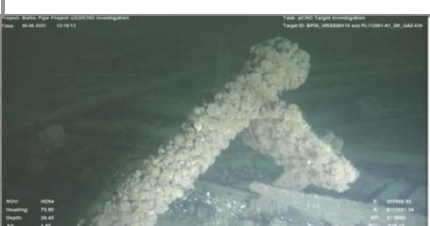
BP06_VIRSSS0116	Wreck					357959,84	6113677,96		41,860	Wooden Wreck same as PL112001-A1_DK_GAZ-630	Wreck. Check video.	Video shows a wreck in quite a good shape. Some chain and rope are spread out to the east of the wreck, and to the south and west there is wooden components. It is entangled in fishing nets. It is likely that the fishing nets are the reason for the degradation of the wreck. Perimeter is based on ROV-Video, SSS and MBES images.	Assumed	100 meters radius based on wreck perimeter. Digital version provided (shapefile)

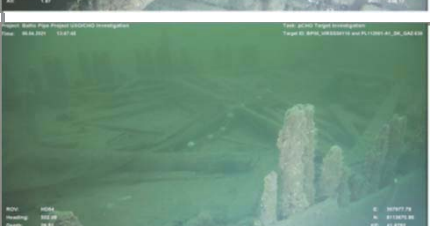
BP06_VIRSSS0111	Wreck and scattered objects					348367,59	6114274,92		32,259	potential CHO / debris / linear object	Wooden wreck part. Straight, square cross section with cut out areas. Check video		Assumed	50

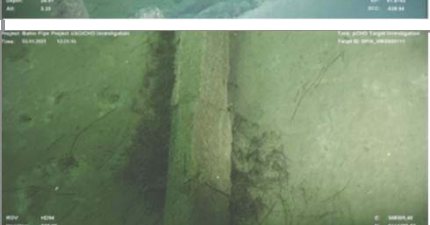
VIR_SSS_0339	Well defined wreck. Pieces scattered around, but otherwise it seems to be very intact.	Wreck	22,11	5,96		352177,31	6114094,60		36,066	Wooden Wreck same as VIRSSS0118/VIRSSS0125	Wreck. Check video.	Video shows a wooden wreck. The main part of the wreck is covered by its iron cargo (rods), while wreck sides have fallen out and are spread around the central area. Single wreck components are spread out over the surveyed area. The windlass is located outside the wreck. Iron stock anchor is present. There seems to be parts of the wreck hidden in the sediment. Poss electrical cables in the wreck? Perimeter is based on ROV-Video, SSS and MBES images.	Assumed	100 meters radius based on wreck perimeter. Digital version provided (shapefile)

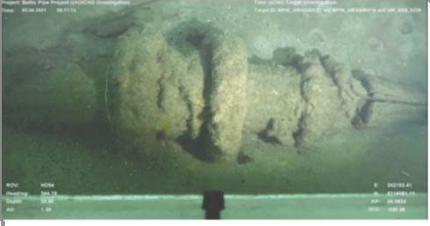
BP06_VIRSSS0125	Wreck					352181,02	6114109,44		36,068	Wooden Wreck same as BP06_VIRSSS0118/VIR_SSS_0339	Wreck. Check video.	Video shows a wooden wreck. The main part of the wreck is covered by its iron cargo (rods), while wreck sides have fallen out and are spread around the central area. Single wreck components are spread out over the surveyed area. The windlass is located outside the wreck. Iron stock anchor is present. There seems to be parts of the wreck hidden in the sediment. Poss electrical cables in the wreck. Perimeter is based on ROV-Video, SSS and MBES images.	Assumed	100 meters radius based on wreck perimeter. Digital version provided (shapefile)

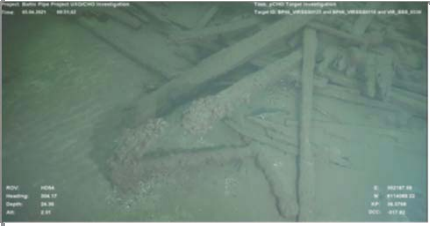
VIR_SSS_0354	Wreck parts from GAZ-630?	Wreck	2,73	0,44		358109,40	6113652,20		42,011	potential CHO / debris	Metal debris. Possible wreck debris	Video shows a number of metal objects, pres debris from the nearby wreck. Perimeter is based on ROV-Video, SSS and MBES images.	Assumed	25 meters radius based on wreck perimeter. Digital version provided (shapefile)

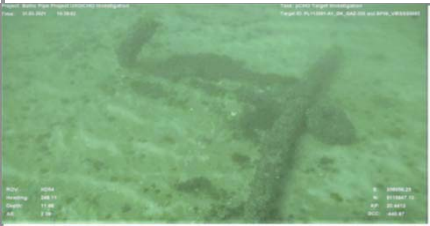
PL112001-A1_DK_GAZ-350	Linear plus point object. Visible in Bathymetry	Linear object	3,61	0,40		336653,93	6115845,14		20,439	Admiralty pattern anchor - same as BP06_VIRSSS0085	Anchor. Wooden stock and quite wide spadeshaped flukes. Well preserved and all parts in place.		Assumed	50

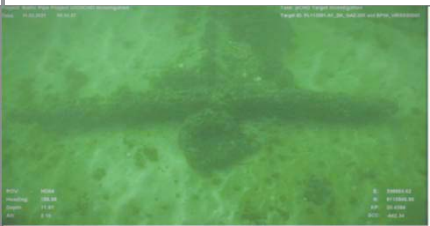
BP06_VIRSSS0119	Linear object. BP06_L13					352324,43	6114062,55		36,216	non-CHO / linear object / debris	Pipe, metal. Possibly wreck part or cargo from adjacent wrecks. Check video.		Assumed	50

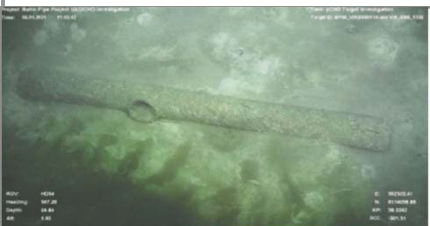
PL112001-A1_DK_GAZ-365	MMO. Anchor?	Anchor	4,37	0,60		337036,07	6114840,24		20,936	Admiralty pattern anchor	Anchor. Wooden stock and quite wide spadeshaped flukes. Well preserved, except for the stock being eroded.		Assumed	50

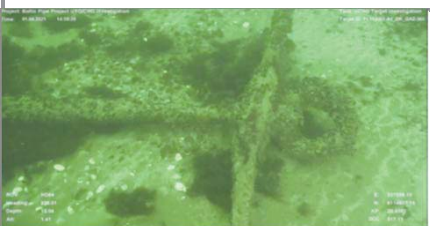
PL112001-A1_DK_GAZ-561	Large anchor, probably with wood stock. Visible in Bathymetry	Anchor	3,85	4,58		344539,89	6113675,42		28,501	Probable 19th century anchor	Anchor. Wooden stock. Flukes missing? Quite well preserved and all parts in place.		Assumed	50

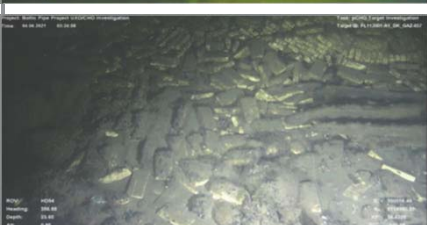
PL112001-A1_DK_GAZ-945	Nice size for ballast mound. Visible in Bathymetry	Mound	14,37	3,78		354856,72	6113148,68		38,832	Wooden Wreck	Wreck. Check video.		Assumed	200

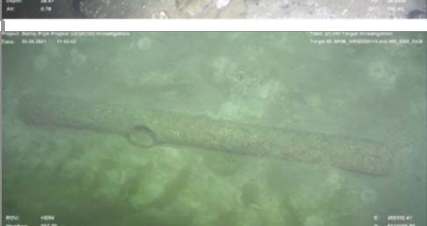
VIR_SSS_0345	Visible in Bathymetry	Anchor	5,53	3,10		350856,19	6113843,16		34,779	Probable 19th century anchor	Anchor. Wooden stock. Flukes and crown missing.		Assumed	50
