NORD STREAM 2 PIPELINE –  
NORTH-WESTERN ROUTE  
Cultural heritage target assessment  
and exclusion zone recommendations

VIR 2740

***16/02648***

June 2019

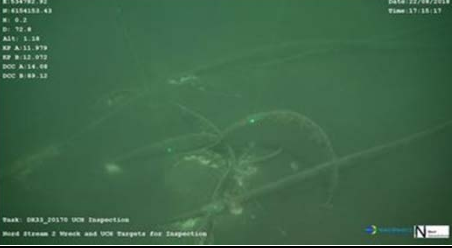
| Name | Side scan sonar | | | | | UTM33_X | UTM33_Y | Visual | | | Exclusion zone R (m) | Confliction |
|---|---|---|---|---|---|---|---|---|---|---|---|---|
| SD-DK33-20170 | Possible buried linear debris | Linear object | 8.18 | 0.32 | 0.00 | 534784.31 | 6154153.75 | | Steel wire rope | N | 0 | |

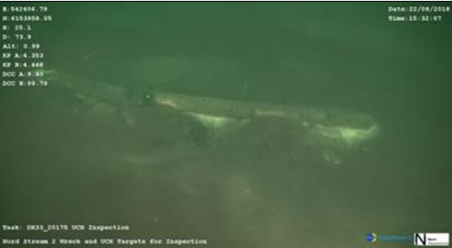
| Name | Side scan sonar | | | | | UTM33_X | UTM33_Y | Visual | | | Exclusion zone R (m) | Confliction |
|---|---|---|---|---|---|---|---|---|---|---|---|---|
| SD-DK33-20175 | | Linear object | 1.71 | 0.31 | 0.05 | 542406.74 | 6153956.42 | | No 360 video (already exists?) Not convinced by this footage | I | Perimeter-based, adjusted | Marginally conflicting |

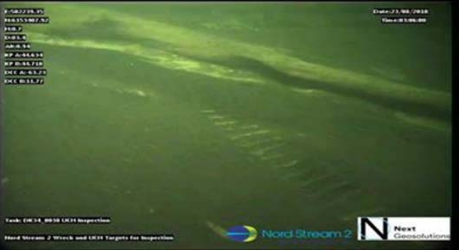
| SD-DK34-0038 | | Linear object | 3.79 | 0.79 | 0.27 | 502239.07 | 6153409.79 | | Natural tree trunk | N | 0 | |

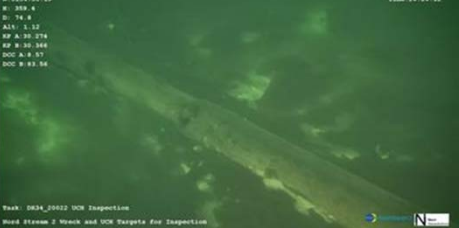
| SD-DK34-20022 | | Linear object | 3.33 | 0.37 | 0.09 | 516506.09 | 6154737.08 | | Metal pipe. Poss. modern gun barrel? | N | 0 | |

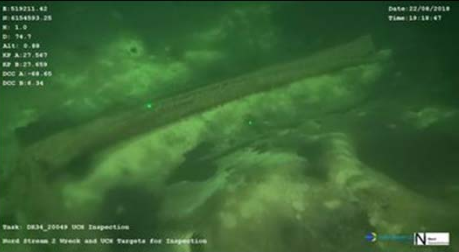
| SD-DK34-20049 | | Linear object | 2.26 | 0.16 | 0.19 | 519212.08 | 6154593.15 | | Twisted piece of metal | N | 0 | |

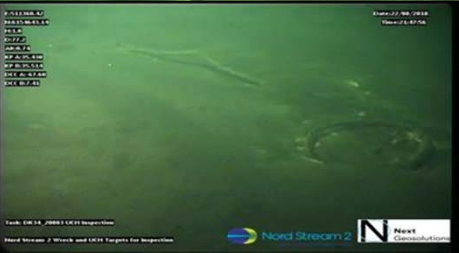
| SD-DK34-20083 | | Linear object | 7.00 | 0.13 | 0.00 | 511359.7 | 6154642.9 | | Steel wire rope | N | 0 | |

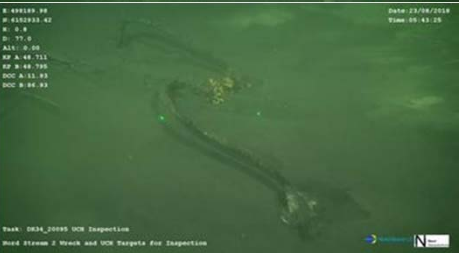
| SD-DK34-20095 | No shadow, possible buried | Debris | 2.63 | 1.04 | 0.00 | 498189.73 | 6152933.98 | | Steel wire rope | N | 0 | |

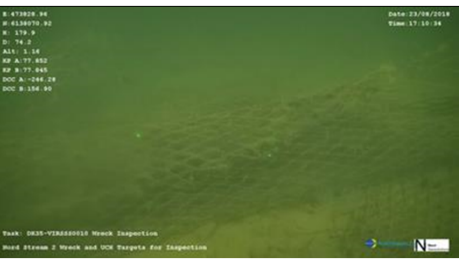
| DK35_VIRSSS0010 | Debris field w. linear features | Debris | 27.34 | 17.63 | 1.21 | 473830.96 | 6138067.31 | | Fishing net | N | 0 | |

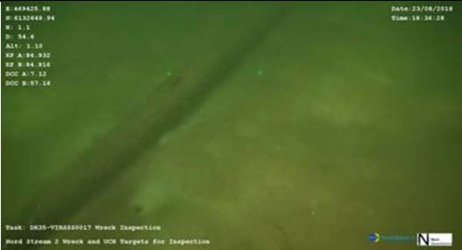
| DK35_VIRSSS0017 | Linear object; poss. semi-buried | Linear angled | 2.95 | 0.16 | 0.12 | 469426.48 | 6132650.21 | | Inconclusive | I | Perimeter-based, adjusted | Marginally conflicting |

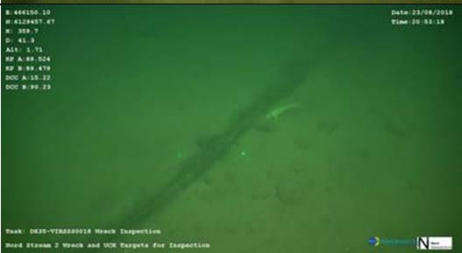
| DK35_VIRSSS0018 | Linear object | Linear object | 8.41 | 0.31 | 0.05 | 466150.78 | 6129459.22 | | Fishing net | N | 0 | |

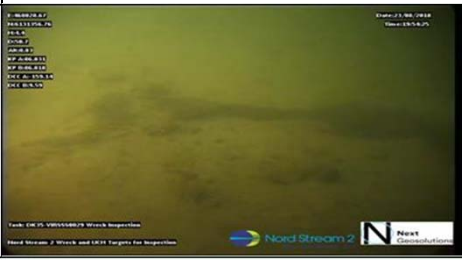
| DK35_VIRSSS0029 | Linear object; poss. objects attaced either end; poss. line debris | Linear object | 6.25 | 0.12 | 0.23 | 468028.26 | 6131355.24 | | Fishing net | N | 0 | |

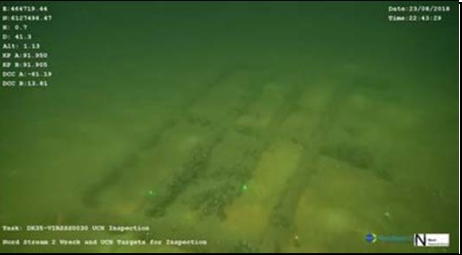
| DK35_VIRSSS0030 | Pres. MMO. Parallel lines | Unknown | 2.28 | 0.99 | 0.10 | 464719.74 | 6127497.42 | | Modern metal railing | N | 0 | |

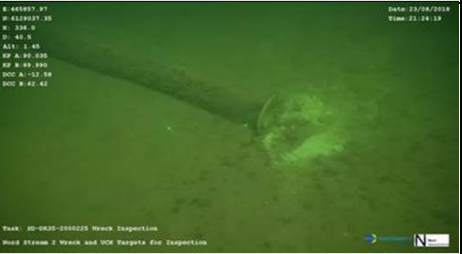
| SD-DK35-2000225 | Pos linear object | Linear object | 4.15 | 0.88 | 0.21 | 465856.7 | 6129037.46 | | Flexible hose | N | 0 | |

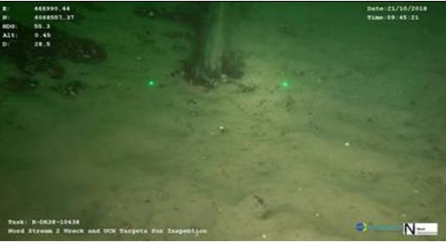
| S-DK38-10438 | | Linear object | 2.49 | 0.46 | 0.09 | 468992.01 | 6068555.69 | | Debris (poss. metal fitting in one end. Tiller?) | I | Perimeter-based | |

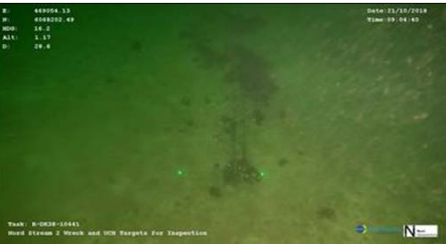
| S-DK38-10441 | | Linear object | 4.79 | 0.45 | 0.08 | 469053.45 | 6068202.59 | | Narrow wooden batten | I | Perimeter-based | |

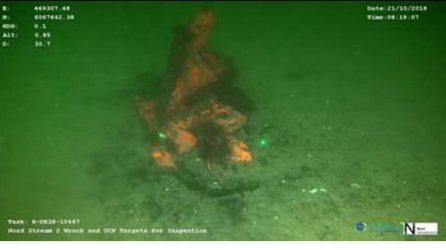
| S-DK38-10447 | No Shaddow | Debris | 3.85 | 1.62 | 0.00 | 469307.56 | 6067640.86 | | Raincoat and (metallic?) debris; the latter heavily covered in marine growth | N | 0 | |

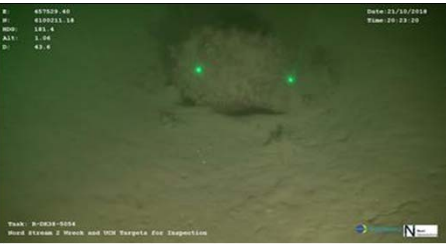
| S-DK38-5054 | | Debris | 5.53 | 1.52 | 0.22 | 457527.96 | 6100211.89 | | Boulder | N | 0 | |

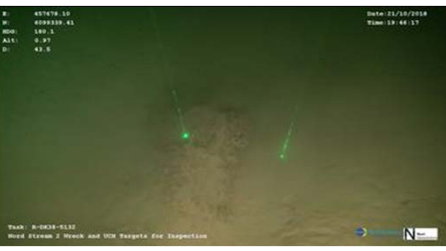
| S-DK38-5132 | | Debris | 3.82 | 0.60 | 0.18 | 457676.17 | 6099342.39 | | Debris | N | 0 | |

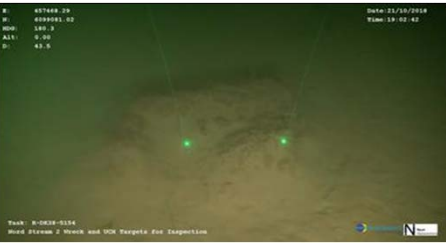
| S-DK38-5154 | | Debris | 2.37 | 1.38 | 0.07 | 457468.71 | 6099081.89 | | Boulder | N | 0 | |

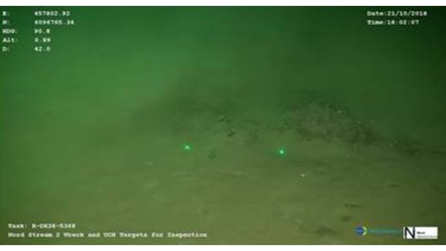
| S-DK38-5368 | | Linear object | 4.20 | 0.42 | 0.07 | 457801.45 | 6096766.62 | | Pres. boulder | N | 0 | |

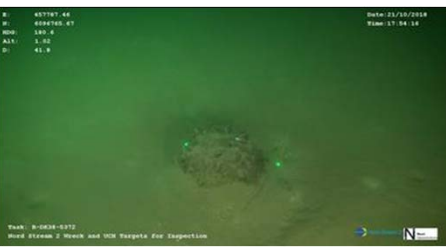
| S-DK38-5372 | | Linear object | 3.48 | 0.56 | 0.21 | 457785.51 | 6096763.21 | | Boulder | N | 0 | |

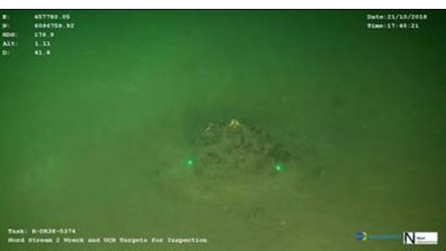
| S-DK38-5374 | | Debris | 3.44 | 0.56 | 0.28 | 457778.88 | 6096760.87 | | Boulder | N | 0 | |

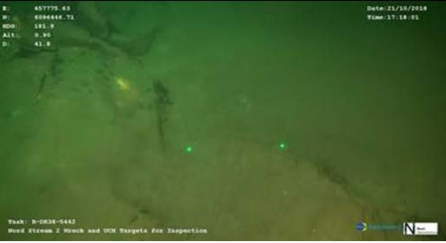
| S-DK38-5442 | | Debris | 3.98 | 2.18 | 0.24 | 457775.29 | 6096444.95 | | Debris | N | 0 | |

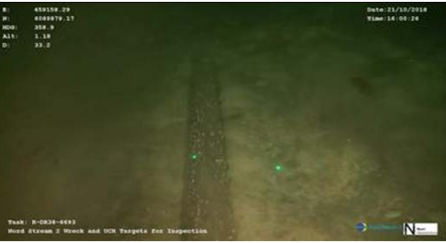
| S-DK38-6693 | | Linear object | 2.62 | 0.19 | 0.18 | 459154.57 | 6089875.25 | | Spar/log; slightly tapered | I | 50 | |

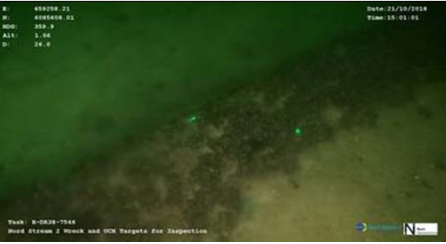
| S-DK38-7546 | | Linear object | 4.39 | 0.60 | 0.31 | 459258.36 | 6085608.52 | | Poss. spar/crane boom; mortise or lugs in one end | I | 50 | |

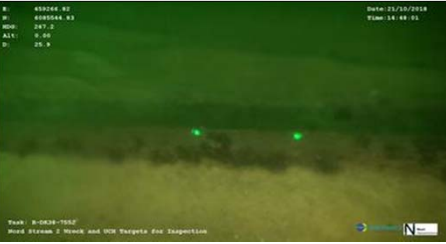
| S-DK38-7552 | | Linear object | 4.14 | 0.43 | 0.15 | 459267.06 | 6085546.47 | | Spar/log/stake | I | 50 | |

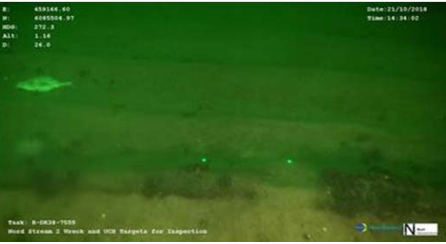
| S-DK38-7555 | | Boulder | 7.37 | 0.60 | 0.10 | 459167.63 | 6085505.19 | | Spar/log/stake/wale (cam not properly focused) | I | Perimeter-based | |

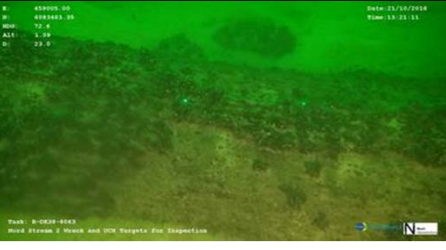
| S-DK38-8063 | | Debris | 4.09 | 2.07 | 0.75 | 459004.91 | 6083461.28 | | Log, sawn | N | 0 | |

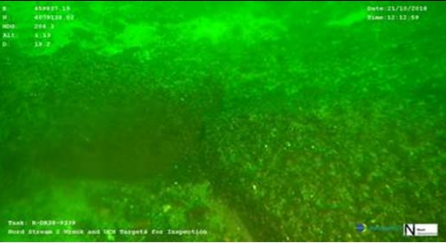
| S-DK38-9339 | Stretched | Boulder | 3.05 | 0.61 | 0.71 | 459835.53 | 6079139.11 | | Boulder | N | 0 | |

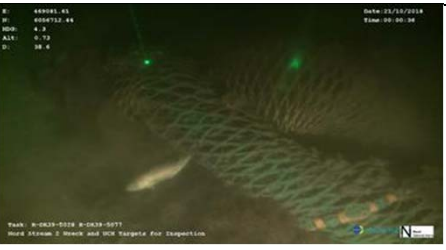
| S-DK39-5077 | No shadow. Partially buried boulder or hard sediment | Other | 6.80 | 1.20 | 0.12 | 469080.69 | 6056713.49 | | Debris | N | 0 | |

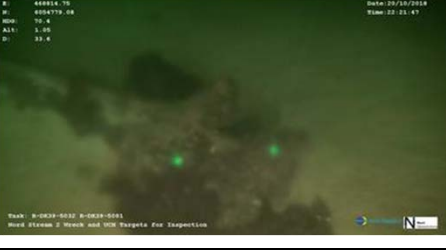
| S-DK39-5081 | | Debris | 7.40 | 0.88 | 0.23 | 468815.99 | 6054782.06 | | Poss. tree; cam. not focused | I | 50 | |

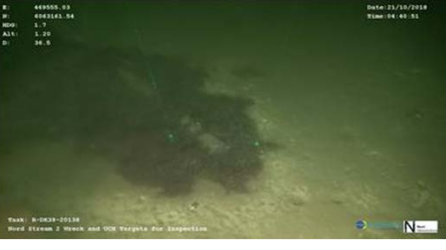
| SD-DK39-20138 | No shadow | Linear object | 2.97 | 0.57 | 0.00 | 469553.89 | 6063161.81 | | Plank/wale/spar/handspike | I | Perimeter-based | |

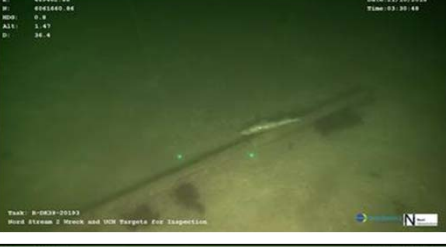
| SD-DK39-20193 | | Linear object | 2.39 | 0.38 | 0.09 | 469462.7 | 6061661.54 | | Spar/log/pipe; material unknown | I | Perimeter-based | |

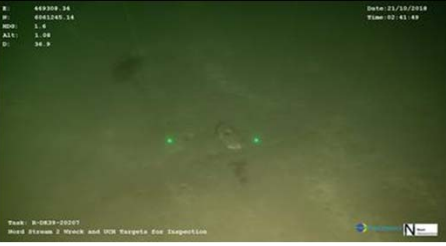
| SD-DK39-20207 | | Linear object | 1.76 | 0.24 | 0.09 | 469307.2 | 6061243.56 | | 40-50 m from target area: spar/log/pipe; material unknown | N | 0 | |

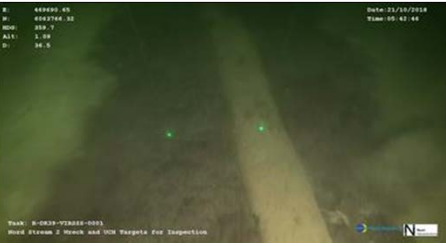
| DK39-VIRSSS-0001 | 1 or 2 linear objects | Linear object | 5.25 | 0.38 | 0.06 | 469692.01 | 6063761.26 | | Log/stake/beam; poss. pointed. Smaller poss. iron obj. nearby. Also net debris | I | 50 | |

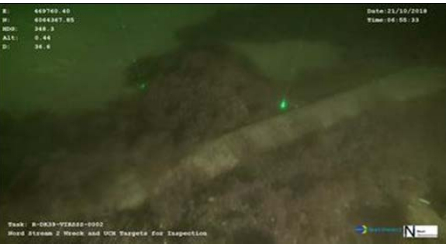
| DK39-VIRSSS-0002 | Linear object | Linear object | 7.40 | 1.09 | 0.13 | 469762.76 | 6064365.88 | | Plank/wale | I | 50 | |

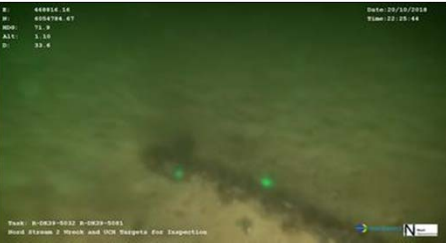
| S-DK39-5032 | | Debris | 7.40 | 0.88 | 0.23 | 468817.28 | 6054784.56 | | (= 5081?) | | 50 | |

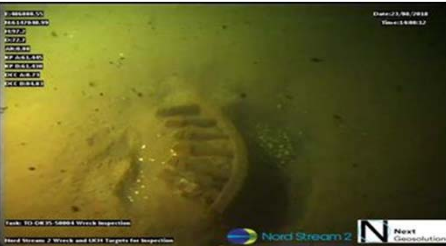
| <b>Project-specific ID</b> | <b>VIR file no.</b> | <b>F&amp;F no.</b> | <b>Desc.</b> |
|---|---|---|---|
| TO-DK-35-50004 | 2902 | 401752-396 | Fighting top or railing |

| TO-DK-35-50004 | Wooden railing | Debris | 0.00 | 0.00 | 0.00 | 486887.68 | 6147840.79 | | Poss. fighting top or railing | Y | 200 | |
