NORD STREAM 2 PIPELINE  
Cultural heritage target assessment  
and exclusion zone recommendations

Mikkel H. Thomsen & Frederik D. Hyttel

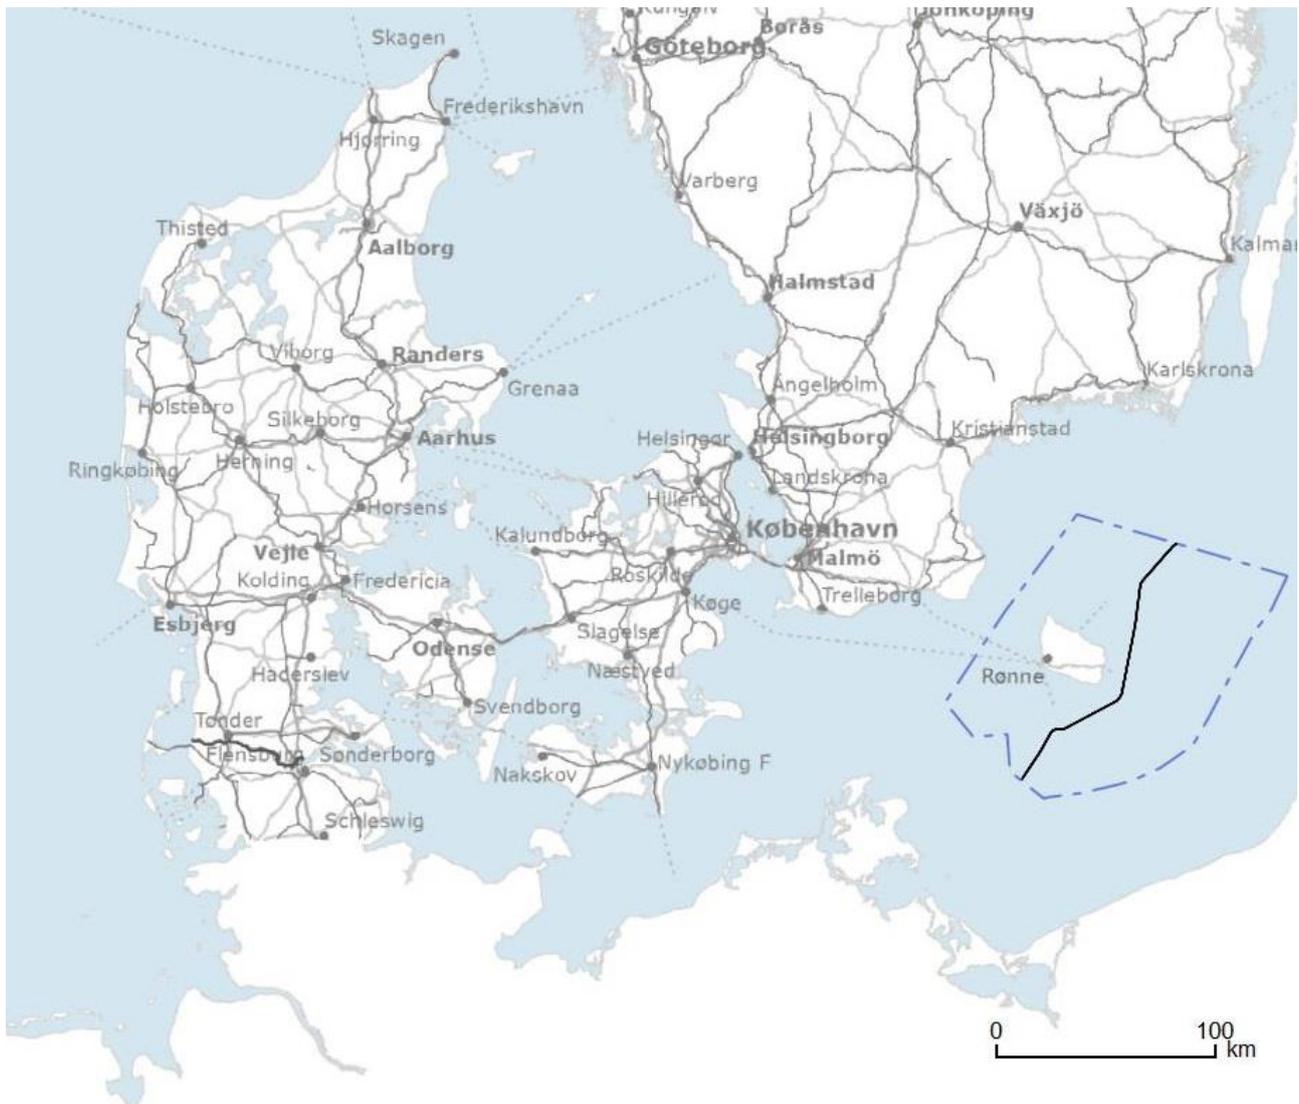
**Fig. 1. Denmark in context, with Danish EEZ around Bornholm in blue, and route design (rev. 07) in black.**  
Graphics: Frederik D. Hyttel © Vikingskibsmuseet. Base map: Styrelsen for Dataforsyning og Effektivisering (skærmkort, dæmpet).

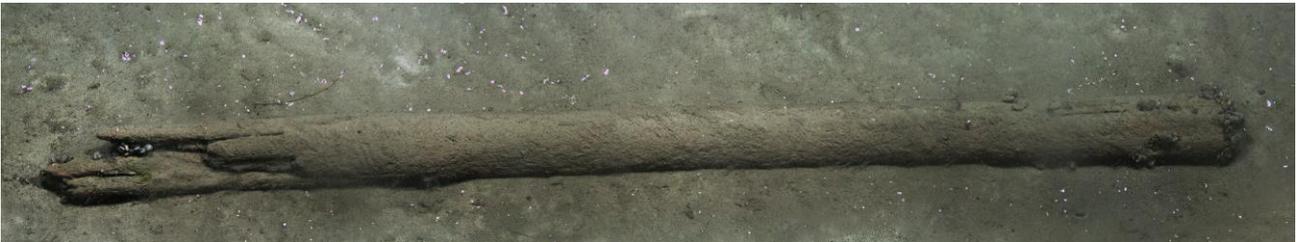
**Fig. 4. Target R35-0745. Photogrammetric model: Matko Čvrljak © Vikingeskibsmuseet.**
