NORD STREAM 2 PIPELINE –  
ANCHOR CORRIDOR  
Cultural heritage target assessment  
and exclusion zone recommendations

VIR 2740

January 2022

## **Anchor corridor. Cultural heritage target assessment and exclusion zone recommendations.**

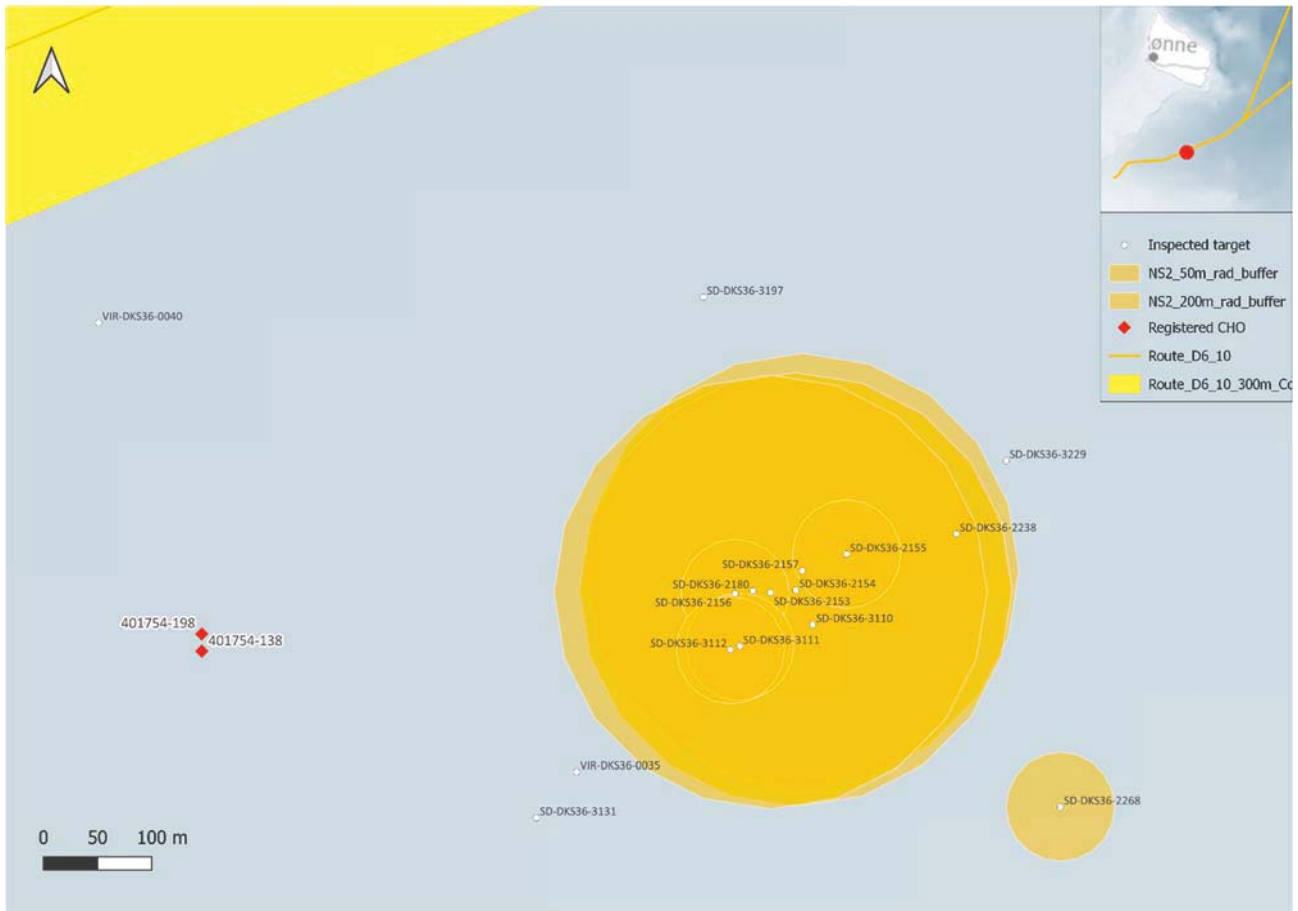
**Figure 2. Map showing the different targets covered by the recommended exclusion zone of SD-DKS36-2153. Base map: Styrelsen for Dataforsyning og Effektivisering (Skærnkort, dæmpet, WMS-service). Bathymetry: EMODnet Bathymetry Consortium (2020): EMODnet Digital B.**

### **SD-DKS36-2153**

Description: Wreck/several wooden wreck parts. One object is probably a mast. A square mast foot in one end of the otherwise cylindrical/conical object may be seen in one image. Another is a possible waterway. Planks, frame elements, knee, pump parts, rudder, scupper. Known to anglers (numerous fishing lures).

The recommended exclusion zone (200 m radius) of SD-DKS37-2153 cover the following targets:

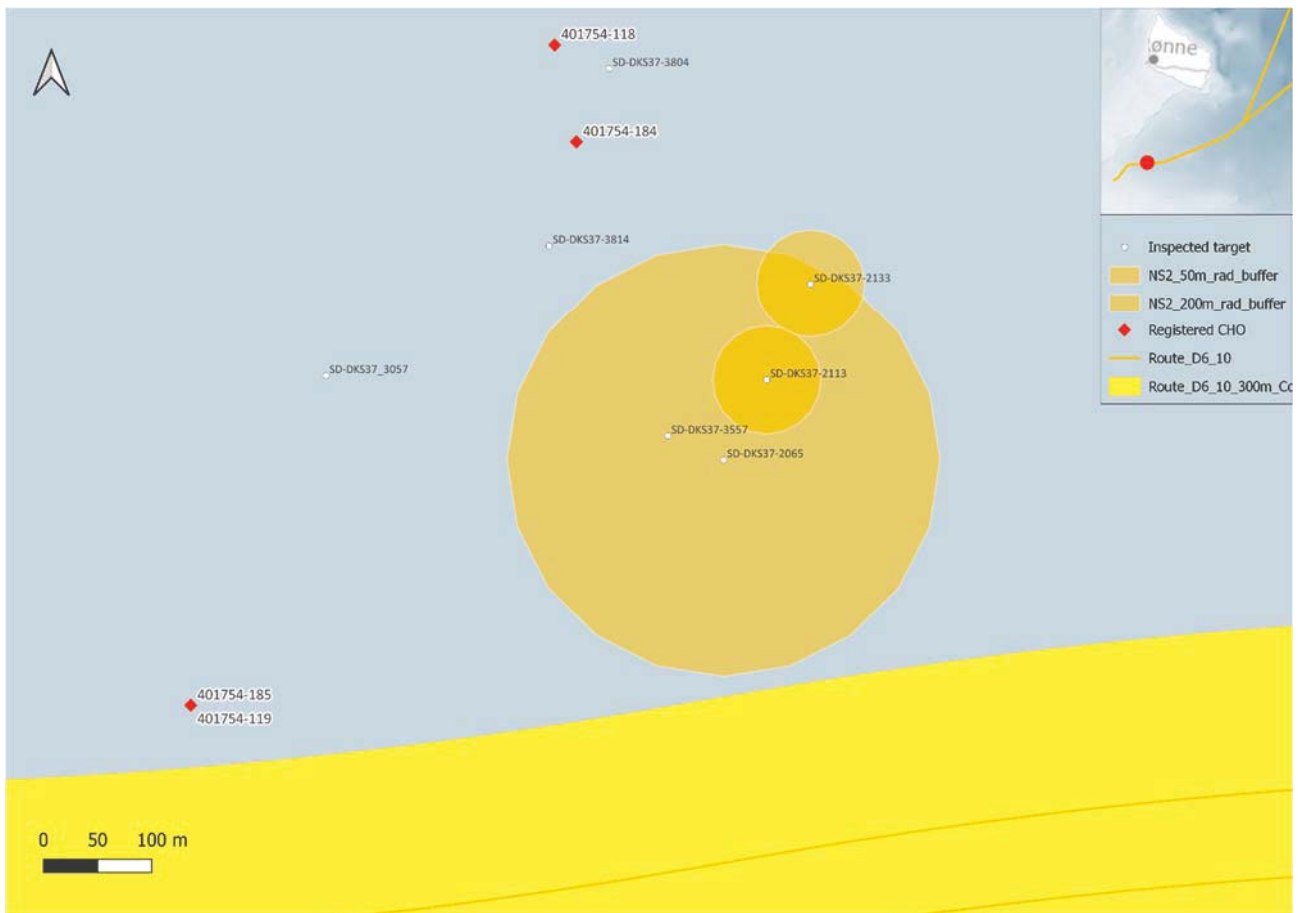
Figure 3. Map showing the different targets covered by the recommended exclusion zone of SD-DKS37-2065. Base map: Styrelsen for Dataforsyning og Effektivisering (Skærmkort, dæmpet, WMS-service). Bathymetry: EMODnet Bathymetry Consortium (2020): EMODnet Digital B.

The recommended exclusion zone (200 m radius) of SD-DKS37-2065 cover the following targets:

- SD-DKS37-2133  
Pres. wreck part: wooden bilge pump pipe
- SD-DKS37-2113  
Wooden board with a couple of nail-holes
