5.2.3 Reconstruction of the ship in torso

Skuldelev 2 was the last and most difficult ship to reconstruct in torso display in the Viking Ship Museum. The general shape of the bottom and the stern of the ship were known features and could be restored following the same principles as for the other ships (Figs 36-37), but the original overall shape and size of the ship had to be estimated by the study of individual features of the floor timbers and other elements found scattered around the ship during the excavation. This study had begun but was not completed at the time the remains were built together in the museum between 1977-1982 and 1986-1993. Some of the observations presented above result from the final processing of all data from this find. Therefore, they were not all taken into account at the time the ship was displayed (Fig. 38).

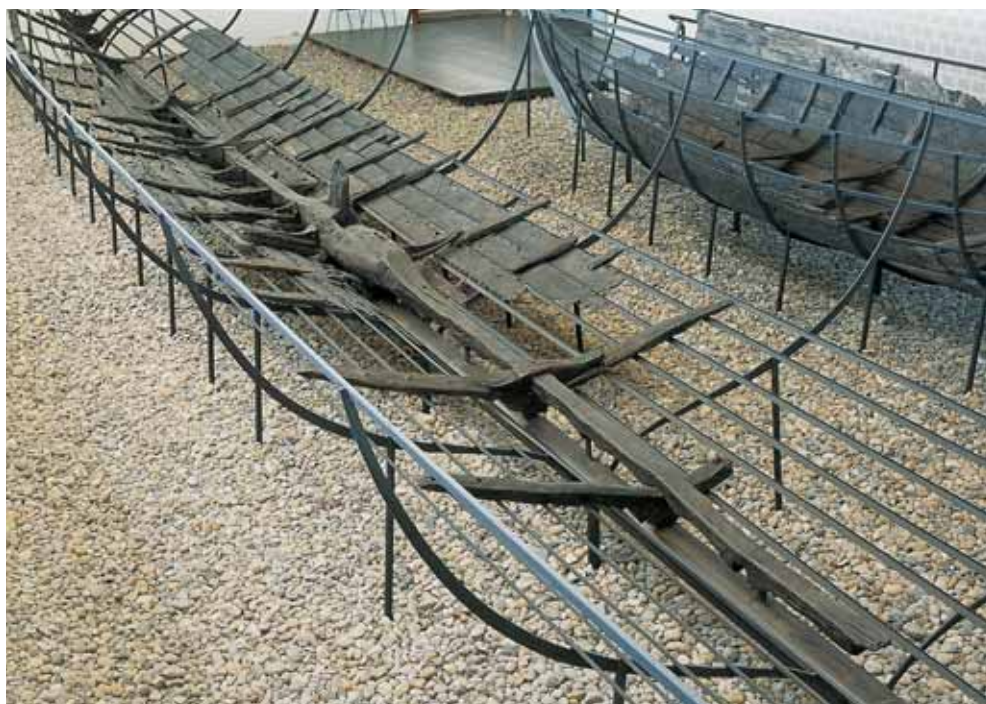
Fig. 36. Skuldelev 2. The stern part of the ship as exhibited in the Viking Ship Museum.

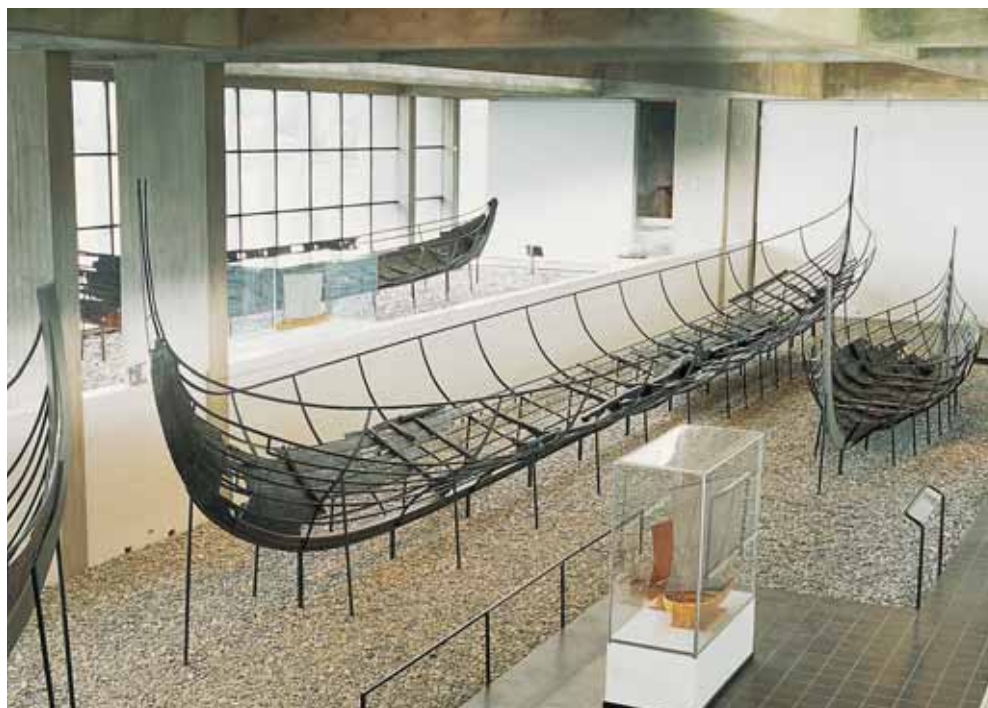
Fig. 38. Skuldelev 2. Overall view of the ship in the museum exhibition.

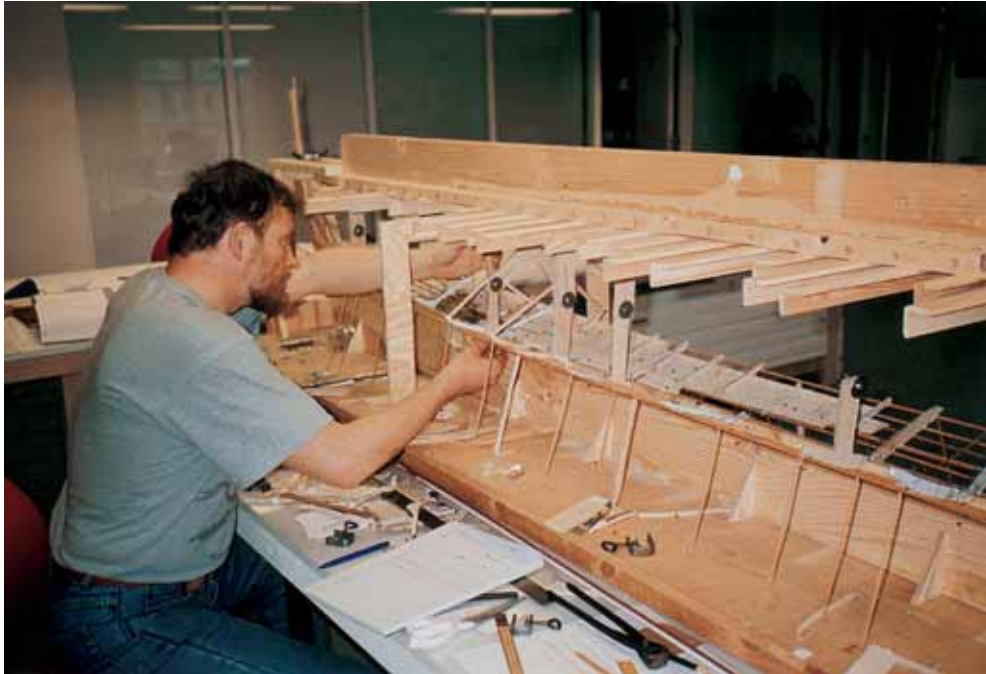
Fig. 39. Skuldelev 2. Working-model at scale 1:10 under construction.

A cardboard model of Skuldelev 2 at scale 1:10, with scaled-down planking and frame-timbers mounted into a wooden frame (Fig. 39), was constructed in 1994-95 by Erik Andersen and Sune Villum-Nielsen.

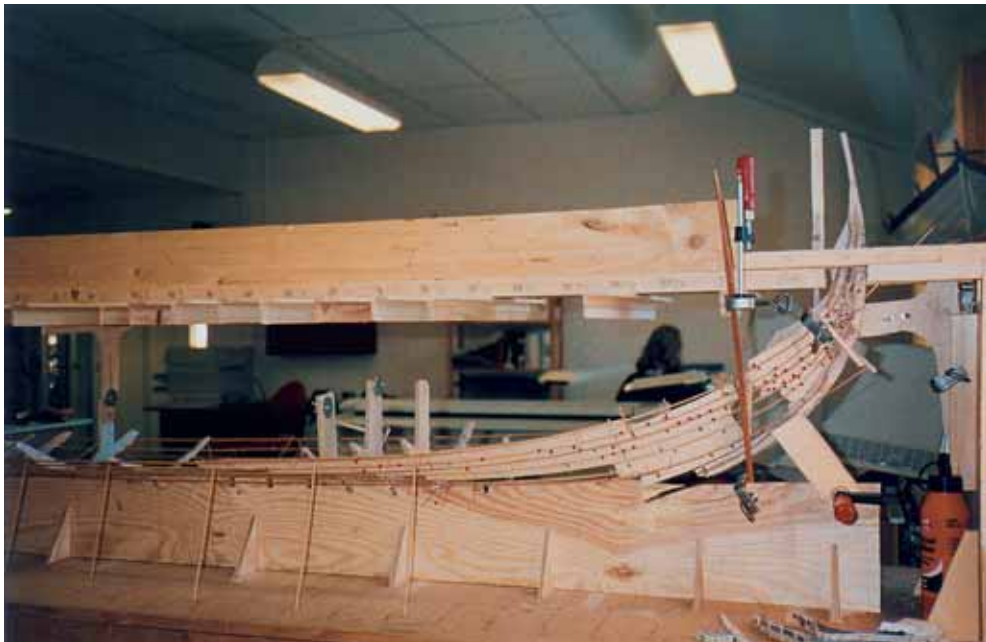
Fig. 40. Skuldelev 2. After part of the working-model.

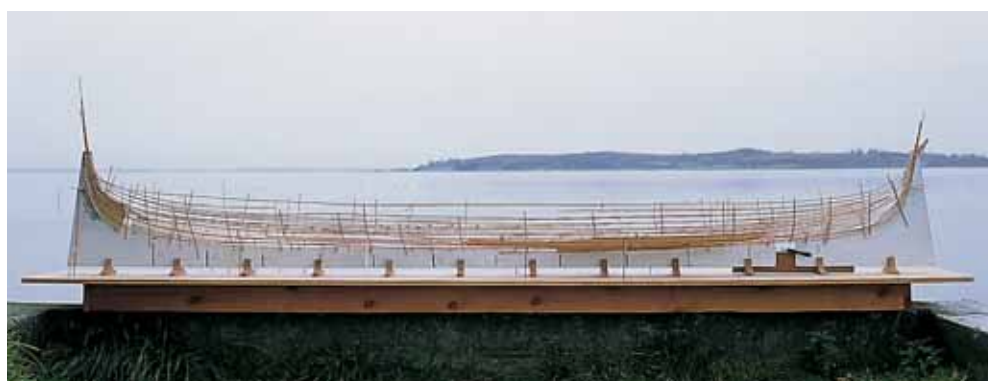
Fig. 41. Skuldelev 2. The working-model completed.

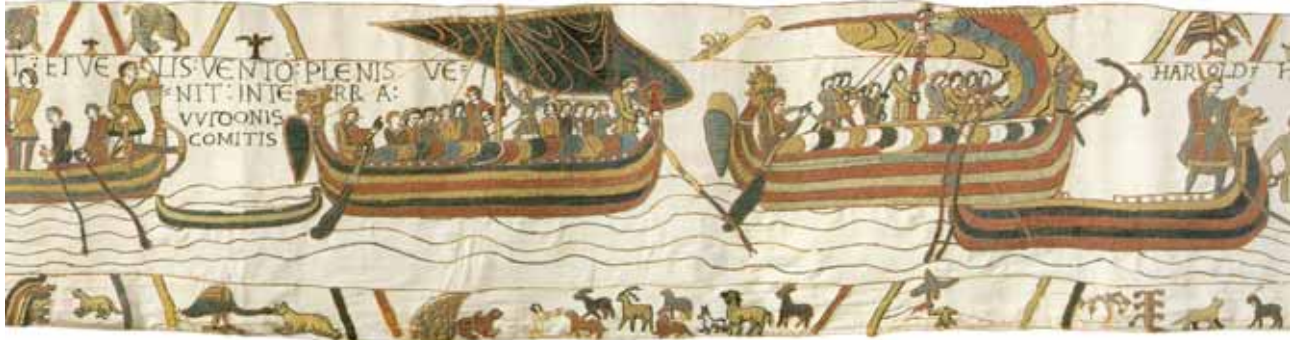
Fig. 58. Harold Godwinson's ship shown on the Bayeux Tapestry at various stages of his voyage to and from Normandy.

Due reference must be made, however, to the artist's iconographic conventions that, for example, depict people oversized in relation to buildings and ships. The size of these ships cannot be determined by simple comparison with the size of the warriors or by their number. André W. Sleswyk, in doing so, suggested a length of only 10-12 m for Harold's ship,³⁰ which must be considered a highly unrealistic size for a vessel used by the Earl of Wessex and his men for a voyage across the Channel. This suggested length would be little more than that of the ship's boat seen towed behind Harold's ship on the tapestry (Fig. 58),

The depiction of sails on the tapestry is a good example of such a process of simplification. The first time a sail is shown (cf Fig. 58), it is presented in its full width at its top

as well as at its lower edge. This would be too dominant an element in the composition, however, if the sails were shown in this way in all ships. Therefore, the other sails are only shown in full width at the yard at the top, whereas the lower part of the sail gradually narrows down to a single rope, symbolically held in the hand of the helmsman (Fig. 59). In practice, ships of this size would always have the sheet of the sail belayed aft at a cleat or on one of the beams. *In principle*, however, it would be the helmsman who was in control of the handling of the sail - which is exactly the message conveyed by the images of the ships on the tapestry.

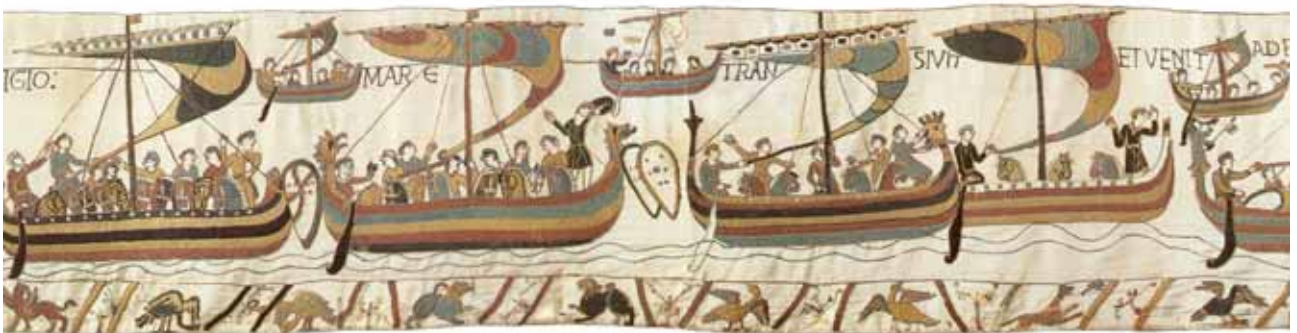
Fig. 59. Norman ships crossing the Channel in 1066. Figs 58 and 59 printed by special permission of the City of Bayeux.

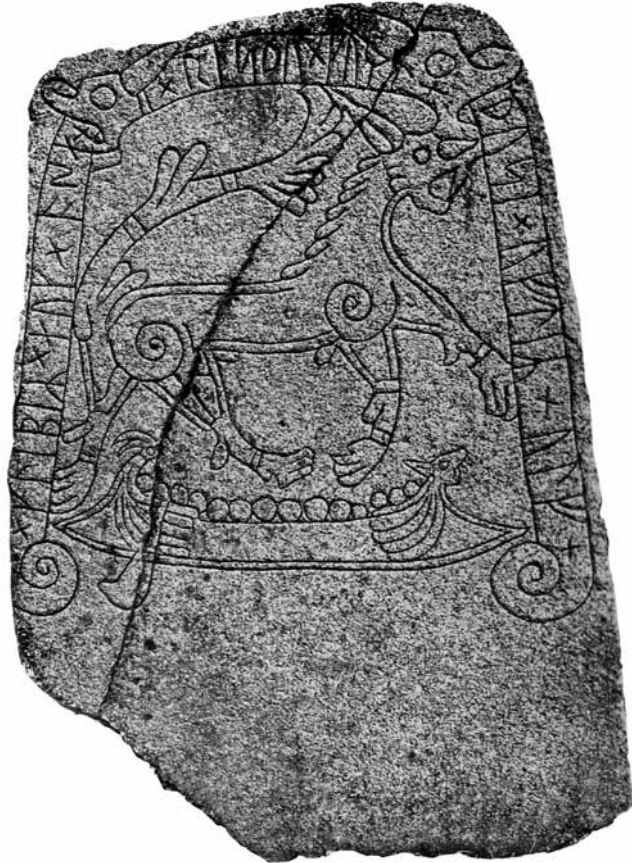
Fig. 61. The runic stone from Tullstorp, Skåne/Scania. Dated to ca AD 1000 by its inscription.

Out of the seven or eight ships that are depicted on such stones found within Viking-Age Denmark, the rune stone from Tullstorp in Scania is a major example⁴³ (Fig. 61). Its inscription: "Kleppe and Åse set up this *kuml* (monument) in memory of Ulv" is simple, yet datable to ca AD 1000. The ship, together with a splendid beast and two wolf's heads, is an element in a composition reflecting aspects of pre-Christian mythology. Here, as on other rune stones and the Gotland stones, there is never any direct connection to be found between the inscription and the pictures.⁴⁴ The interpretation of these scenes is the subject of a lively debate,⁴⁵ as the ship may be seen in several different roles: as the magic ship *Skiðblaðnir* of the god *Freyr*, as the ship *Naglfar* of the *Ragnarök* myth, as the boat from which the god *Thor* fished for the World Serpent, or as a means of transport for the deceased to the next world. In the case of the Tullstorp stone, the combination of the ship and the beast makes a good case for the *Ragnarök* myth of the end of the world, involving the wolf *Fenrir* and the ship *Naglfar*.

The ship on the Tullstorp stone, therefore, does not represent the ship of Ulv, for whom the stone was erected, if he ever had a ship himself. It was a symbol related to another world, an icon for a myth which may have been composed centuries earlier and have little bearing on the actual character of contemporary longships. The Tullstorp ship has

ram-like projections at both ends, and a similar profile is seen on several other rune stones, Gotland stones, and coins from the early ninth century. These features probably are reminiscent of an early stage in the transition of Scandinavian ships from rowing vessels to sailing ships before the beginning of the Viking Age.⁴⁶ No stems of this character have been found in Scandinavia, neither among the few pre-Viking finds, nor among the numerous Viking-Age stems found with a ship or as loose elements. This does not, however, preclude the possibility that ships were built this way for a period, possibly in the seventh and eighth centuries, and that these ships played an active, formative role in the myths at that time. Even many of the rigging details that can be seen on several of the Gotland stones appear to represent early stages in the adaptation of sailing

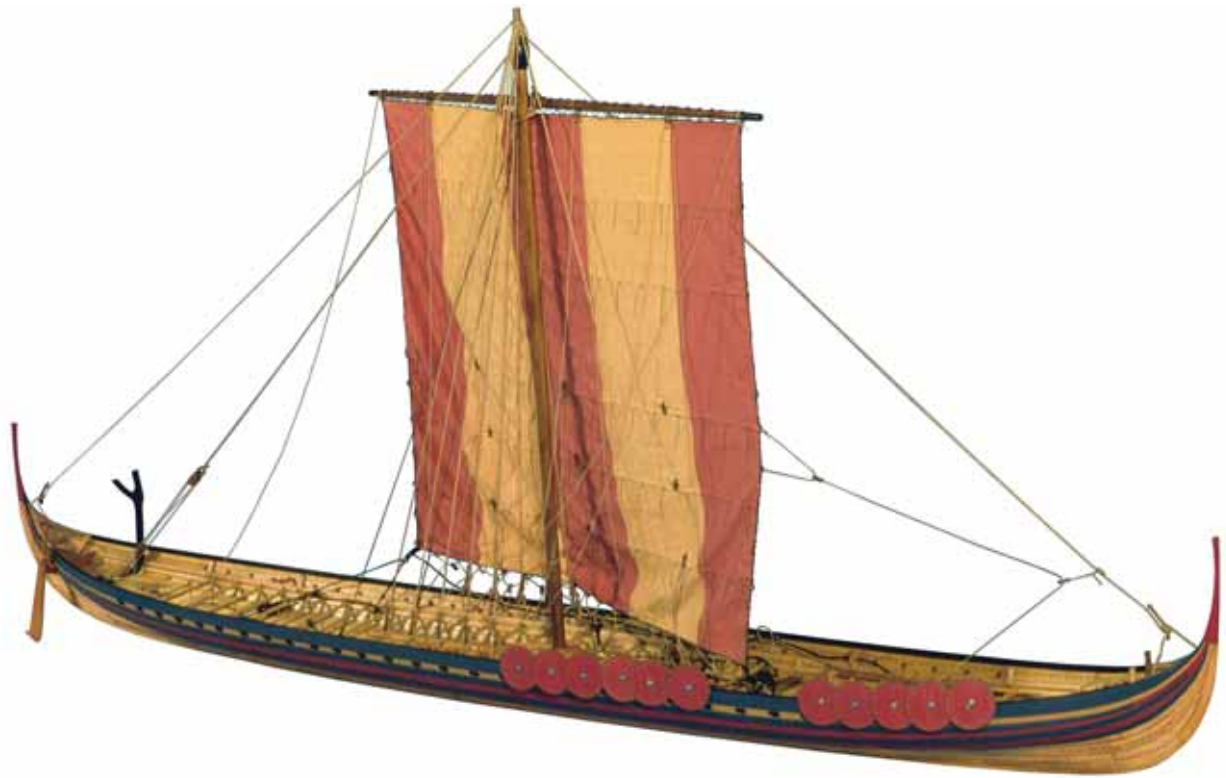
Fig. 64. A model of the Skuldelev 2 longship as it may have looked in ca 1050. 1:10 scale model made by Morten Grønbech, with the rigging reconstructed by Erik Andersen and Vibeke Bischoff.
