FEHMARN BELT FIXED LINK MARINE ARCHAEOLOGICAL REPORT

The Excavations on the Wreck of Lindormen

Ostsee Gebiet 1433, LA 3

AA2012-279

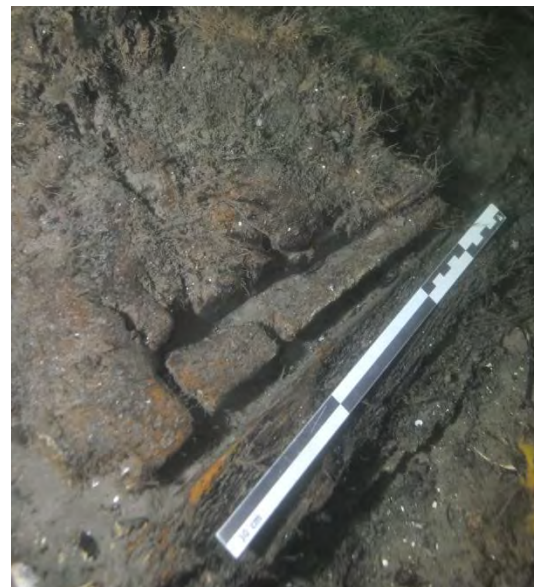
Figure 11: Frame timber with peculiar feature.

reveal the sided face of four framing elements – a single butt joint flanked by two continuous timbers. There is no direct evidence that the elements are connected to one another, but the density of the pattern and the uniform timbers certainly render the possibility feasible. A curious anomaly is a deformed frame on the after port side. It appears that a wedge has been inserted between the frame and the planking, but the wedge and frame are in fact part of the same timber. It seems unlikely that the timber should have received such peculiar damage after the ship's sinking, and might be attributed to a mistake, or perhaps a conscious use of sub-par timber, during the construction process.

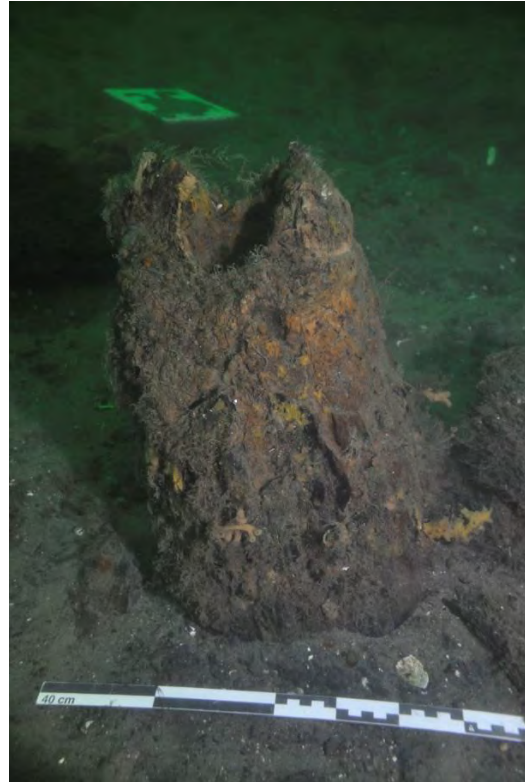
Figure 17: Protruding pump shaft.

What are most likely two pump shafts, protrude from the seabed about 11.5 m from the presumed stem. They are positioned symmetrically around the ship's centreline 2.9 m apart, and the shafts consist of two similar hollowed-out tree trunks with an outside diameter of 25-27 cm and an inside diameter of about 8 cm. Both shafts were examined to determine their internal depth. The western shaft, which extends 45 cm above the seabed, was found to be obstructed at a depth of 2.5 m below the seabed, and the eastern shaft, which extends a full 80 cm above the seabed, at just 2.2 m. The discrepancy may partly be explained by the slight starboard list of the ship, raising the port side relative to the seabed, and thus resulting in a slightly shallower sounding depth. The shaft may naturally also be obstructed at different depths by objects other than the ship's bottom, resulting in different readings again.

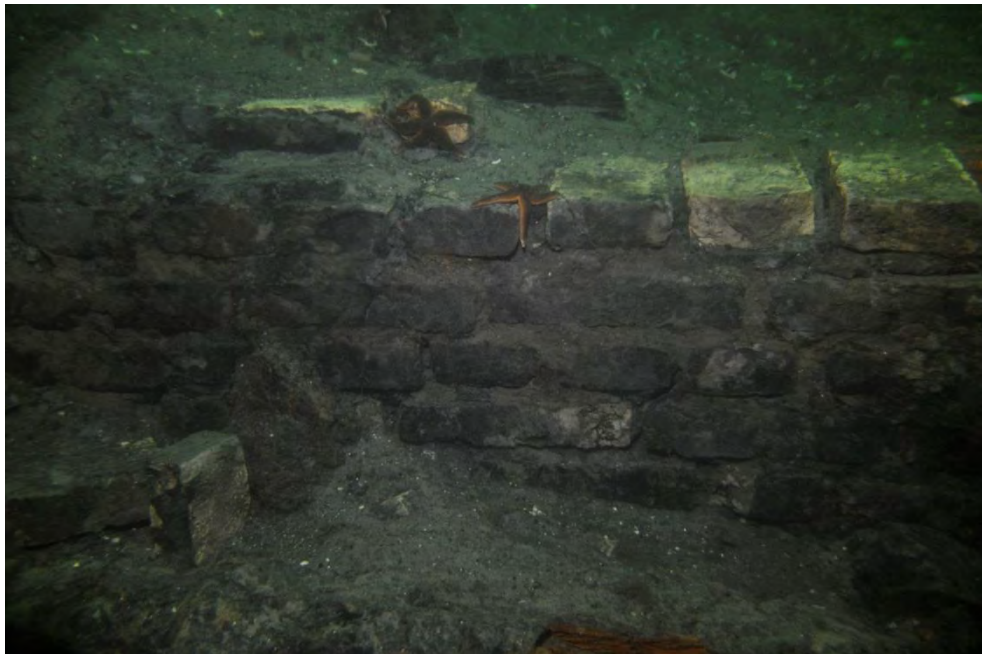
Figure 19: Looking north in the north brick wall of the galley.

The protruding bricks either end of the after wall seem to indicate the full length of the wall, and assuming the woodwork on the starboard side is similar to the port side—although presumably in the shape of a full wall rather than merely a threshold—the width of the galley athwartships is nearly identical to the 2.75 m measured on *St. Sophia* (Bergstrand and Arbin 2003: 22, 31), and slightly smaller than the 2.90 m of the *Vasa* (Ray 2009: 42). The dimension along the keel, around 1.3 m, is however strikingly short in comparison to these two ships, both sporting galleys well over 2 m long. Considering also the proportion of the floor space occupied by the *ezel*, the excavated area seems unlikely to have made up the entirety of the galley workspace, leaving simply no room for a cook. Perhaps, then, the forward plank does in fact not delimit the forward edge of the galley, but rather a transition from the hearth to a second compartment.

The small yellow bricks used throughout are again very similar to the type used in *St. Sophia* and the later *Lossen* (Molaug and Scheen 1983: 156), and probably with good reason. Danish brick production had declined through the 16th century, and by the turn of the century many bricks were imported from the duchies and the Netherlands. The galley bricks match the type known as *flensborgsten* very well, characterised by its generally yellow colour, slight thickness of no more than 4.5 cm, and 1:2:4 side ratios including mortar joints (Cathrinesminde 2002: 49, 63, 80). However, these flensborgsten predominantly produced in the duchies only gained widespread popularity in Denmark during the 18th century. During the 1620s and 1630s similar bricks were exported from the Netherlands in large

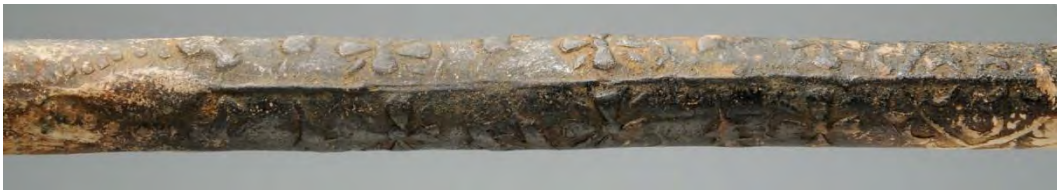
Figure 47: Stem of pipe X76 with floral motif.

The collection of stem fragments, despite their greater numbers, hold little potential for refining the answers granted by their companion bowl fragments. While some of the stems connected to EB stamped bowls display a repeated decorative motif of fleurs-de-lis framed in diamond shapes, care should be taking in attributing other stem fragments with this motif, even in a similar execution, to Edward Bird. While this may well be the case, the motif is one of the earliest used decoratively on clay pipes in Holland, and gained popularity in a number of different areas (Duco 1981: 248-9, 377). Similarly, the extensive floral motif of X76 is known from Amsterdam during the same period, but seems difficult to attribute any more precisely (Duco 1981: 251)

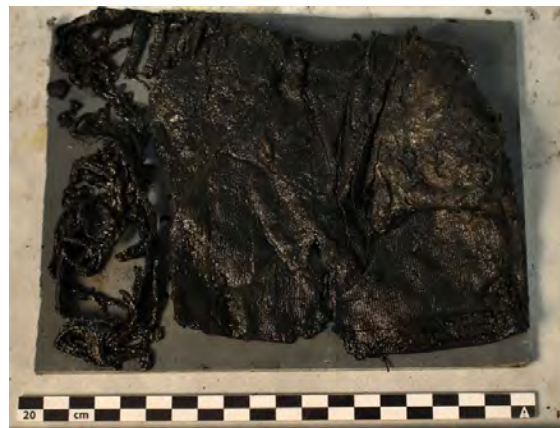
Figure 49: Textile find X 166. Custom made handbag, presumably from sailcloth, with decorated opening.

Whereas the find was found pitch black due the lack of oxygen where it was deposited, later on the embedded iron content from nearby finds turned the cloth rusty red.

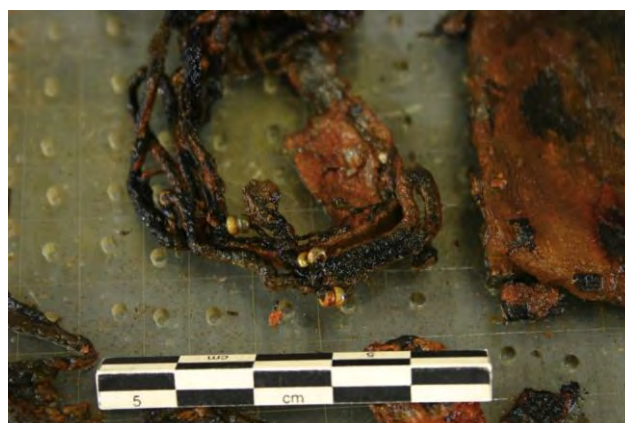
Figure 50: Bag X 166 with tiny glass beads on the decorative threads around the opening.

Another fine textile find is item X 166 (fig. 49). It seems to be custom made rectangular bag from sailcloth, the long sides and one small side sewn together, whereas the other small side is left open. Along this opening there is some decoration attached, e.g. twirled threads laid in loops. The cleaning process in the laboratory revealed, that on these threads tiny glass beads are attached (fig. 50). It is worth noting, that no women were present on board, which means that the masculine fashion in the baroque era comprised highly decorated items, which nowadays would not be expected on board of a man-of-war.

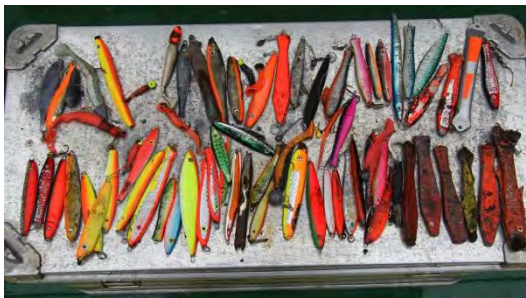
Figure 54: Modern sinkers and lures collected on and in the sediment.

Before the cut is a 3 mm hole through the sinker, giving the impression of a double-headed fish albeit with heads offset 90 degrees from each other. Numerous sinkers and lures from the 20th and 21st century were encountered at the site—their recent or not quite so recent date rather obvious—and some of these had in fact penetrated the sediments to surprising depths,

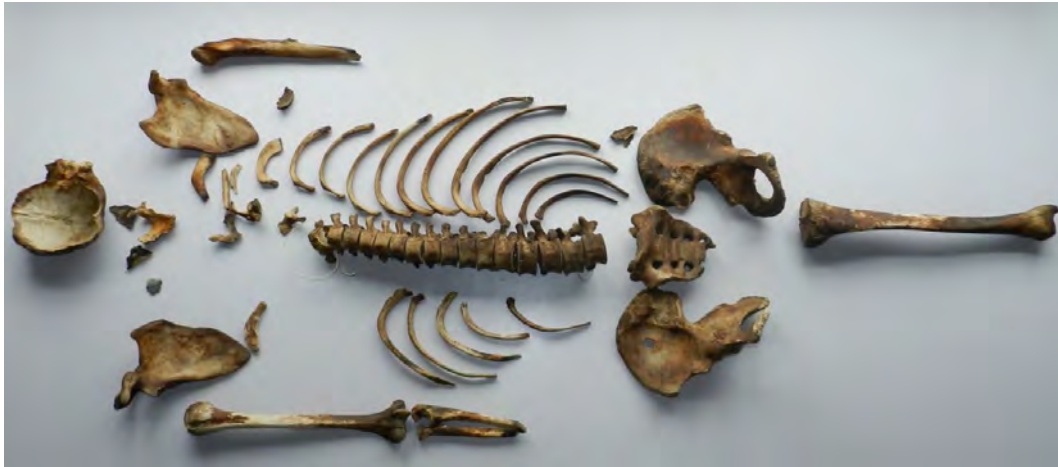
Figure 55: Bones X56 laid out.

Several bones show degenerative changes which, given the age of the individual, may well reflect a life of hard physical labour. This may render a position among the higher spheres of the ships' hierarchy unlikely, but does not necessarily point to a common sailor either. If the recovered shoe (X91) did indeed belong to this man (his slight stature perhaps explaining the small size), then a relatively well-paid position as gunner or non-commissioned officer might perhaps be a more, or at least equally, appropriate guess.

The circumstances of the man's death and his ending up on his back in the hold are naturally difficult to establish. It is clear, however, that the skeleton sustained fractures in at least two separate incidents. The first occurred around the time of death, and resulted in the lengthwise fracture of the left upper arm. A significant force must have been required to affect such damage—the left lower arm is not represent among the recovered material, but it may well also have been damaged or even severed—and it seems likely that the same event was the cause of death. The other incident(s) evidently occurred post-mortem, and appears not less violent: the right lower arm was fractured, and the skull largely crushed. Parts of the upper body including the skull fragments were discovered underneath one of the recovered bronze guns (X121), suggesting a likely cause of the trauma.

Many of the bones exhibit varying degrees of discoloration, but this seems more likely to have been caused by biological processes in the sediments rather than by any factors related directly to the events in 1644. Likewise, the few discernible occurrences of cut marks have probably been inflicted during or after recovery. A distinctly blackened area of the cranium may, however, have been caused by exposure to high temperatures around the time of death, and the presence of several small beads of melted bronze embedded in the rear of the cranium seems to support this hypothesis. Assuming a relation to the post-mortal skull trauma, the bronze traces furthermore indicate that both the fatal and subsequent incidents occurred while the ship was still afloat. Conceivably, the man was killed on the gun- or upper-deck during the battle, and subsequent either placed in the hold intentionally, or simply left to drop through the levels of the ship—along with the guns—as the decks disintegrated.

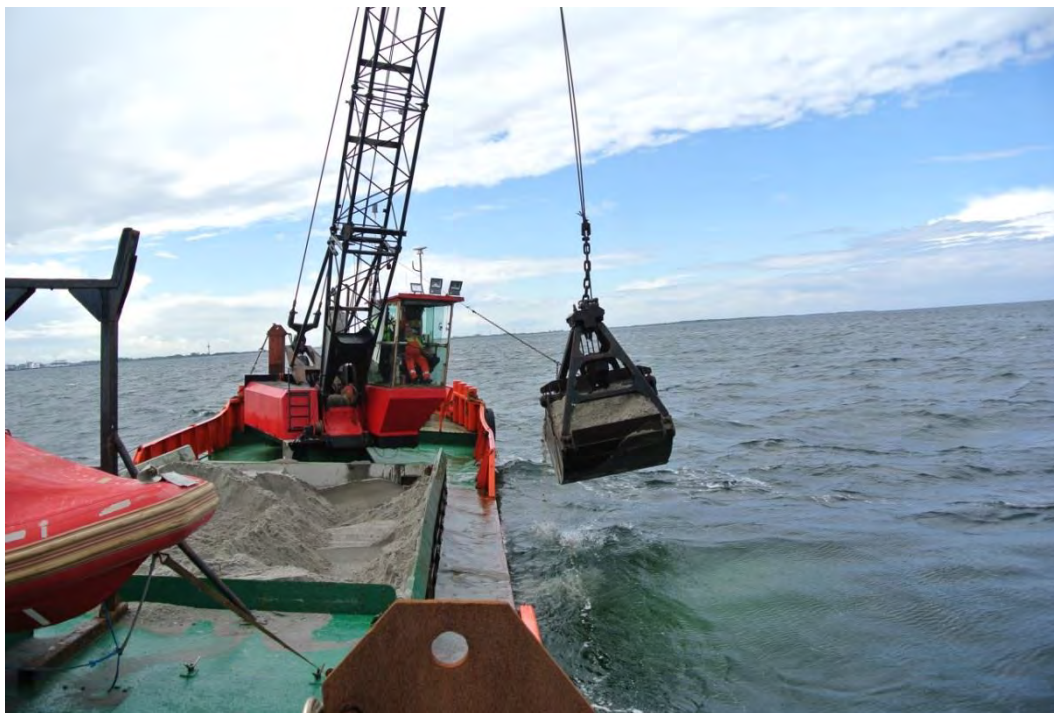
Figure 58: Sand is deposited from the vessel M/V Merete Chris onto the wreck.

In consequence of these assessments, a complete covering of the wreck was deemed the best solution to prevent further biodegradation to the ship timbers and provide a protection against accidental damage to the wreck during the nearby construction activities of the Fehmarn Belt tunnel. As a side effect, looting of the wreck by sports divers would also be prevented. In May 2014, the wreck was covered with 3300m³ of sand and 750m³ of coarse gravel, creating an artificial mount of two layers. These works were carried out under supervision of the ALSH and Femern A/S by Peter Madsen Rederi A/S. Based on the bathymetric mapping, the sand was distributed in small, precisely placed batches from a specialized ship with the help of a DGPS positioned grab dredge. The sand was distributed evenly and without loss to sedimentation or damage to the wreck this way. In a second step, the layer of gravel was added to the cover, serving to prevent erosion of the sand mount and creating a basis for biological activity and the quick growing of a reef.

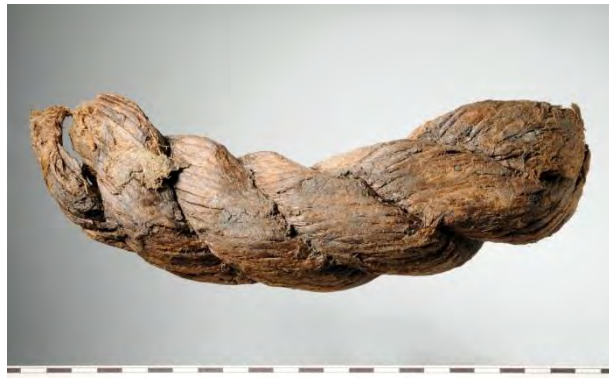
Length of cordage, 24 cm long and Ø 5.5 cm. Z-twist of three strands Ø 3 cm, each of yarns Ø 0.2-0.4 cm. Imprint suggests that the hawser formed part of a larger cable.

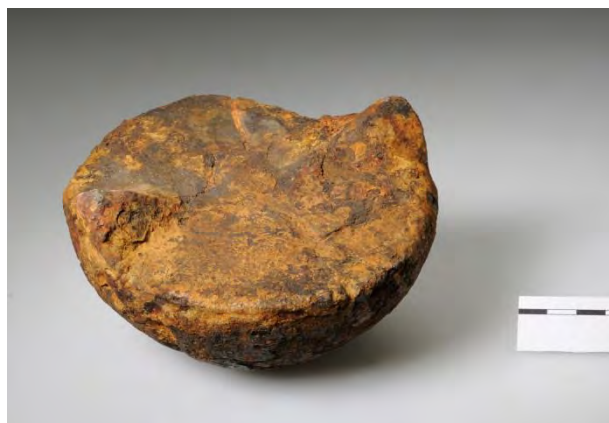
X4 Location: Stern area

Iron hemisphere with triangular protrusions, presumably part of a chain shot. The edge is slightly damaged in one place, but with no other grooves or marks. Ø 12.7 cm.

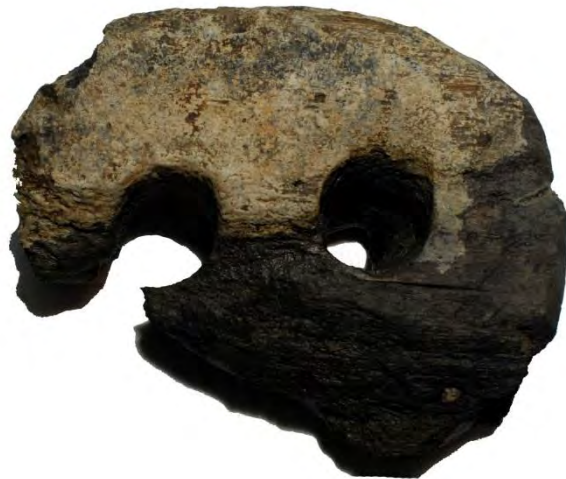
X6 Location: Bow area

Wooden deadeye with significant damage and only two recognisable holes. Score of trapeze-shaped section, 2.5-4 cm wide, and 1.9 cm deep. Evidence of fire damage and some encrustation. 21.5 x 17.3 x 7.4 cm.

One of the elements, a partially eroded three-hole deadeye (X6), was found on the surface in the bow area of the ship. The deadeye measures 21.5 x 17.3 x 7.4 cm although only the thickness is completely representative of the original size. Two of the presumed three holes are evident although only one is intact, and both show signs of wear. Their maximum diameter measures around 3.5 cm. The surface is

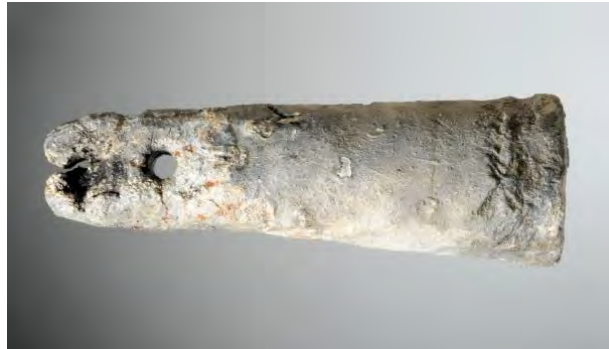
X18 Location: Trench 1

Fragment of bronze sheave. About 50% preserved but with some deformation. The asymmetrical section is probably a result of heat-damage. 13 x 7.5 x 3 cm, internal Ø 2 cm.

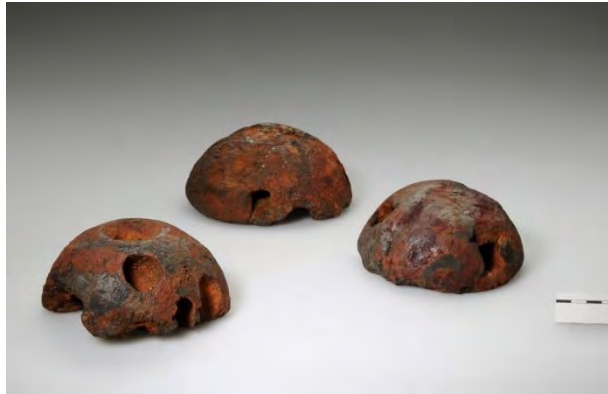
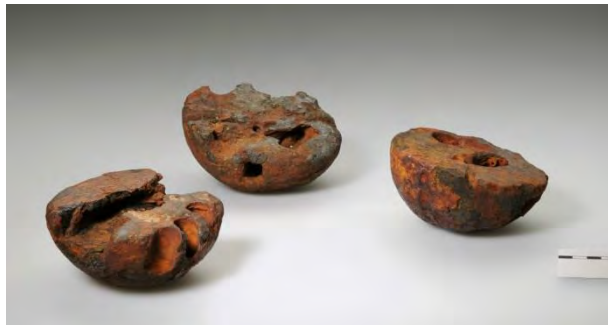
The first chain shot (centre) has a 0.7 cm wide groove of semi-circular cross section crossing its outside, and the flat face has traces of triangular recesses to accommodate a partner. These are offset 30° counter-clockwise from the groove. On the outside, 0.8 cm from the edge and perpendicular to the groove, is a 1.4 x 1.4 cm hole. The hole is 5.3 cm deep with no narrowing, and runs at a 30° angle to the flat face. There are traces of internal barbs. Ø 13.4 cm.

The second chain shot (right) is similar to the first, but features a 1 cm wide groove, and a 2 x 2 cm hole 1 cm below the edge. The hole is 4 cm deep with decreasing height, and runs parallel to the flat face. There are no traces of internal barbs. Ø 12.3 cm.

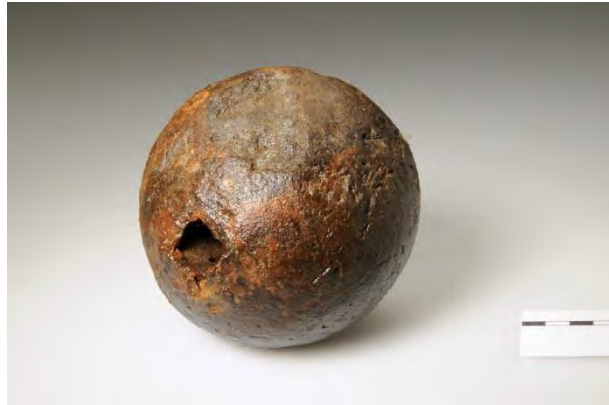
X23 Location: Stern area

Iron sphere, presumably cross-bar shot. 2 x 2 cm hole through the centre, with internal barbs. Slight trace of a line around the outside, perpendicular to the hole. Ø 11.5 cm.

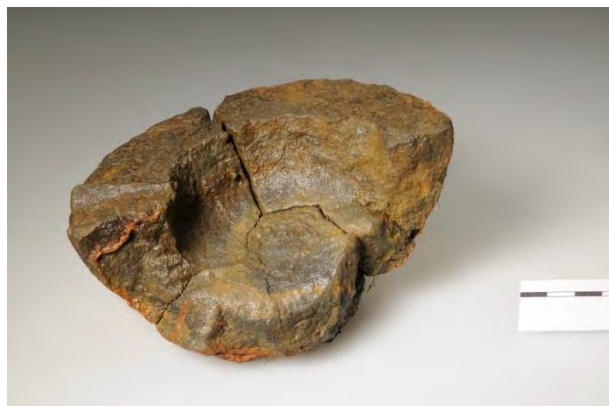
X24 Location: Stern area

Two connected iron fragments, presumably part of a chain shot, but with a hollowed-out centre. 45% of the circumference remains, and the hollow centre leaves a wall-thickness of 2.3-3 cm. A 0.8-0.9 cm wide groove crosses the outside, and a single 1.5 cm wide triangular protrusion is preserved on the remaining flat face, offset 20-25° from the groove. 13.5 x 9 x 6.5 cm, reconstructed Ø 14 cm.

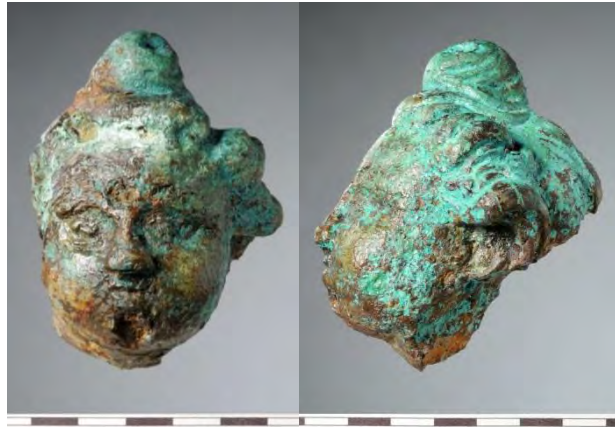
X26 Location: Stern area

Head of humanoid bronze figurine, belonging to the cascade of bronze gun X120 but recovered separately. Oriental female with a rather full face and intricate hair. Damage from heat on the left side of the head and on the neck. 8 x 5.5 x 5.3 cm.

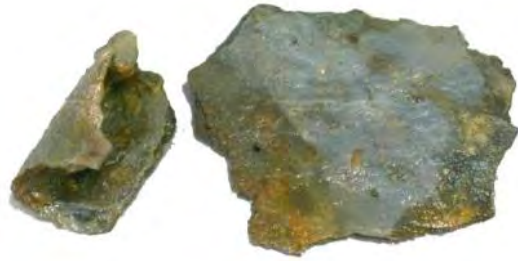
X36 Location: Trench 1

Lot of bluish bronze or copper sheathing, with evidence of limited heat damage. Some edges are bent in a U-shape to accommodate an element 2.5-3 cm thick. Some occurrences of 0.3 cm round nail holes. Up to 16 x 15 x 0.3 cm.

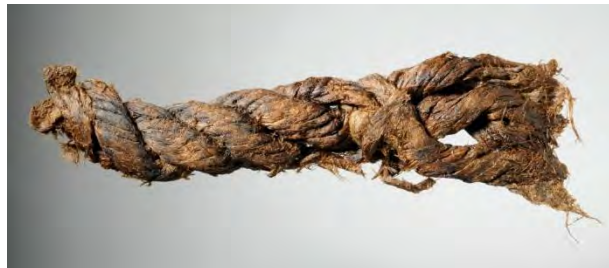
X38 Location: Trench 1

Sample of cordage from coil, 23 cm long and Ø 2.5 cm. Z-twist of three strands Ø 1.5 cm, each of 10+ yarns.

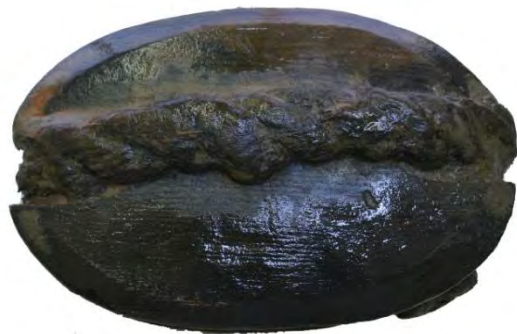
X45 Location: Trench 1

Single-sheaved wooden rigging block, with preserved cordage through and around, discovered alongside the almost identical X46. Rounded outline with chamfered edges and a 15.5 x 3.1 cm sheave-hole. Strop scores cut top and bottom, with an additional perpendicular score at the bottom. 22 x 14.5 x 8.4 cm.

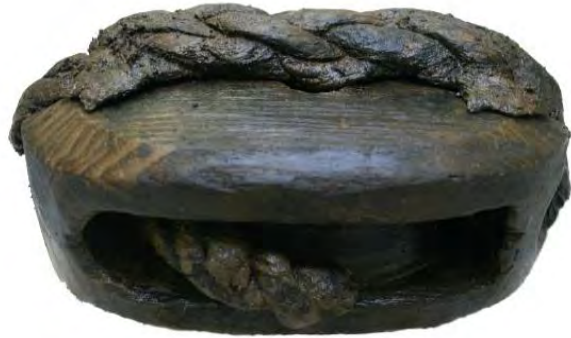
X46 Location: Trench 1

Single-sheaved wooden rigging block, with preserved cordage through and around, discovered alongside the almost identical X45. Rounded outline with chamfered edges and a 14.2 x 3.1 cm sheave-hole. The preserved working line is Ø 2.5 Z-twisted of three strands, but the strop appears plaited of four similar strands. Strop scores cut top and bottom, with an additional perpendicular score at the bottom. 20 x 12 x 8 cm.

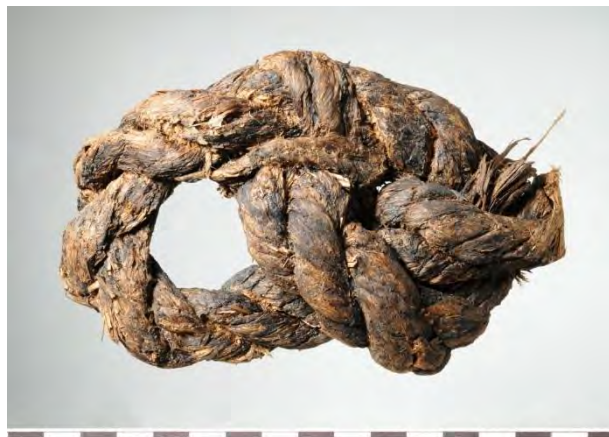
X47 Location: Trench 1

Piece of cordage recovered near blocks X45 and X46. Ø 2.5 Z-twist of three stands Ø 1.2 cm with overhand knot or half hitch. Appears to have been tied around a round object Ø 2.5.

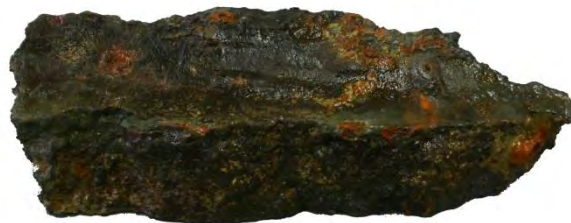
X48 Location: Stern area

Fragment of bronze gun barrel. Somewhat irregular bore with fairly sharp edges. Wall thickness 6.5 cm, with no obvious marks. 33 x 14 x 8 cm, and an estimated internal diameter of 12.2 cm.

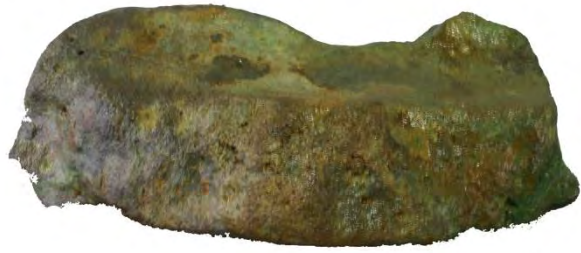
X49 Location: West side

Fragment of bronze gun barrel with smooth eroded edges. Wall thickness 6 cm, with no obvious marks. 34 x 19 x 9.5 cm, and an estimated internal diameter of 16.8 cm.

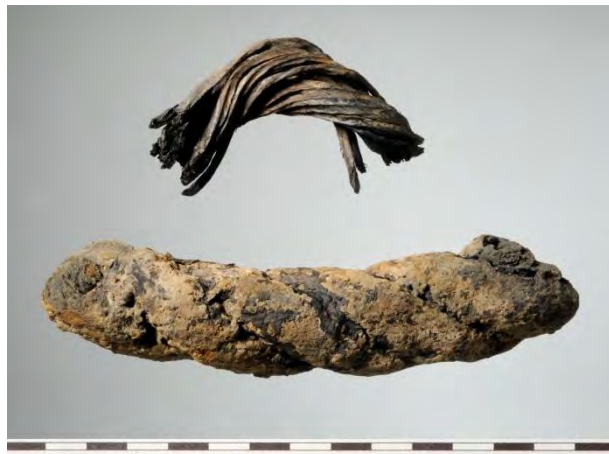
X53 Location: Trench 1

Piece of cordage with several loose strands, up to 14 cm long and Ø 2.5. The most intact piece is completely solidified. Z-twist of three strands Ø 1.5, each of yarns Ø 0.2-0.3 cm.

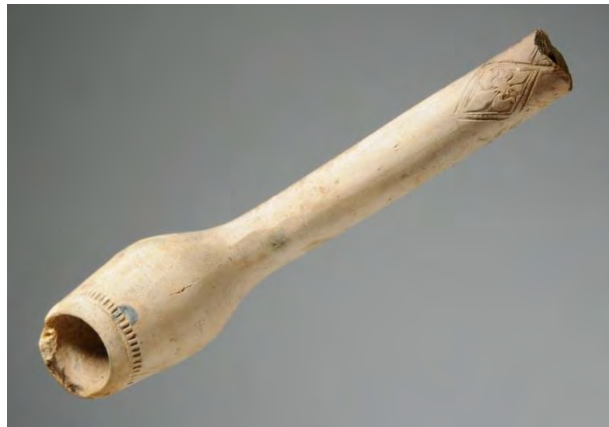
X55 Location: Trench 1

Fragment of clay tobacco pipe with bowl and part of stem preserved. The stem is stamped with a motif of a fleur-de-lis inside a diamond, repeated at least twice although only one is preserved in its entirety. The heel is marked with the encircled letters EB, and there is rouletting around the mouth of the pipe. Stem 5.3 x 1 cm, Ø 0.3 cm hole. Bowl up to Ø 1.8 cm, 1.5 cm at the mouth.

An examination of the shape of the bowls seems to support a Dutch origin for not just the pipes attributed to Edward Bird, but also those with no recognisable markings. Although X55 and X102 are slightly more bulbous than the rest, there are generally strong similarities to an example attributed to Edward Bird before 1645 (Duco 1981: 257). When compared to a general stylistic chronology, the pipes seem to reflect the Dutch style of sometime around 1630-40 (Atkinson and Oswald 1972: 176). The pipes made by Edward Bird were however no fashion accessories, nor known for their high quality, but rather ordinary pipes for ordinary people. A measure of stylistic conservatism is therefore quite reasonably to be expected, not least given the sizeable trade network and foreign customers, thus perhaps accounting for the slightly early dating (Duco 1981: 374).

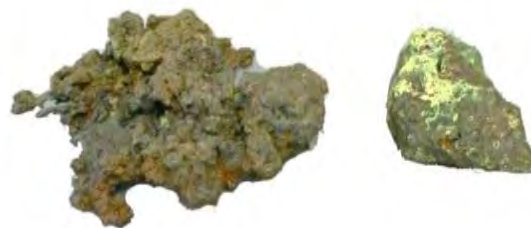
X59 Location: Trench 1

Two bronze pieces, one completely melted and one heat-damaged.

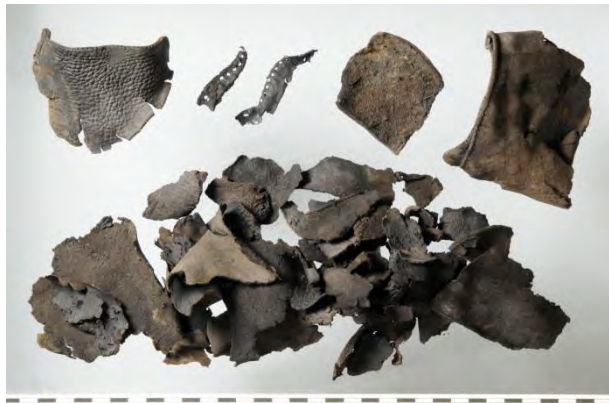
X62 Location: Trench 1

Lot of leather fragments, several with original edges and stitching. Perhaps some suggestion of footwear.

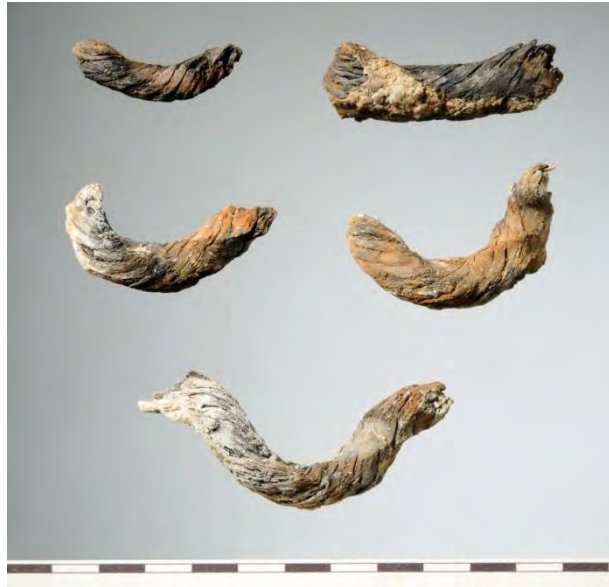
X66 Location: Trench 1

Strands of cordage, Ø 1.1 cm.
Originally Ø 2 cm Z-twist of three
strands.

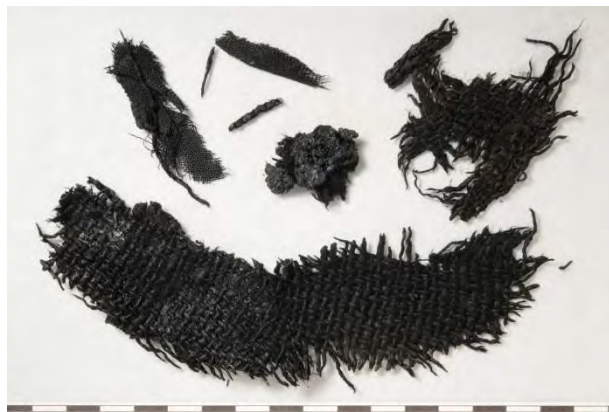
X67 Location: Trench 1

Fragments of textile found near the
skeleton. Mix of fine and coarser
weaves.

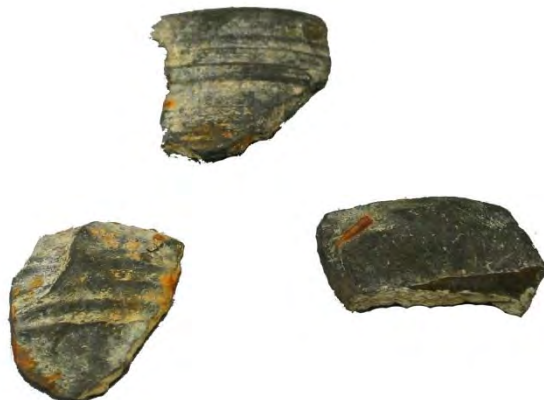
X69 Location: Trench 1

Three fragments of earthenware.
Bluish glaze inside and trace of
brown glaze outside. One piece with
rim. Up to 5 cm with a material
thickness of 0.6 cm.

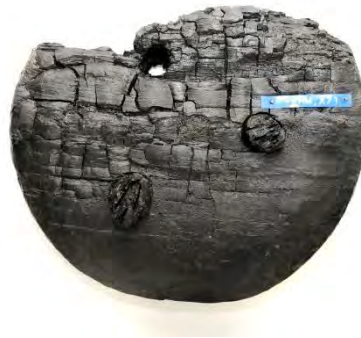
X71 Location: Trench 1

Circular wooden tripod seat with fragments of two Ø 3 cm legs. Partly burned and with some charring. Slightly conical section, with flat seat and convex bottom. 27.5 x 5.6 cm.

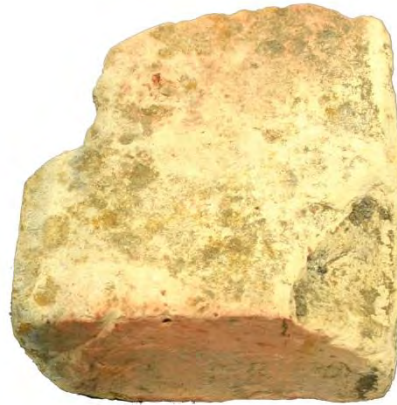
X72 Location: Galley

Lot of pale yellow bricks and fragments, up to 22 x 10.5 x 4.5 cm.

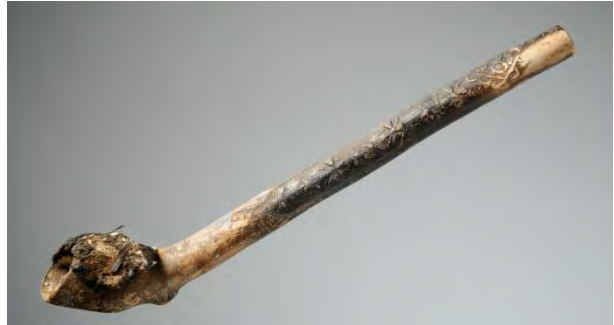
X76 Location: Trench 1

Decorated clay tobacco pipe found near the skeleton, with remains of textile on the bowl. The stem is decorated with a 9 cm long floral motif and there is rouletting around the mouth. No other marks. Stem (incomplete) 12 x 0.9-1 cm, Ø 0.3 cm hole. Bowl up to Ø 1.9 cm, 1.5 cm at the mouth.

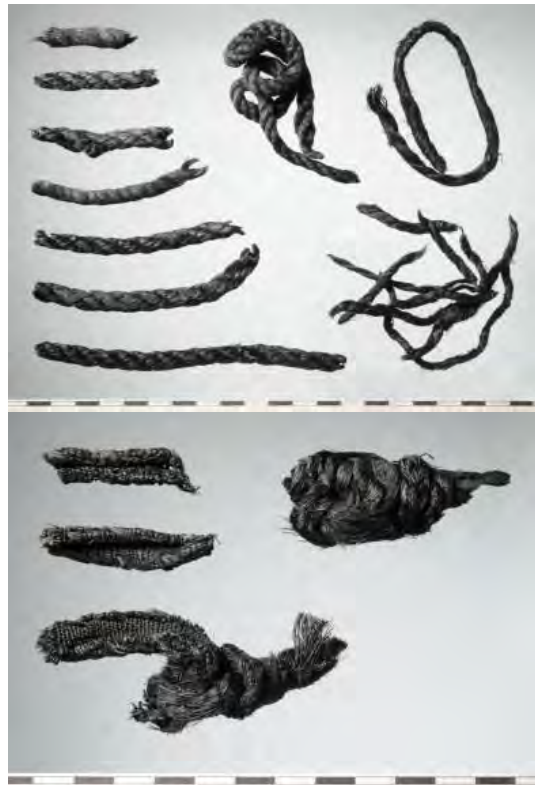
X77 Location: Trench 1

Lot of cordage and coarse textile found near skeleton. Several smaller cordage pieces Ø 0.4-0.9, Z-twisted of three strands Ø 0.2-0.5 cm, one preserved in a loose coil with evidence of hitches. One example of three-stranded plait. Some fragments with textile ribbons and knotting.

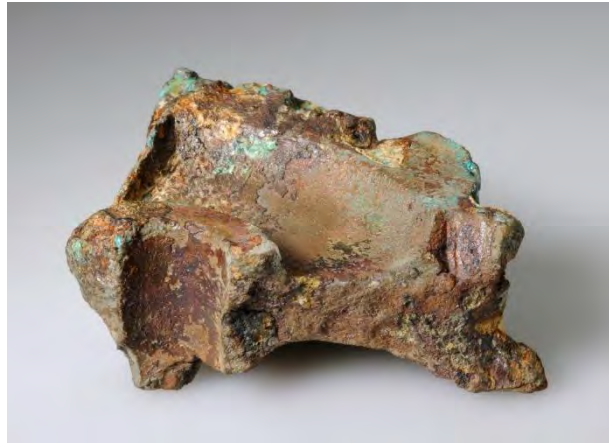
X79 Location: Trench 1

Fragment of bronze sheave. About 80° preserved but with some deformation. The asymmetrical section is probably a result of heat-damage. 8.5 x 6 x 3.6 cm, internal Ø 2 cm, reconstructed external Ø 12 cm.

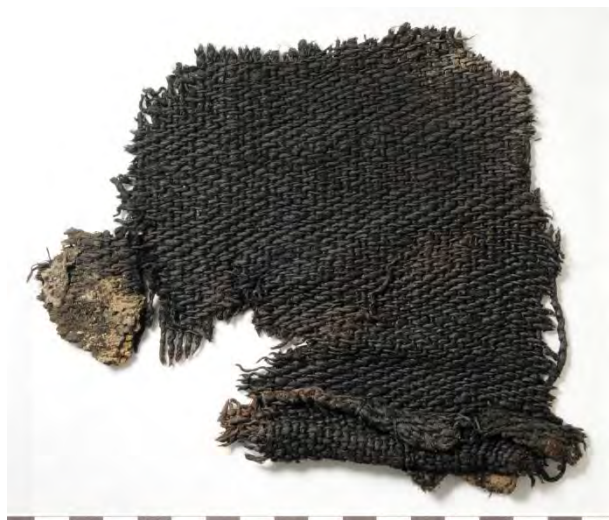
X82 Location: Trench 1

Piece of dense textile with possible original edge. 15 x 12 x 0.1 cm.

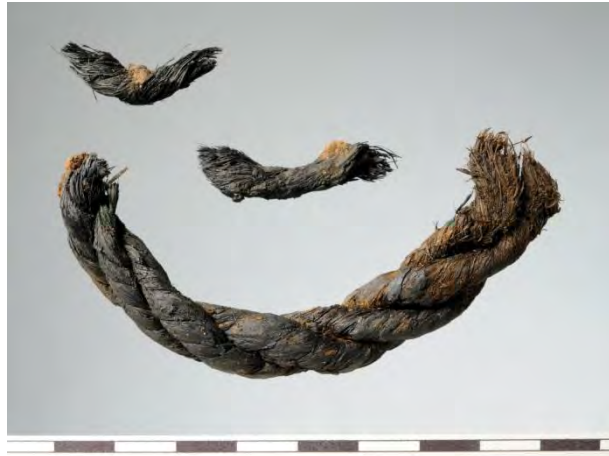
X83 Location: Trench 1

Piece of cordage Ø 1.1 cm, Z- twist of three strands Ø 0.5 cm, each of three yarns. 12 cm long.

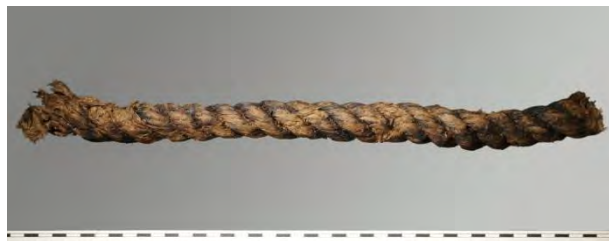
X84 Location: Trench 1

Piece of cordage Ø 2.5 cm, Z-twist of three strands Ø 1.3 cm, each of 12 yarns. 44 cm long.

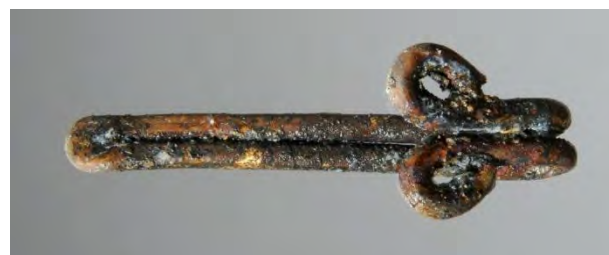
X86 Location: Trench 1

Hook of brass wire. 4.1 x 1.4 x 1.3 cm, wire thickness 0.2 cm.

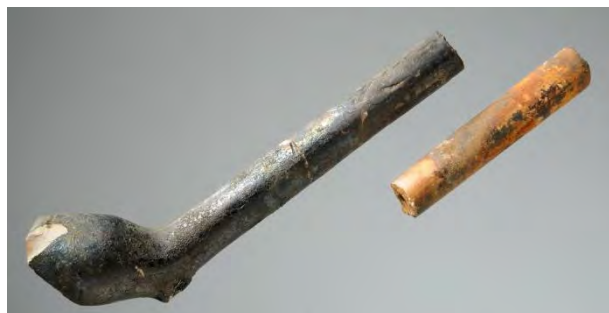
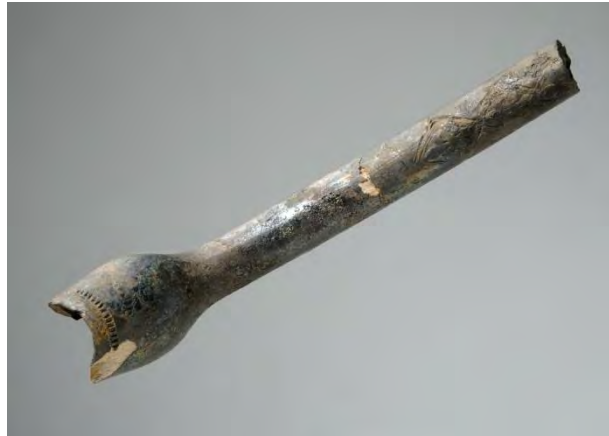
X87 Location: Trench 1

Three fragments of clay tobacco pipes, hereof two connected bowl and stem fragments. The stem is stamped with a motif of a fleur-de-lis inside a diamond, repeated at least three times underneath one another, although only two are preserved in their entirety.

The heel is marked with the encircled letters EB, and there is rouletting around the mouth of the pipe. Stem 7 x 0.9-1.1 cm, Ø 0.3 cm hole. Bowl (damaged) length 3.1 cm, up to Ø 1.6 cm, and 1.5 cm at the mouth.

Unrelated stem fragment, 4.8 x 0.8 cm, Ø 0.3 cm hole.

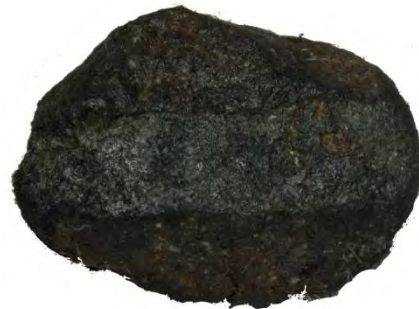
X89 Location: Trench 1

Fragment of iron sphere, presumably 25% of a cross-bar shot with a bar width in excess of 1.9 cm. 7.5 x 5.5 x 2.9 cm, reconstructed Ø 8 cm.

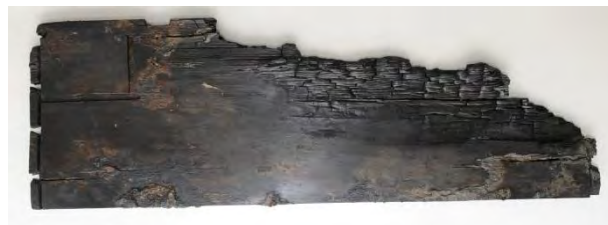
X90 Location: Trench 1

Plank of wooden chest, with some charring and fire damage. Presumably back plate, with dovetails and grooves for fitting a till on the inside. Top edge has a recess and the back side traces of iron strapping and nails. 94.5 x 30.5 x 2 cm.

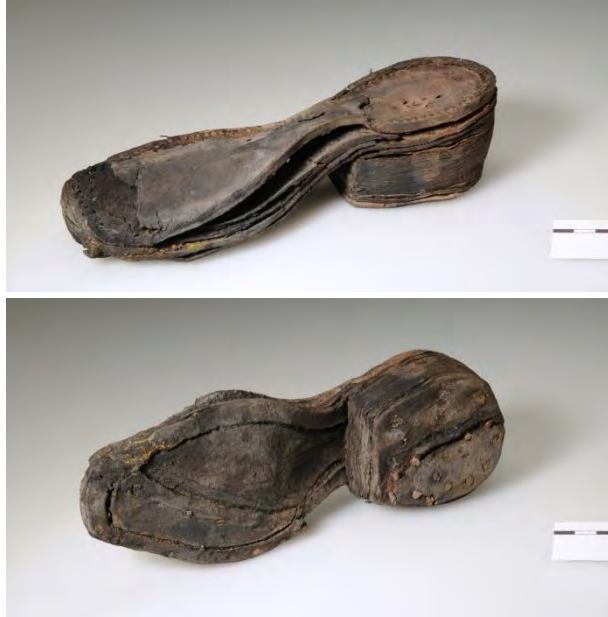
X91 Location: Trench 1

Sole of leather footwear with heel, found near skeleton. Several layers are preserved, including the insole with clear traces of stitching and remains of cordage around the edge. Decorative pattern on the outsole, with a possible diagonal repair or reinforcement patch. Several instances of smaller and larger pointy wooden pegs in sole and heel. 23.5 x 8.5 x 1.5-5 cm.

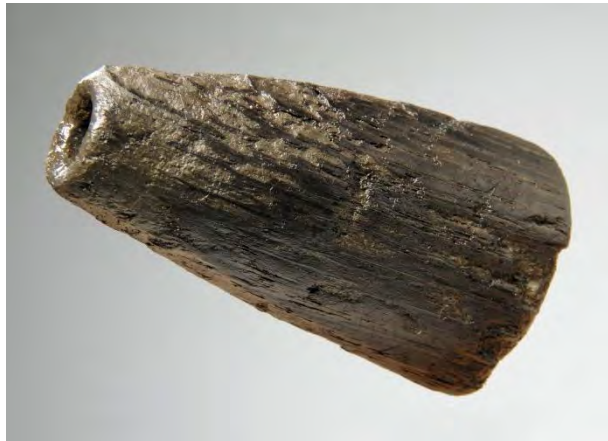
X92 Location: Trench 1

Wooden handle with small pierced brass plate at the base, 0.7 cm x 0.7 cm, over a 0.1 cm hole. Handle of oval to round cross section with a central Ø 0.6-0.7 cm hole. Found near X90. 6.3 x 1.5-3.3 x 1.8 cm.

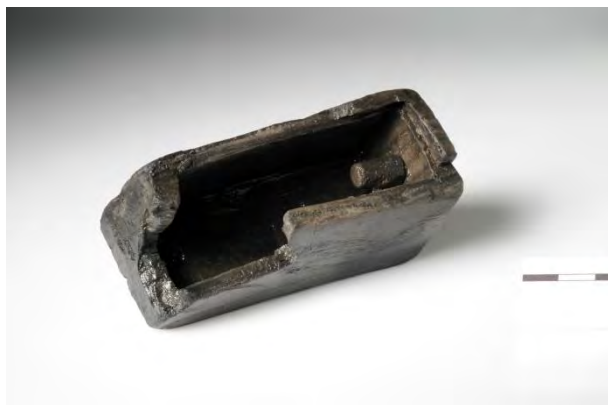
X93 Location: Trench 1

Wooden box and three small fragments, presumably related to lid X101. Recess for a sliding lid. Carved from one piece with the exception of a Ø 0.6 cm plug extending inwards from the back end. Single depression in the bottom. Found near X90. Externally 9 x 3.7 x 4 cm, internally 7.6 x 2.3 cm.

Wooden sliding lid, most probably related to box X93. Flat bottom with slightly bulging top, chamfered front and back. Clear 1.5 cm wide recess to facilitate removal. Slightly narrower at the back, perhaps due to damage. 8.3 x 2.8 x 0.4 cm.

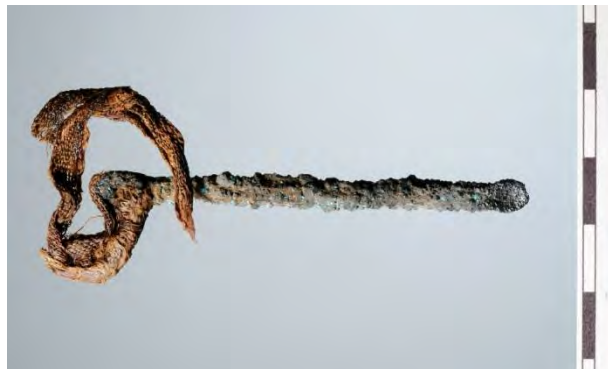
X95 Location: Trench 1

Concreted cylinder, perhaps a needle, with a small eye one end and flattening to a spoon shape the other end. A 1 x 8 cm piece of textile is attached through the eye, apparent wound with string for the first 2 cm. Found near X90. 6.3 x 0.4 cm.

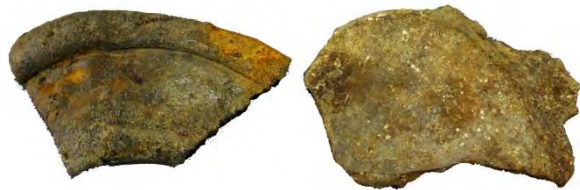
X96 Location: Stern area

Two pieces of rather irregularly shaped ceramics. One appears to include the transition between a flat bottom and the side of a vessel, and the other part of a wide rim. 11 x 9 x 0.5-0.9 cm, and 12 x 7.5 x 0.8 cm respectively.

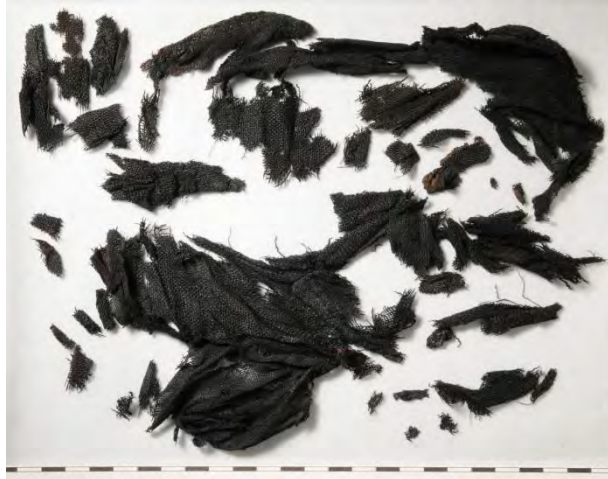
X99 Location: Galley

Lot of medium-fine textile, 26 x 10 cm.

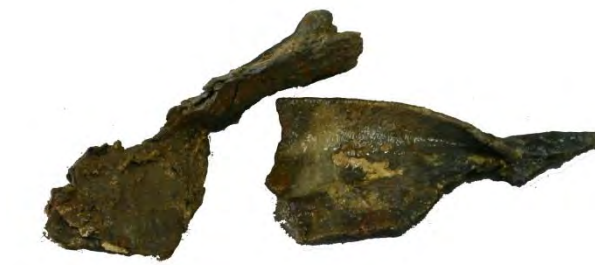
X100 Location: Trench 1

Eight pieces of deformed bronze or copper, some recognisable as sheathing and others entirely melted. Up to 20 x 9 cm.

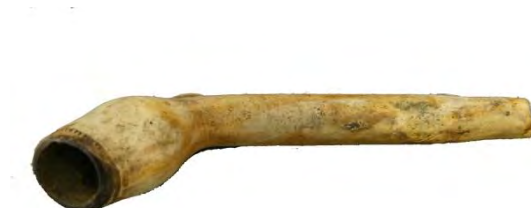
X102 Location: Trench 1

Clay tobacco pipe with rouletted bowl, and traces of a single fleur-de-lis in diamond motif on the stem. Stem 6.5 x 0.9-1.1 cm, Ø 0.3 cm hole. Bowl 3.2 cm long, up to Ø 2.1 cm, and 1.5 at the mouth.

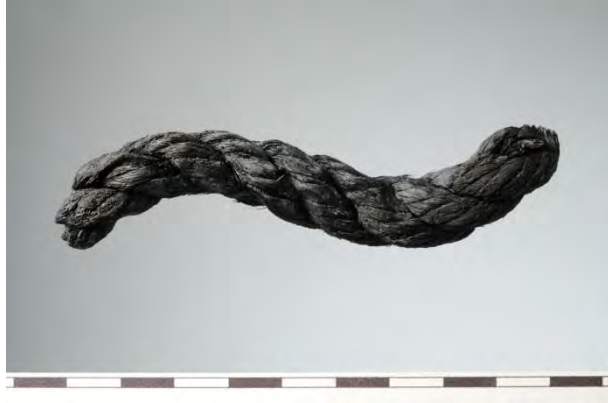
X103 Location: Trench 1

Piece of cordage Ø 1.4 cm. Z-twist of three strands Ø 0.7 cm, each of 6 yarns. 9 cm long.

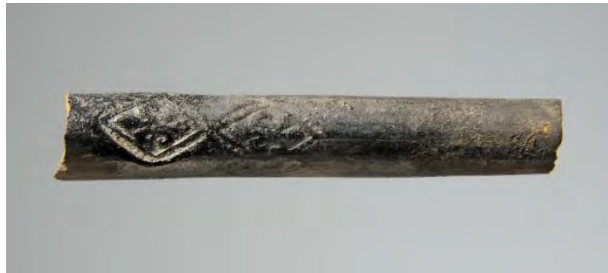
X105 Location: Trench 1

Stem fragment of clay tobacco pipe, stamped with fleur-de-lis in diamond motifs. Two of the stamps are aligned lengthwise, with a single stamp place more randomly either side. 5.2 x 0.8-0.9 cm, Ø 0.3 cm hole.

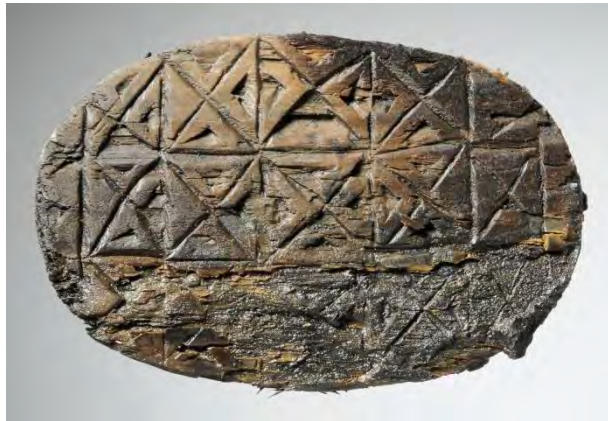
X106 Location: Trench 1

Oval wooden lid with carved decoration in linear patterns on top, presumably from bent-wood box. Slight fire damage. Small treenails preserved along the edge. 11.4 x 7.4 x 1 cm.

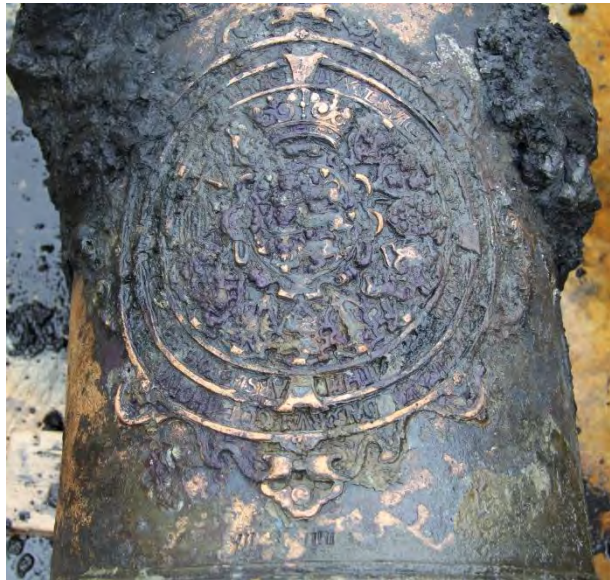
X120 Location: Stern area

Fragment of bronze gun, broken between second reinforce and chase, with the rear part preserved. Well-preserved with some damage to the dolphins. Cylindrical trunnions with a cascable shaped like a woman (see X26) holding a marine mammal. Large decoration attributed to Christian IV. 110 cm long, Ø vent 37.5 and Ø bore 13.0 cm. 850 kg.

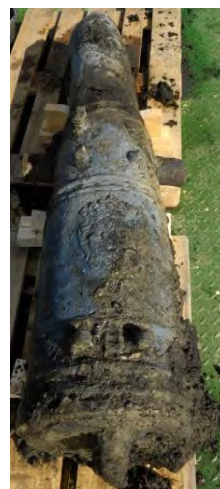
X121 Location: Trench 1

Two fragments of a bronze gun, found separately. Broken just before the cylindrical muzzle. Significant damage to the dolphins and cascable, and slight deformation of the chase. Decorated with a dragon in relief on the chase, and Christian IV's cypher on the first reinforce. Traces of incision referring to maker and date at the bottom of the chase. Length 204 cm, Ø vent 33.6 cm and Ø bore 11.0 cm. 700 kg.

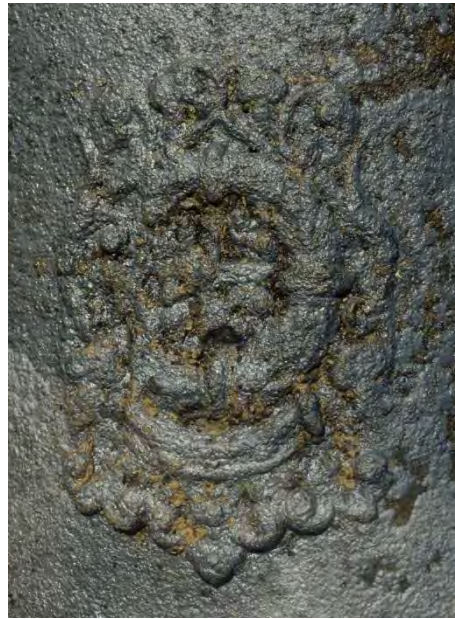
X122 Location: Trench 1

Fragment of bronze gun, broken across second reinforce. Significant damage to the dolphins and the cascable. Decorated with Christian IV's cypher on the first reinforce. Possible but largely unintelligible lettering over the vent field. Length 90 cm, Ø vent 44.5 cm, estimated Ø bore 14.8 cm. 1000 kg.

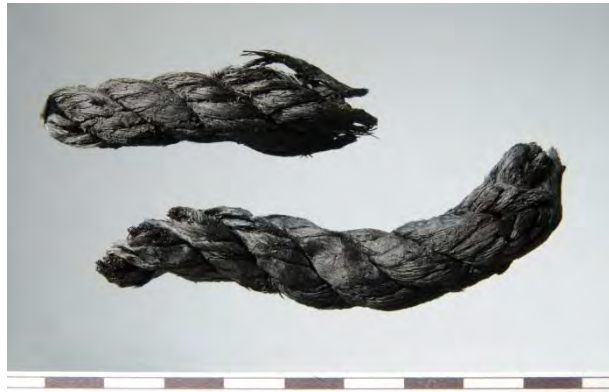
X125 Location: Trench 1

Two pieces of cordage Ø 1.3 cm, Z-twist of three strands Ø 0.7, each of six yarns. Combined length 15 cm.

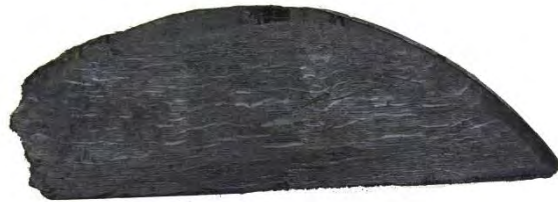
X128.2

Cant head piece, with one hole in the edge. 46 x 16.5 x 1.5 cm.

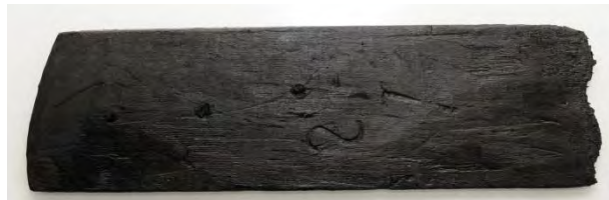
X128.3

Middle head piece, with three holes in the long edge and two in the short. Four plugged holes Ø 1-1.3 cm. Marked with a reversed S. 57 x 16 x 2 cm.

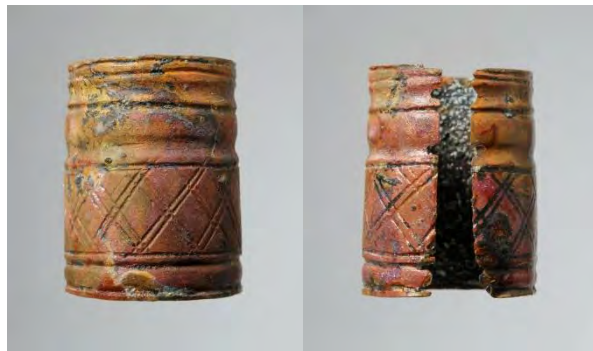
X129 Location: Trench 1

Open metal ring or fitting, with bands of decoration, some slightly concave and other slightly convex. Large area with doubled diagonal cross-hatching. 2.7 cm with Ø 2.1 cm.

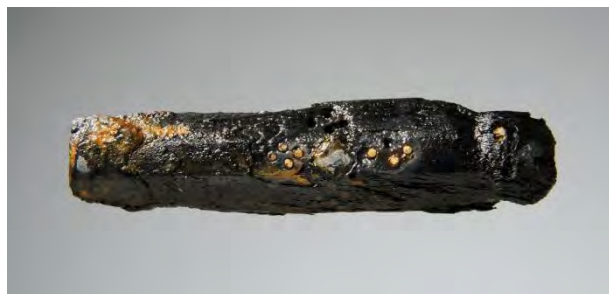
X131 Location: Trench 1

Wooden handle with decorative brass elements. Slightly pear-shaped with a carved pommel, and traces of a 0.6 x 0.3 cm iron tang. One side is decorated with a whitish metal diamond surrounded by clusters of Ø 0.1 cm brass inserts, some of which are missing. 6.8 x 1.6 x 1 cm.

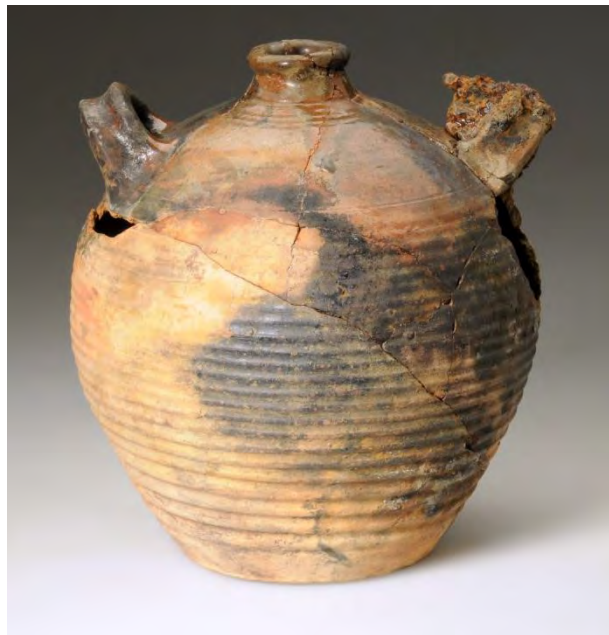
X134 Location: Trench 1

Lot of related ceramic sherds, almost constituting an entire jug with narrow opening and two horizontal handles. Outside partly glazed and decorated with ribbing and incisions. Reconstructed 17.5 x 16.6.
