FEHMARN BELT FIXED LINK MARINE ARCHAEOLOGICAL REPORT

The Excavations on the Wreck of Lindormen

Ostsee Gebiet 1433, LA 3

AA2012-279

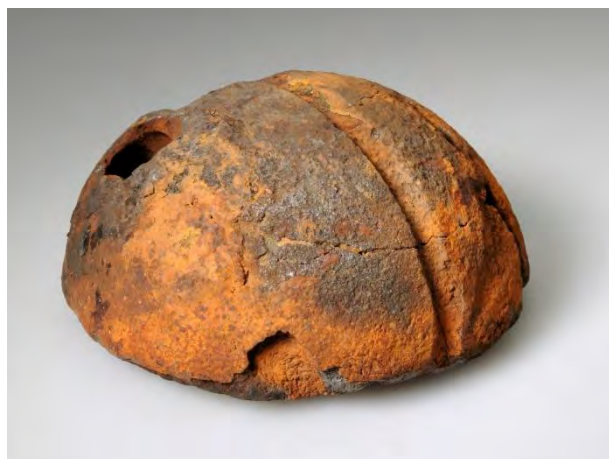
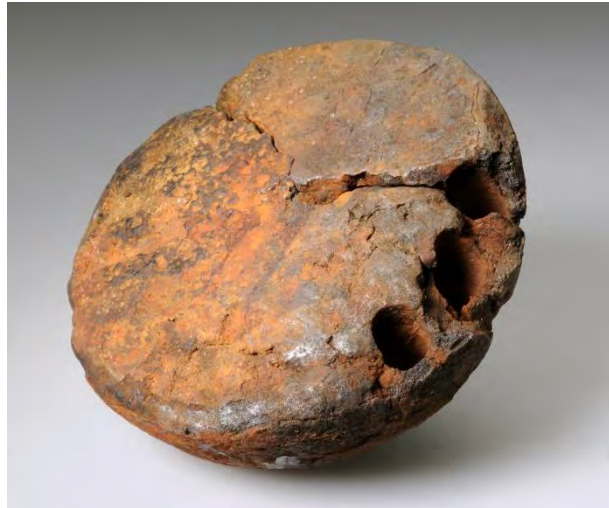
X135 Location: Stern area

Iron hemisphere, presumably part of a chain shot with some biological damage. A 1 cm wide groove of semi-circular cross section crosses the outside, and the flat face has traces of triangular recesses, offset 30° counter-clockwise from the groove. On the outside, 1 cm from the edge and perpendicular to the groove, is a 1.8 x 1.8 cm hole. The hole is 5 cm deep with no narrowing, and runs parallel to the flat face. There are traces of internal barbs. Ø 13.4 cm.

Picture to the left: Base of the shot with biological caused bore-holes on the front edge.

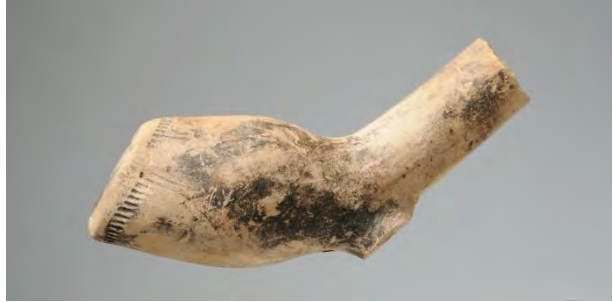
Fragment of clay tobacco pipe. The heel is marked with the encircled letters EB, and there is rouletting around the mouth. Stem 2.1 x 1 cm, Ø 0.3 cm hole.

Bowl 3.1 cm long, Ø up to 1.7 cm, 1.4 cm at the mouth.

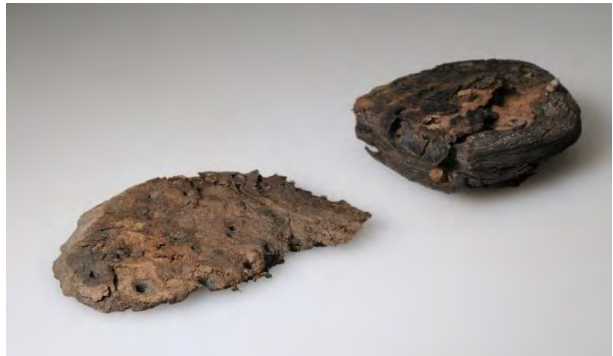
X141 Location: Trench 1

Two fragments of footwear. Heel in several layers with pointy wooden pegs. 5.9 x 5.7 x 1.3 cm.

Heel-end of sole with traces of stitching. 8.5 x 4.8 x 0.2 cm.

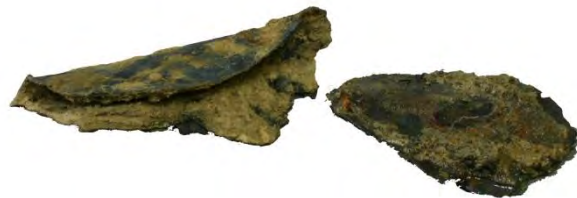
X150 Location: North of galley

Lot of copper sheathing fragments. Some edges bent in U-shape. Single Ø 0.3 cm round nail hole. Material thickness 0.05-0.3 cm.

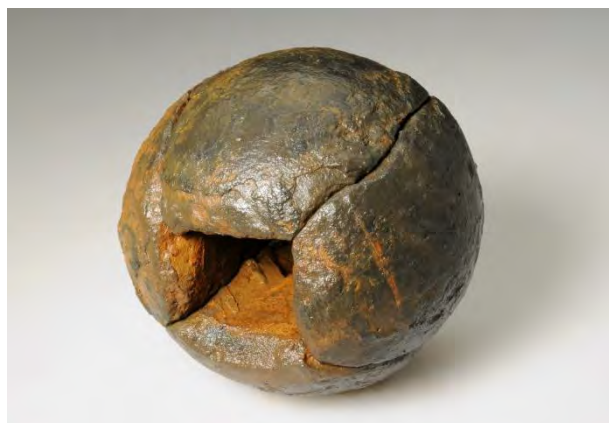
X151 Location: Trench 1

Iron sphere in four pieces, presumably cross-bar shot, with 3 x 3 cm hole through the centre. Two opposite inside faces show traces of barbs. Small angular cavity inside. Ø 9.5-9.8 cm.

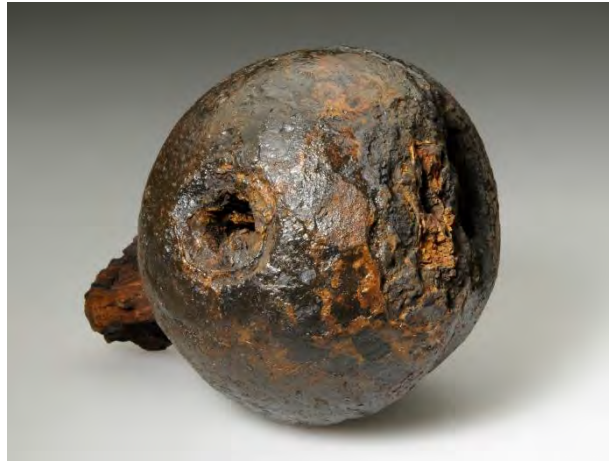
X153 Location: Trench 1

Iron sphere, presumably scissor shot, with remains of the blades. Each blade is 4 cm wide and 1.8-2.0 cm thick, with a flat pentagonal cross section. The two hemispheres are slightly misaligned, and the blades are offset 1.4 cm at the shot surface. Countersunk 2 cm hole through both. Up to Ø 13.0 cm.

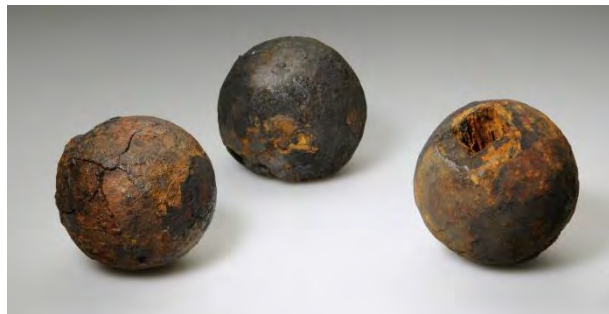
X154 Location: Trench 1

Three iron spheres, presumably one cross-bar shot Ø 9.5 cm with central 2.5 x 2.5 cm hole, and two solid shot of Ø 9.6 and 9.1 cm.

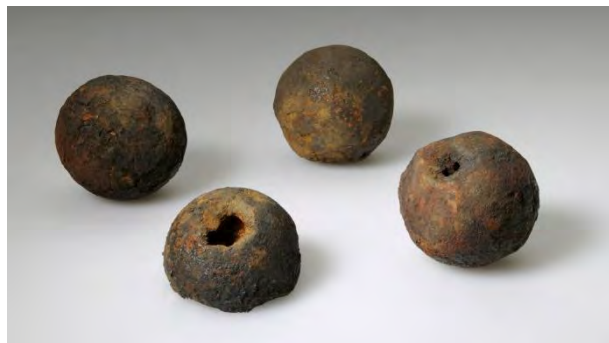
X155 Location: Trench 1

Six iron spheres, one with some damage. Presumably balls from grapeshot, with three balls Ø 4.9 cm, two Ø 5.0 cm and one Ø 4.8 cm.

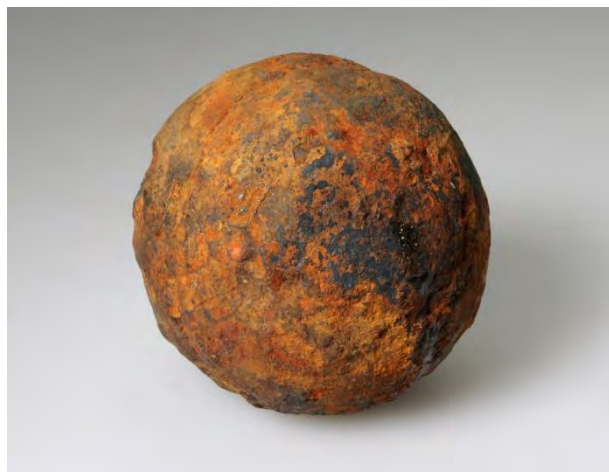
X156 Location: Trench 1

Iron sphere, presumably round shot. Some remaining traces of casting. Ø 6.8 cm.

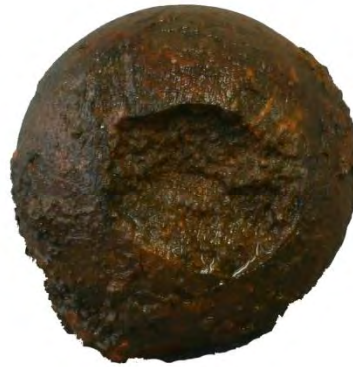
X157 Location: Trench 1

Iron sphere, presumably round shot.
Some damage and traces of casting.
Ø 9.6.

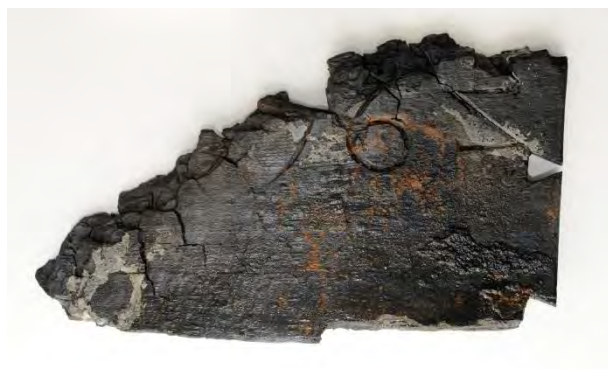
X161 Location: Trench North

Wooden element, damaged with
some charring. Dovetails along one
the short edge and rebate along the
long one. Partly preserved engraved
symbols. 34.5 x 20 x 2 cm.

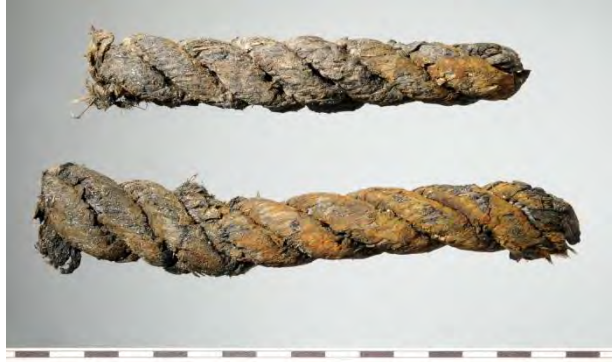
X162 Location: Trench North

Two pieces of cordage Ø 1.6 cm, Z-twist of three strands Ø 0.8 cm, each of 5+ yarns. Combined length 28 cm.

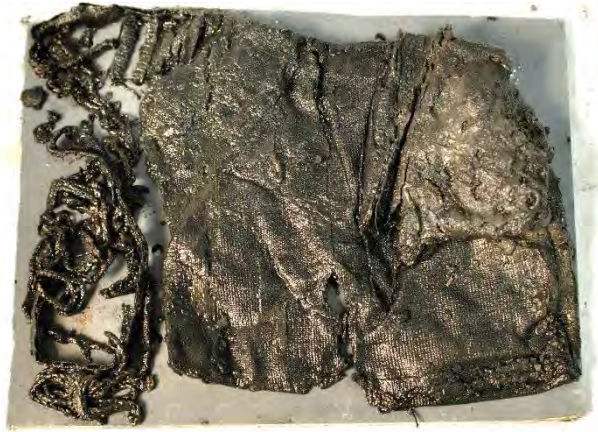
X166 Location: Trench North

Largely intact textile item, presumably a bag. Sewn with some seams showing and others hidden. Long strap of doubled textile, 0.5 cm wide. Fine Ø 0.2 cm cordage attached to strap, containing a multitude of knots and incorporating no less than five elongated eyelets. The string is decorated with clusters of very small yellow and green beads. 13 x 13 cm.

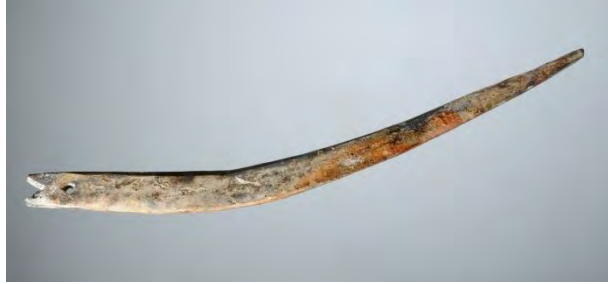
X171 Location: Trench North

Lead piece, rudimentary fish-shape, presumably sinker. Curvature on both axes, Ø 0.3 cm hole and notch each end.
18.0 x 1.0 x 1.2 cm.

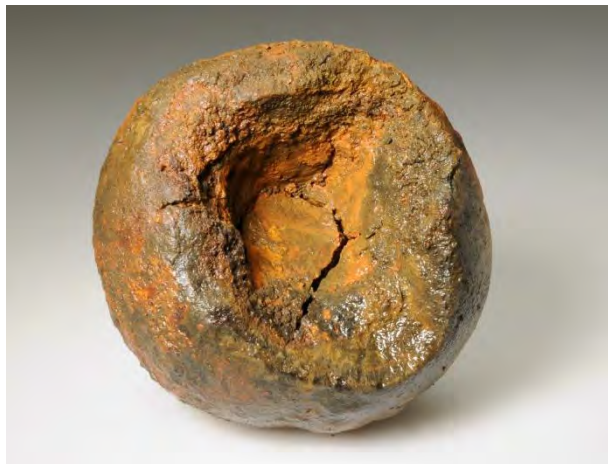
X174 Location:

Iron sphere, partly hollowed-out by pseudo-square 4.5 x 4.5 cm hole. Perhaps round shot with significant damage. Ø 130 cm.

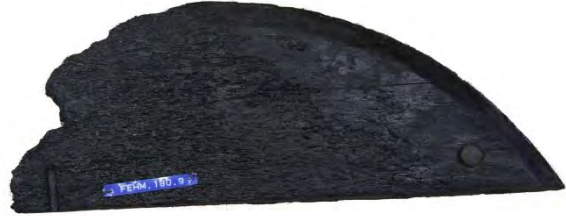
X180.9

Cant head piece, with two holes in the edge. One plugged hole Ø 1.5 cm. 44 x 17 x 2 cm.

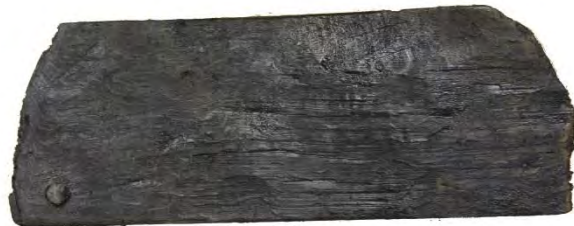
X180.10

Middle head piece, with two holes in both edges. One plugged hole Ø 1.5 cm. 52 x 20 x 2 cm.

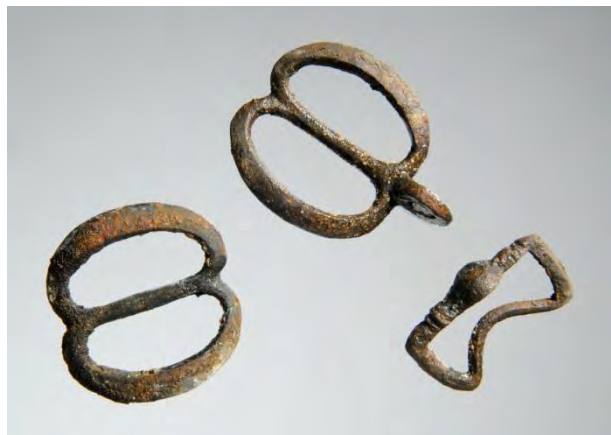
X182 Location: Trench North

Three belt fittings in brass, recovered from X176. Two are apple-shaped, one with an additional smaller eye. 2.6 x 2.7 x 0.2 cm and 3.2 x 2.6 x 0.8 cm respectively.

One smaller baluster-shaped bar with some decoration, 2.5 x 1.3 x 0.9 cm.

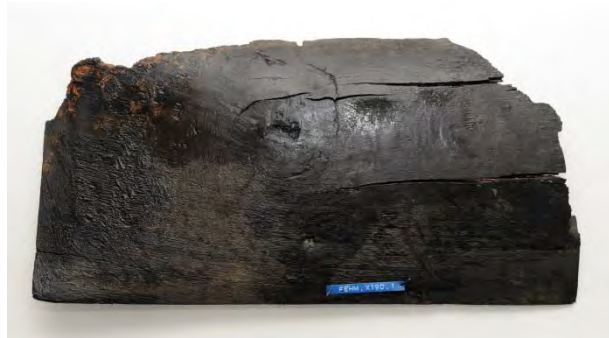
X190.1

Board with damage, all three preserved edges chamfered both sides to 0.6 cm. 56 x 28 x 1.6 cm.

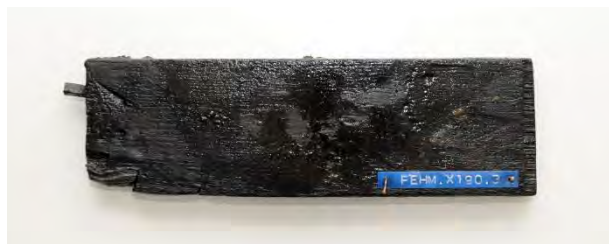
X190.3

Panel with three holes in one long edge. One short edge has an additional two holes, one still holding a dowel. The other terminates in a narrow central lip. 26 x 8 x 2.2 cm.

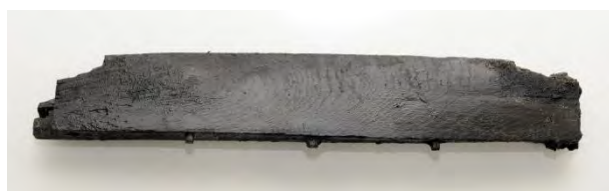
X190.4

Panel with five square holes in long edge, some still with dowels. 2 cm wide recess along one short edge, with perpendicular hole. 52 x 8.2 x 2.2 cm.

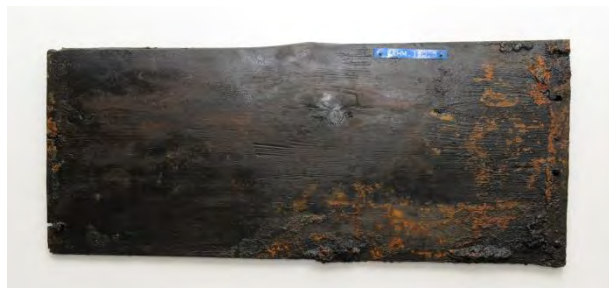
X190.5

Board, attached to X190.9 upon recovery. Holes along both short sides, four near one and two near the other. 54.2 x 23.3 x 0.8-1 cm.

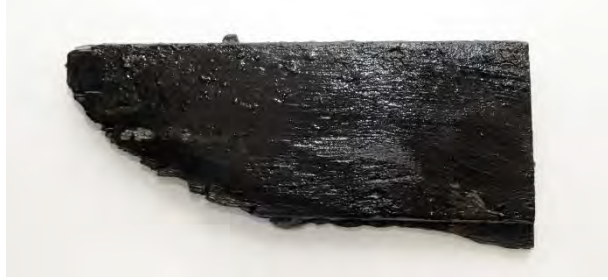
X190.6

Panel with three holes in one long edge, and trace of a recess along the other. Short edge slants slightly. 27 x 12 x 2.2 cm.

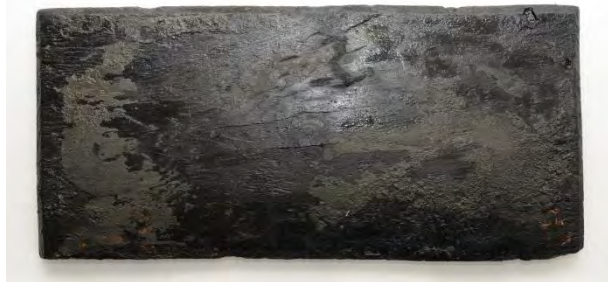
X190.8

Board, chamfered on three edges of one side. Holes along both short edges, at least four near one and two near the other. 60 x 27.5 x 2 cm. Occurrences of small amounts of brass on both sides.

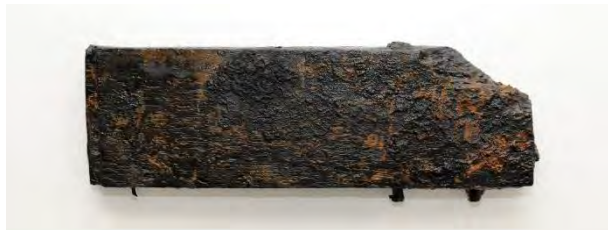
X190.9

Panel, attached to X190.5 upon recovery. Similar to X190.3, but with four holes in long edge. 25.8 x 8 x 2.4 cm.

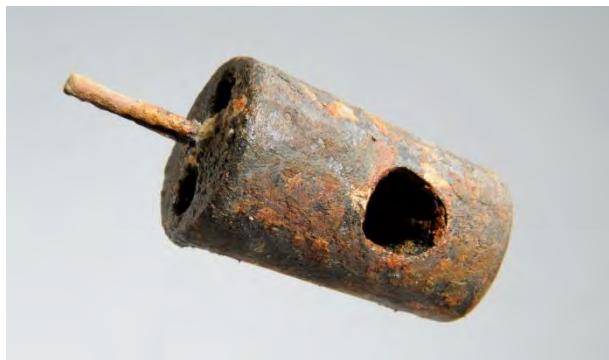
X194 Location: Trench North

Lead object, conical with Ø 0.7 cm transverse hole. A Ø 0.2 cm brass extends from the larger face. Perhaps part of tap key, but probably recent. 3.0 x 1.5-1.7 cm.

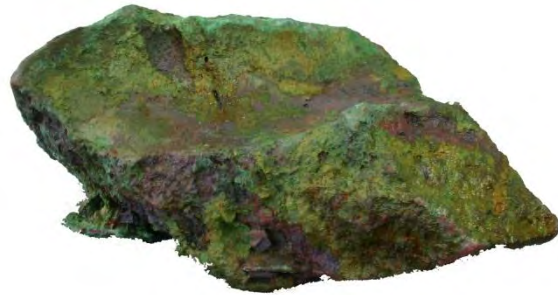
X204 Location: East side

Fragment of bronze gun barrel with fairly sharp edges. Wall thickness c. 8 cm, with no obvious marks. 33 x 28 x 15 cm, and an estimated internal diameter of 15.1 cm.
