NORD STREAM 2 PIPELINE –  
NORTH-WESTERN ROUTE  
Cultural heritage target assessment  
and exclusion zone recommendations

VIR 2740

***16/02648***

June 2019

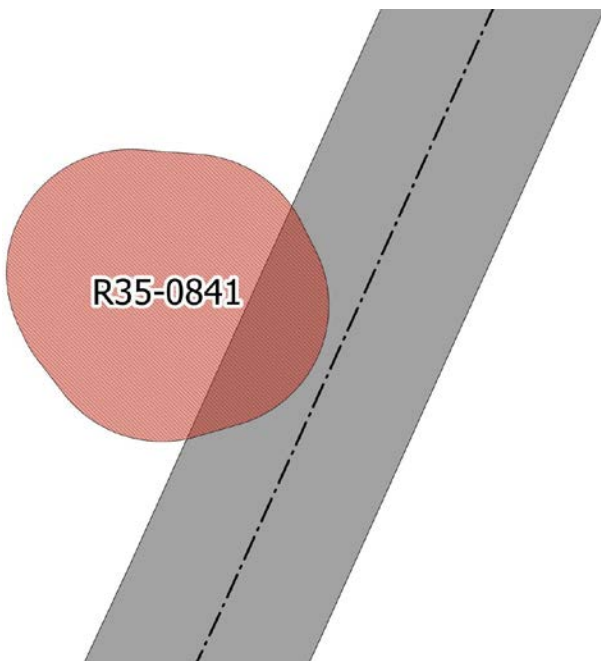
A target is said to be *marginally conflicting* if the target exclusion zone intersects with the pipelay corridor (or, eventually, intervention work areas), but does not intersect the design route centre line. Minor pipelay re-routing within the lay corridor is feasible so that the ‘as-laid’ position of the pipeline does not intersect with the exclusion zone (Figure 2A). In this case the pipelay contractor must manoeuvre away, maintaining a minimum of half the lay corridor (8.25 m) from any target exclusion zone; the so-called *lay-avoid* procedure. If this should prove impossible (for example because of proximity of another object on the opposite side of the lay corridor), further mitigation may be required by the Danish Agency for Culture and Palaces (Slots- og Kulturstyrelsen, SLKS), e.g. further investigation, rerouting the pipeline, removing the object, or securing it *in situ*.

Fig. 2A. Marginally conflicting exclusion zone.

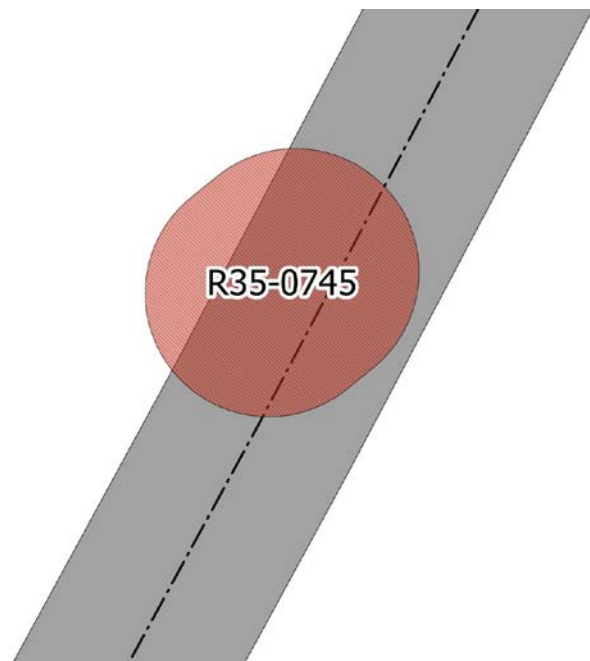
Conversely, a target is said to be *conflicting* if its final exclusion zone intersects with design route centre line (Figure 2B).

Fig. 2B. Conflicting exclusion zone.
