BALTIC PIPE, DANISH BALTIC SECTOR  
Screening of geophysical data and target inspection  
for the proposed Baltic Pipe gas pipeline  
- Anchor Corridor

VIR 2813

***SLKS 18/00033***

March 2022

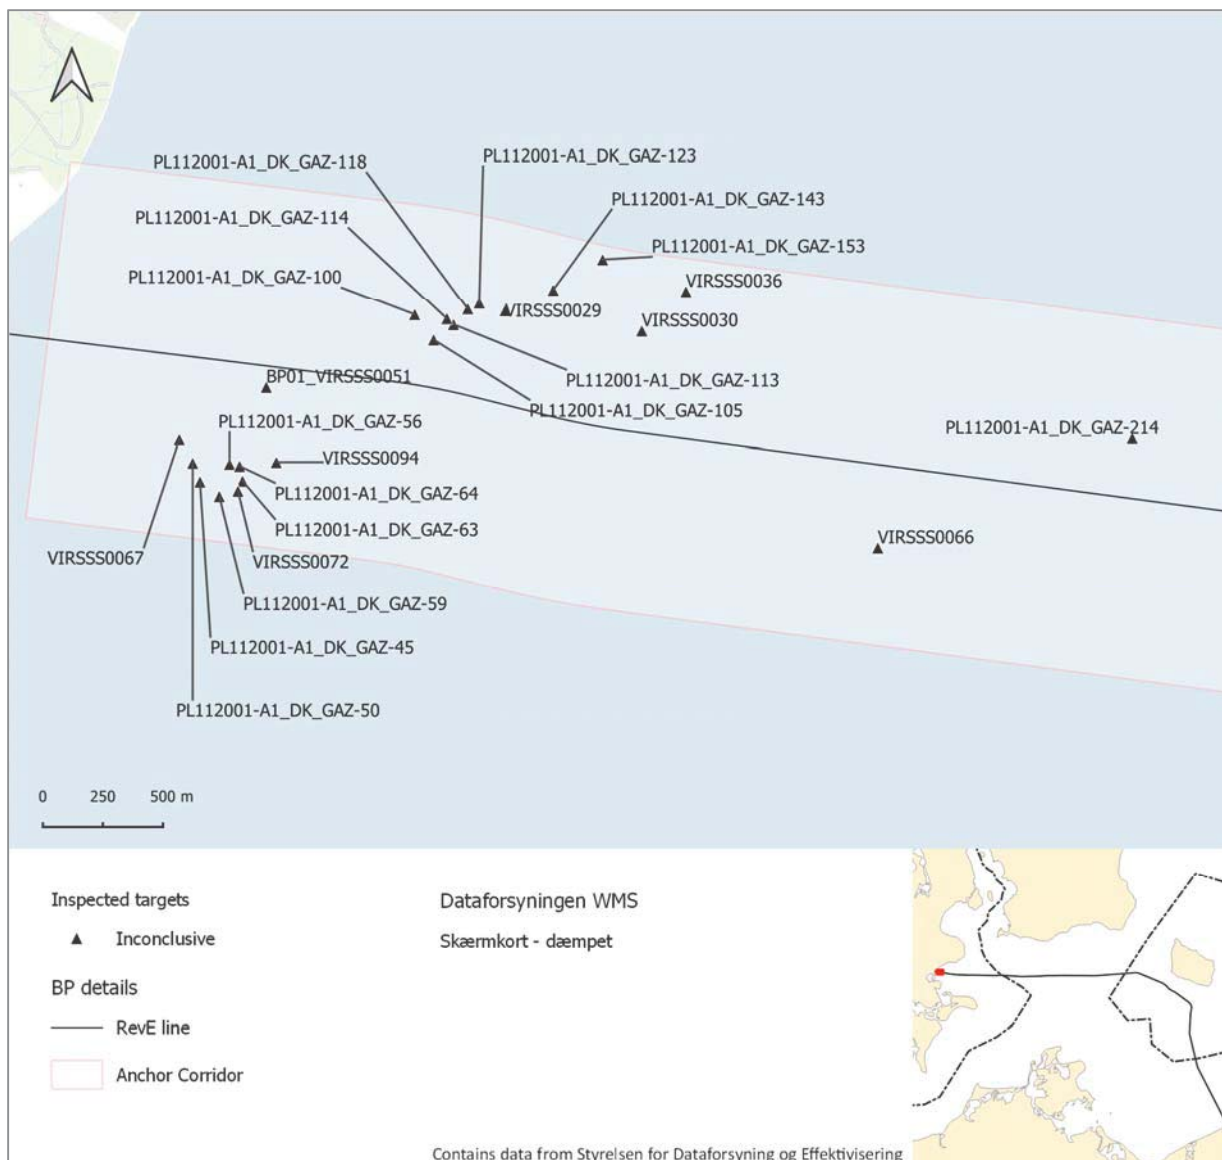
It has proven difficult to identify, and indeed date, many of the objects due to visibility constraints and marine growth. 27 are thus classified as *Inconclusive* after the visual inspection, regarding their status as potential underwater cultural heritage (Appendix 1 and 2). Most of them (23) are situated nearshore (Figure 2), and are different types of wooden objects. Three are situated off Bornholm (see Appendix 5). It is possible that a diver inspection could clarify their nature in many cases. However, for the present project, it has proven possible to design anchor corridor and exclusion zones respectively, so that confliction is avoided.

Figure 2. Nearshore inconclusive targets. Drawing: Marie Jonsson © Vikingeskibsmuseet.

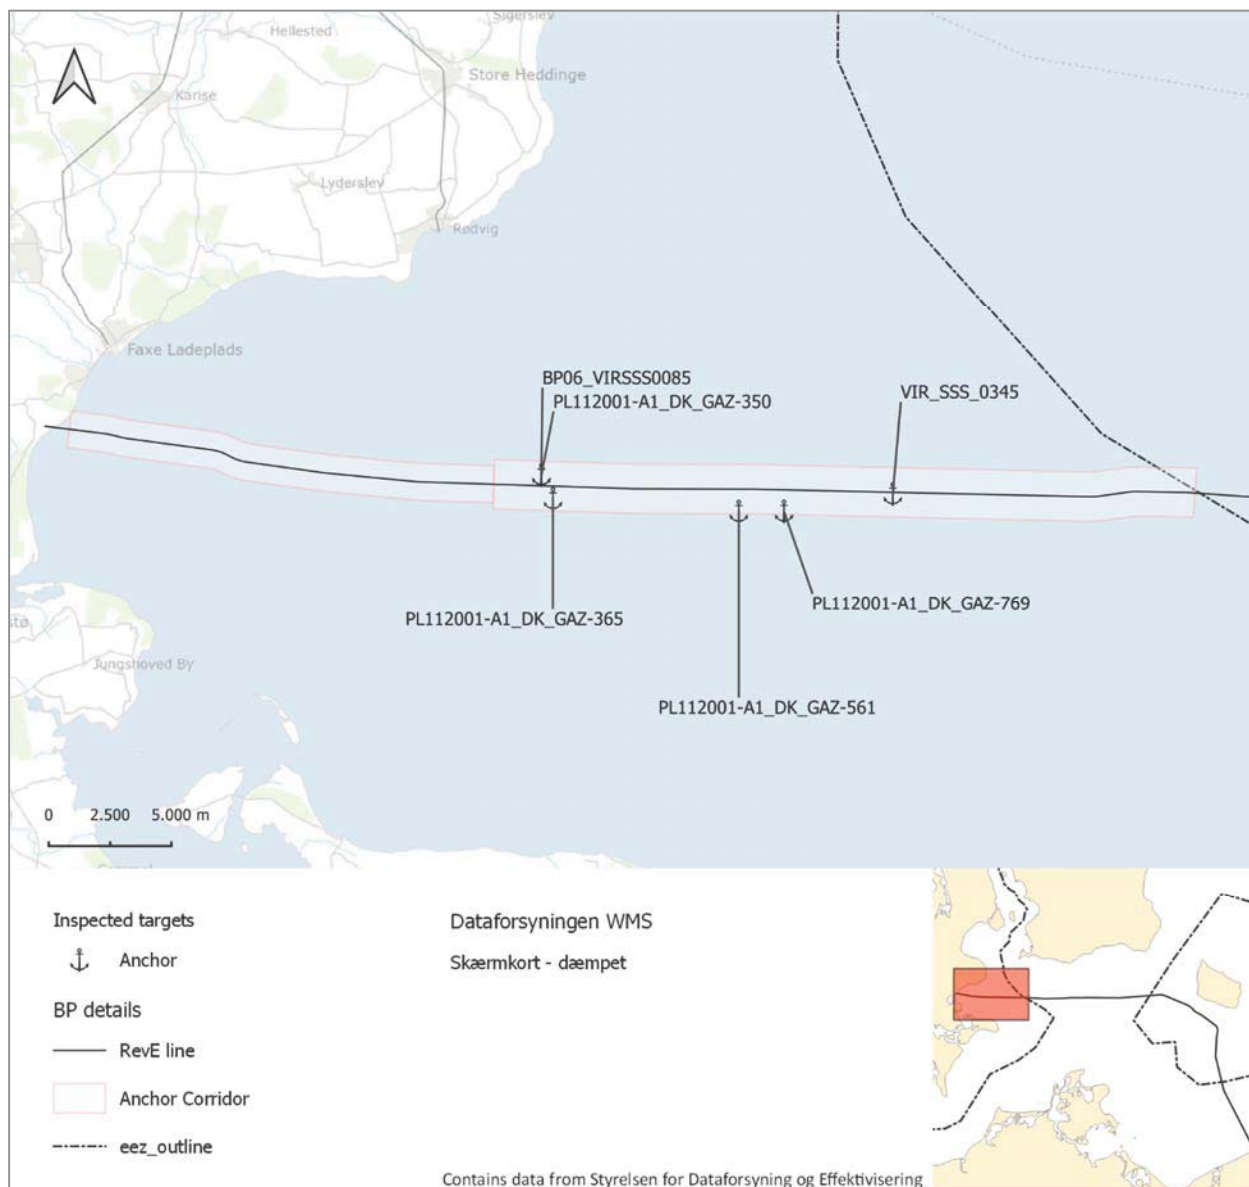
All anchors are located in section 06 of the corridor (see Figure 3). Wrecks and wreck parts are more evenly dispersed in the anchor corridor sections except for the shallower parts of Rønne Banke near Bornholm, see Appendices 3-5.

**Figure 3. Position of anchors. Drawing: Marie Jonsson © Vikingeskibsmuseet.**

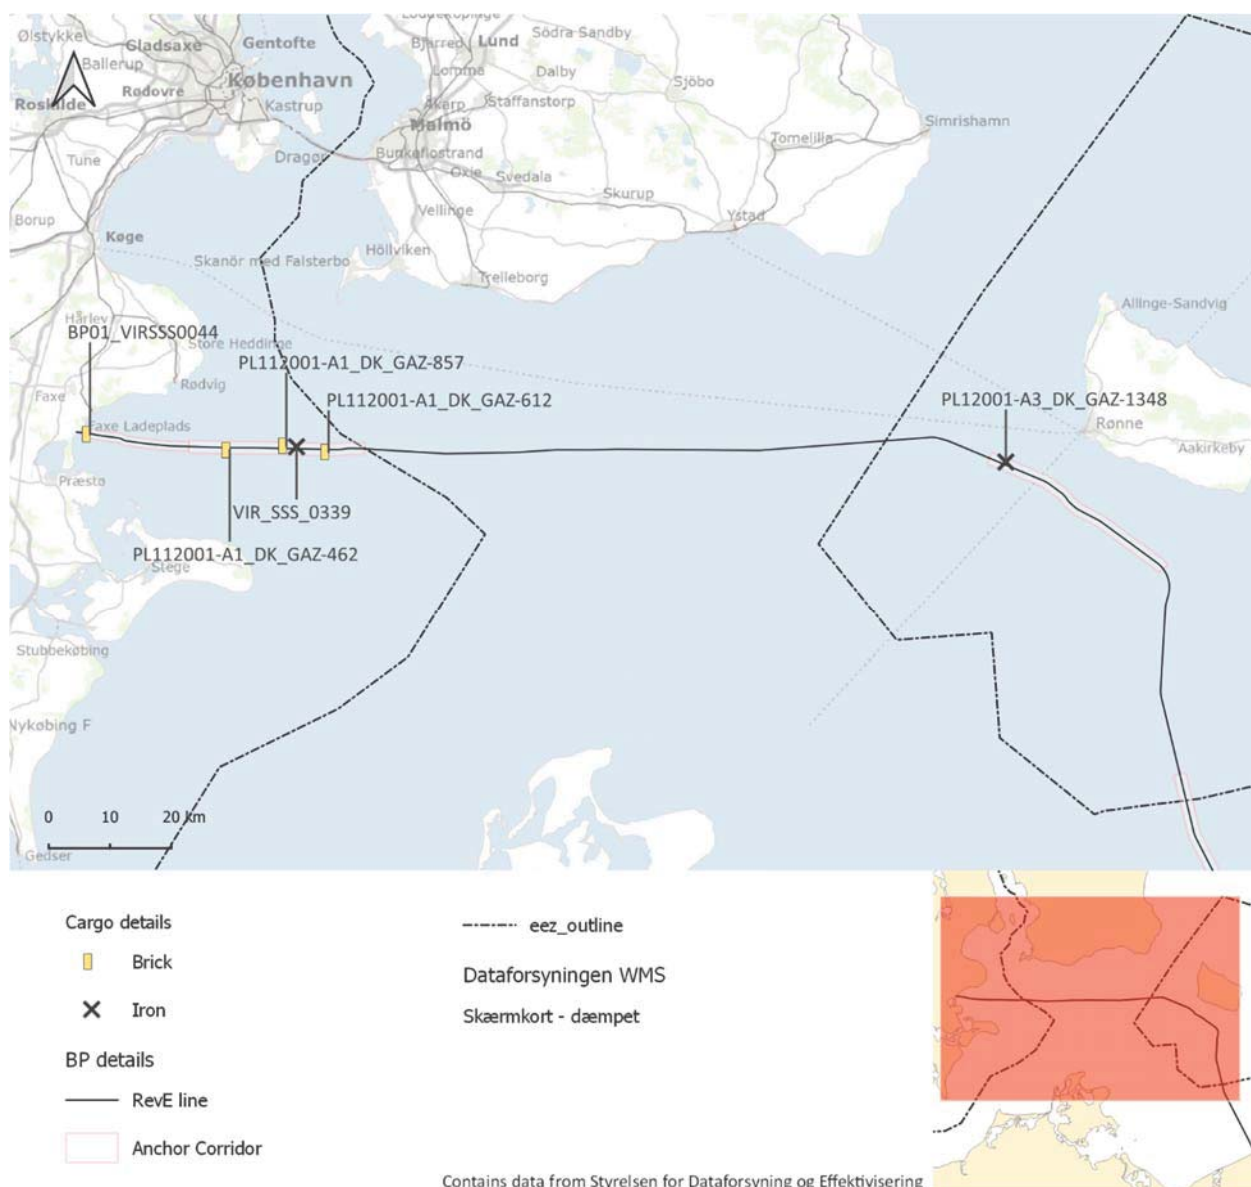
The four brick-loaded wrecks are all located in section 01 and 06, “nearshore”; one of the iron-loaded wrecks is in the same area, while the other in section 09, near Bornholm (Figure 4).

Figure 4. Locations of wrecks with brick or iron loads. Drawing: Marie Jonsson © Vikingskibsmuseet.

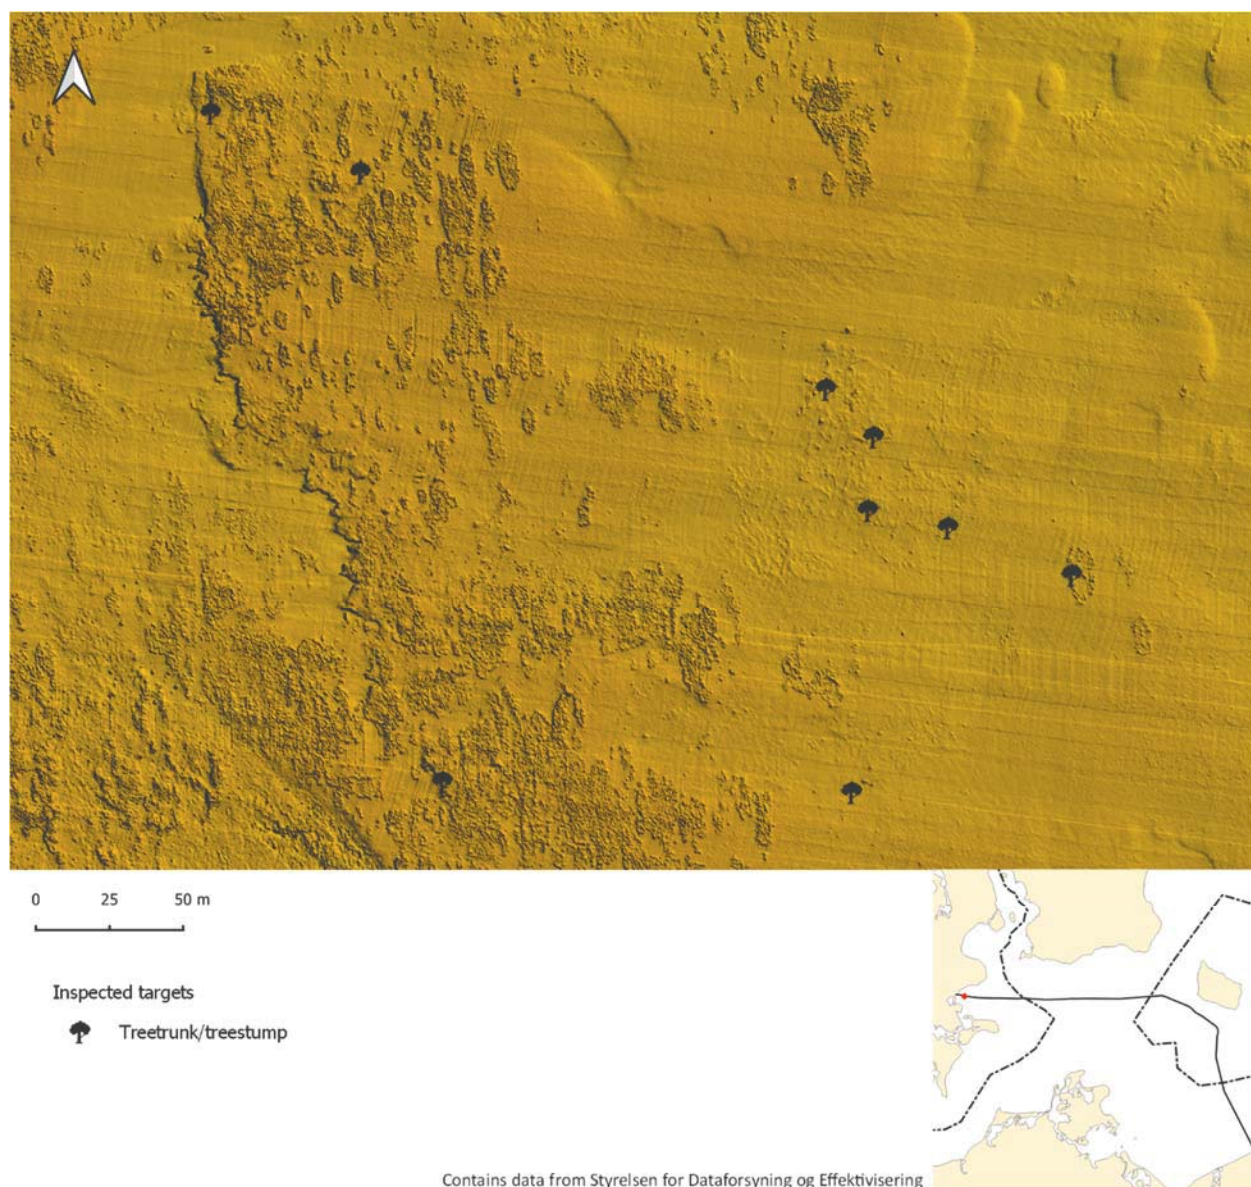
It should be noted that most of the 46 identified tree stumps/tree trunks are rooted stumps, i.e. remains of submerged forests *in situ*. A number the linear objects selected during the side scan sonar screening were found to be fallen tree trunks surrounded by roots and other debris from decomposing submerged forests during ROV investigation. Potentially these areas are more extensive than earlier estimated, see Figure 10, where the “rough patches” could be remains of the ancient forest off the Zealand coast.

**Figure 10: Confirmed remains of submerged trees, and potential forest remains (rough patches). Drawing: Marie Jonsson © Vikingskibsmuseet.**

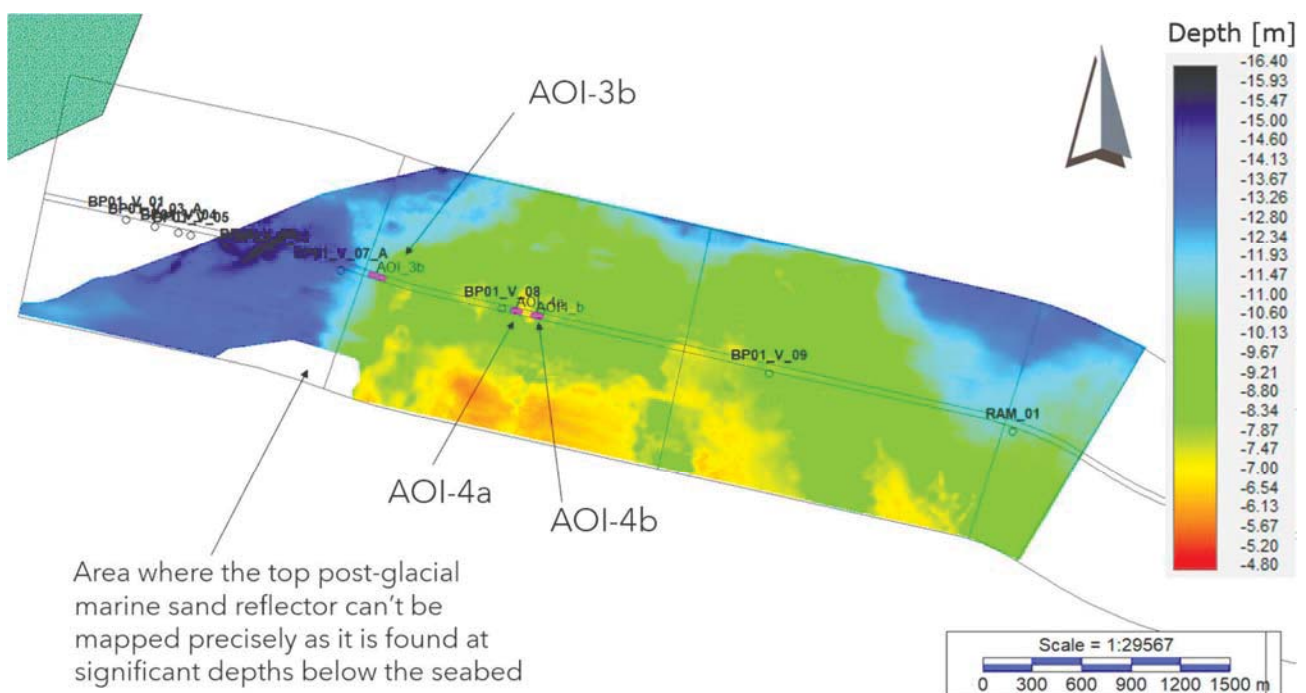
This renewed interpretation indicates that the affected lay corridor AOIs 3b, 4a and 4b were situated marginally in the prehistoric landscape; probably on (barrier?) islands north of a more substantial land mass (see Figure 12). This is reflected in the limited number of finds from the three areas where habitation is likely to have been only seasonal/occasional – perhaps as outliers from more permanent settlements situated further south.

**Figure 12: The interpreted Mesolithic landscape surface near the Fakse landfall (Przychodzen 2022, fig. 4-1).**

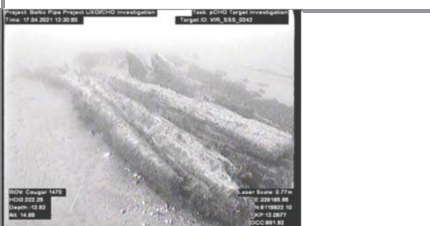
M-806-0002-NHP	Wreck					360281,12	6112974,66		44,242	potential CHO / debris / linear object	Wooden construction plus some smaller objects. Possible wreck	Video shows parts of a wooden Construction. There is one long beam, some smaller timbers sticking out anlongside of it, and one knee standing upright. Only a small portion is visible, but chances are there is more buried in the sediment. In the MBES a depression is visible, and the objects are resting in the NW part. Perimeter is established based on ROV-video and MBES.	Assumed	25 meters radius based on wreck perimeter. Digital version provided (shapefile)

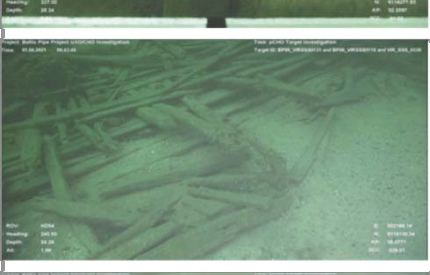
BP06_VIRSSS0118	Linear object; near wreck. BP06_Li10, L12					352169,40	6114080,40		36,060	Wooden Wreck same as BP06_VIRSSS0125/VIR_SSS_0339	Wreck. Check video.		Assumed	100 meters radius based on wreck perimeter. Digital version provided (shapefile)

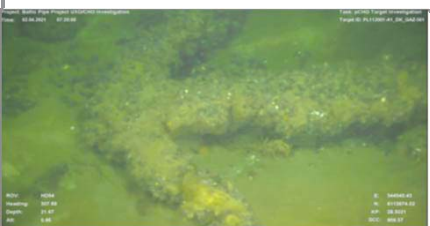
PL112001-A1_DK_GAZ-612	Visible in Bathymetry	Mound	9,23	9,84		357320,92	6112792,80		41,320	Brick mound - possibly Danish provenance after 1700	Wrecksite. Wreck buried in the sediment, the main feature is the brick cargo of yellow bricks.		Assumed	200

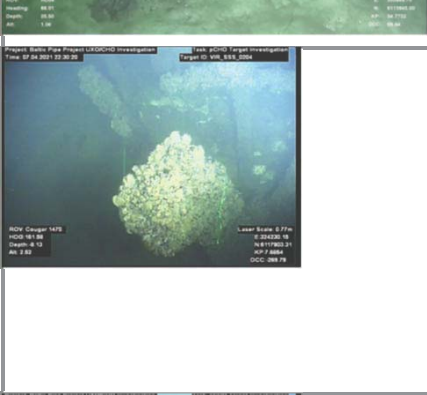
BP01_VIRSSS0071						324232,07	6117902,81	-11,00	7,687	CHO / Wooden wreck	VIR_SSS_0204 is the same target as identified in BP01_VIRSSS0071	<p>TIR notes: The wreck sits upright on a sandy seabed, has low relief (mostly standing &lt;2 m off the seabed) and is badly degraded. The outline of the wreck is best appreciated from the BlueView sonar and when viewed in this imagery the bow of the wreck would appear to be the NNE end. The wrecks wooden construction is best observed: at the bow and stern areas; the ribs rising out of the seabed along its flanks; and hull planks seen within the wreck at the bow and stern areas. The sides of the wreck are mostly missing and only represented by the remaining ribs. Sections of interior and exterior hull boards (clinker-clad?) remain close to the seabed at the bow. Most of the interior of the wreck is filled with cobble-sized objects.</p> <p>Little detail can be discerned within the body of the wreck due to the cobble-sized objects that fill the wreck and that themselves are covered with marine growth. However, a cylindrical wooden object poking vertically up through the middle of the wreck, slightly forward of the mid-point of the wreck might be the remains of a mast?</p> <p>Five isolated items of wooden debris were found surrounding the wreck with debris extending approximately 24 m from the wreck's centre.</p>	Assumed	Custom radius based on wreck perimeter. Digital version provided (shapefile)
