NORD STREAM 2 PIPELINE –  
ANCHOR CORRIDOR  
Cultural heritage target assessment  
and exclusion zone recommendations

VIR 2740

January 2022

## **Anchor corridor. Cultural heritage target assessment and exclusion zone recommendations.**

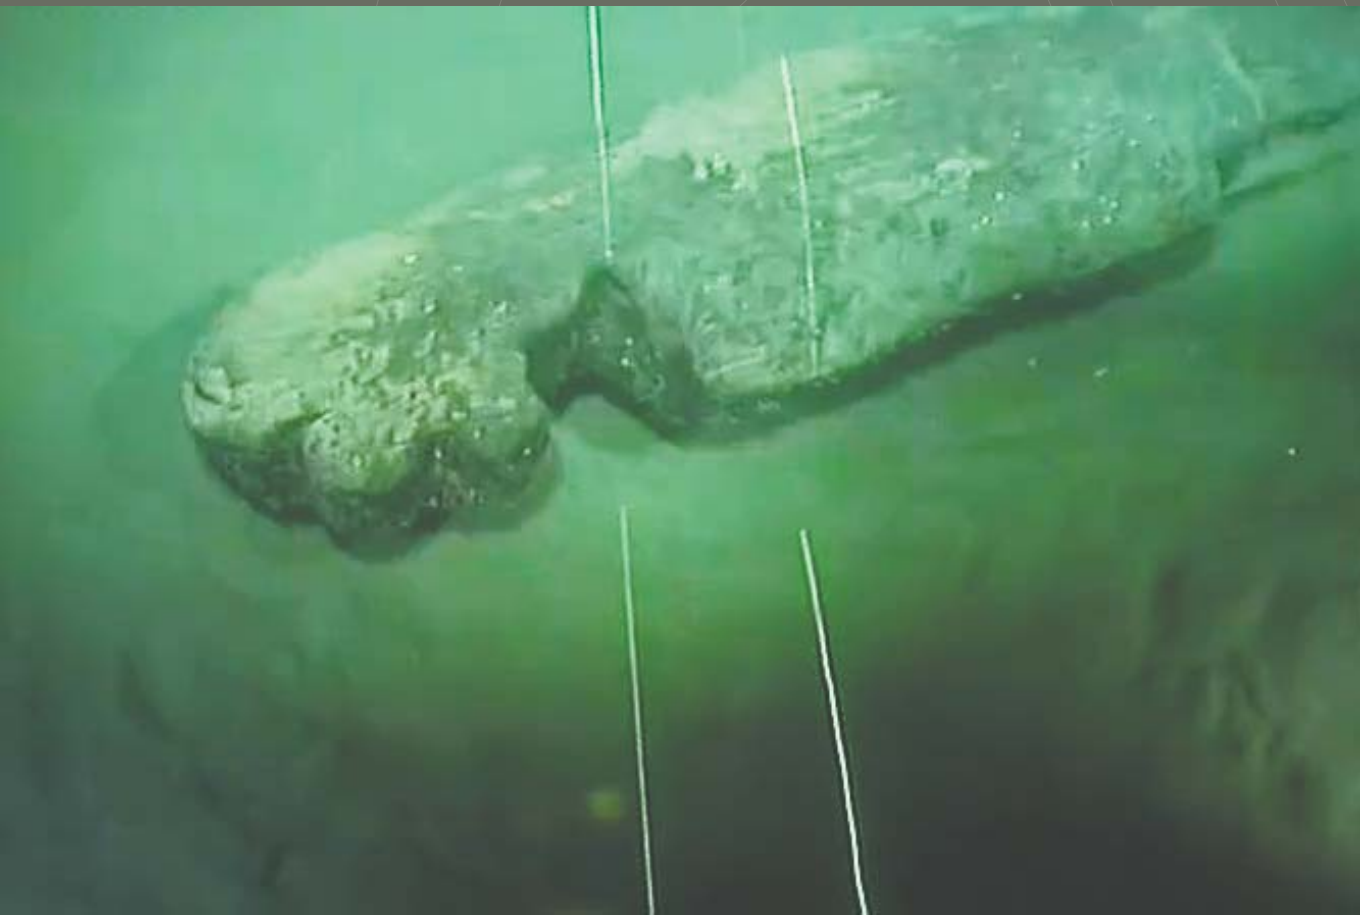
Cover illustration: Rudder, DKS36-2294 © Nord Stream 2 AG/Baltic Explorer

SD-DKS36-2294	504624,8	6065059,3	Rudder, c. 17th c. Decorative carving on the protruding top end. Semi-buried; poss. more in vicinity		Confirmed	50
SD-DKS36-2295	505044,5	6065259,9	Log or fishing stake		non-CHO	n/a
SD-DKS36-2296	505696,5	6065544,4	Rope or wire debris		non-CHO	n/a
SD-DKS36-2300	507514,0	6066217,4	Not found in 6x6m. A seabed scar may be the anomaly		non-CHO	n/a
SD-DKS36-2302	510007,4	6067228,7	Seabed scar is pres. the anomaly		non-CHO	n/a
SD-DKS36-2303	510029,7	6067239,9	Not found in 6x6m. A seabed scar may be the anomaly		non-CHO	n/a
SD-DKS36-2315	516903,1	6070171,9	Insufficiently documented. Log, timber. MMO/CHO		Assumed	50
SD-DKS36-2333	507593,7	6066225,0	Seabed scar is pres. the anomaly		non-CHO	n/a
SD-DKS36-2334	508298,7	6066541,8	Wire debris		non-CHO	n/a
SD-DKS36-2342	519840,7	6072287,5	Wooden log . Situated close to SD-DKS36-2343 and SD-DKS36-2382, so probably timber cargo, and fairly modern.		non-CHO	n/a
