### 5.5.3 Reconstruction of the ship in torso

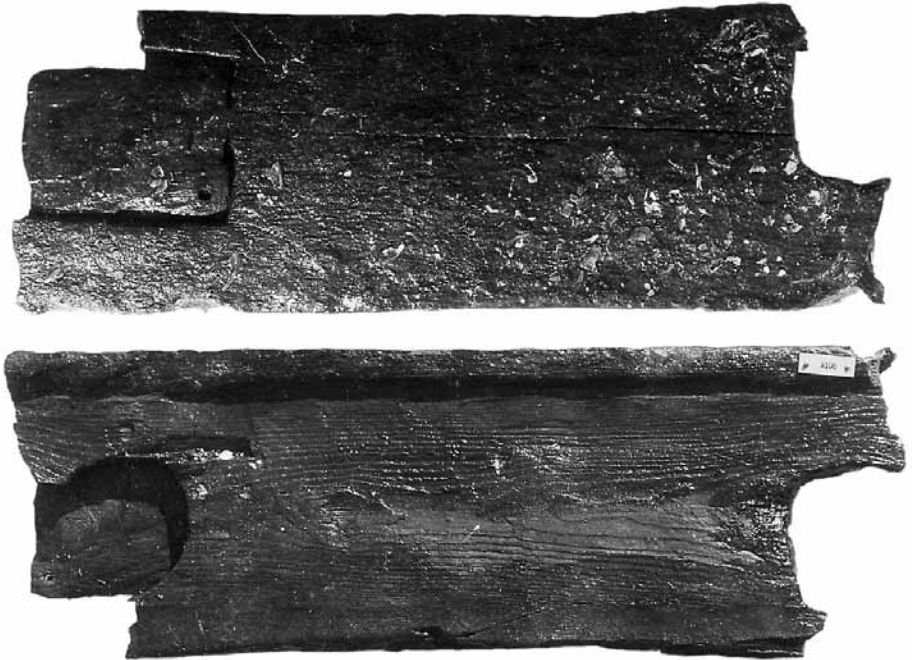
Fig. 24. Skuldelev 5. Fragment of the sheerstrake, seen from the outside (above) and from the inside (below). To the left is a covered-over oar-hole from the first system and to the right one from the second system, positioned at  $1\frac{1}{2}E$ .

As many as fourteen holes for oars have been cut through the 7.7 m-long middle length of the port sheerstrake of ash (Figs 24-25). Initially, they appear confusing but they clearly match two different systems. One system, which consists of a line of round holes, also has several holes that have been closed from the outside with small patches of oak. The distance between the holes, from centre to centre, varies between 70 cm and 88 cm, averaging 78 cm. This length of plank evidently came from another ship that had an average frame distance of ca 78 cm, which accommodated the first system of circular oarports.

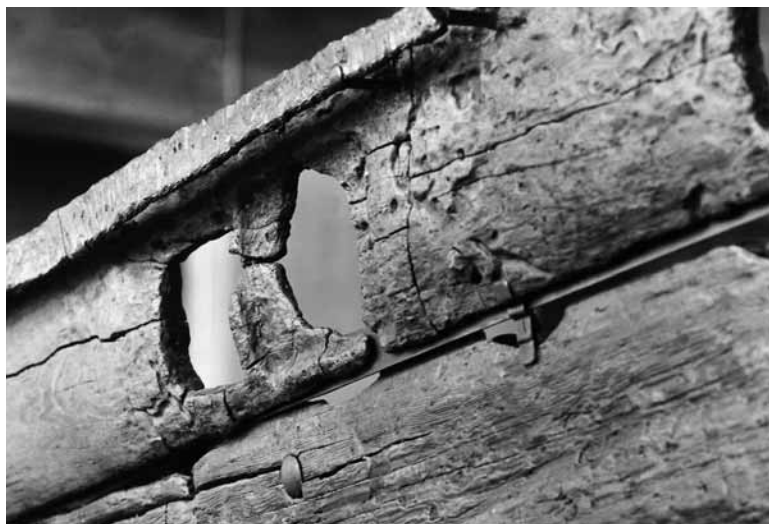
Fig. 26. Skuldelev 5. The shield-rack in position along the upper edge of the sheerstrake.

Several interesting features, including the rack for mounting the shields of the warriors/oarsmen on the outside of the sheerstrake, were badly affected by the ship's post-depositional, *in situ* decay and erosion. Luckily, however, a small part of this particular element survived amidships (Fig. 26, cf Figs 5 and 25). It is of oak with a preserved length of 1.48 m, made from a ca 5 x 5 cm lath that had been cut in such a way that the full thickness is only preserved in a few small areas held against the upper edge of the sheerstrake with small treenails, ca 1 cm in diameter. In between these points of attachment, the thickness narrows to 2 cm, leaving a 3 cm-wide slot between the outside of the sheerstrake and the rack. In these slots, the shields of the warriors would be mounted outboard as illustrated in several Viking-Age depictions.

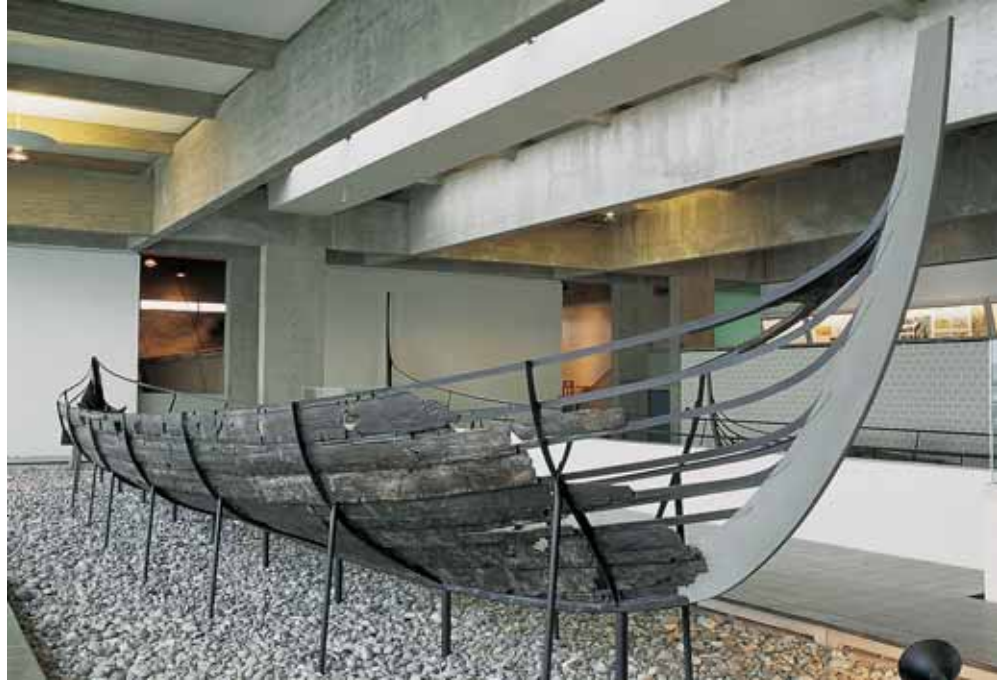
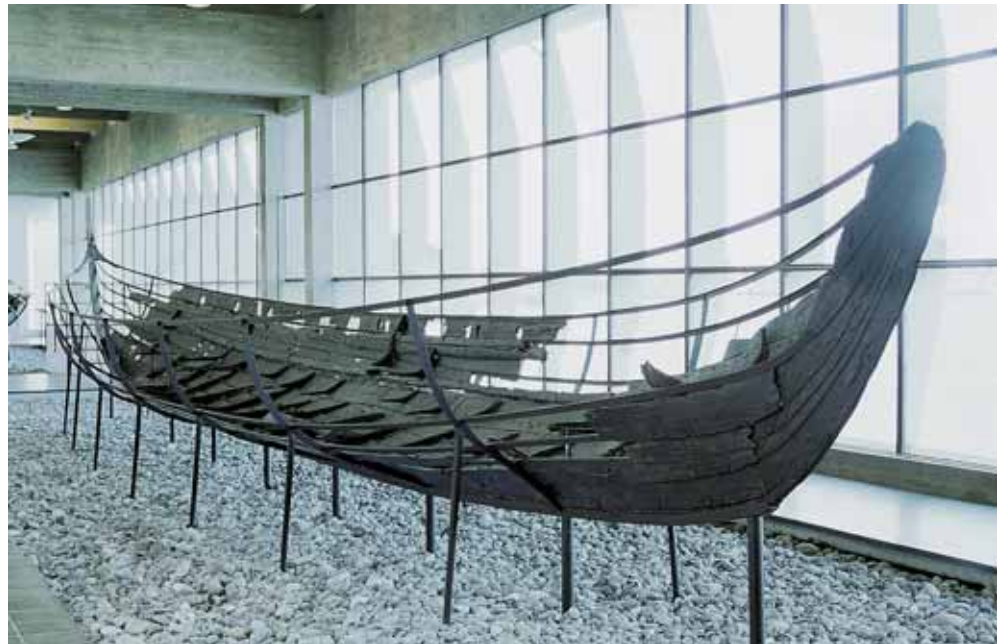
*Fig. 27. Skuldelev 5. The restored ship in the Viking Ship Museum, seen from aft.*

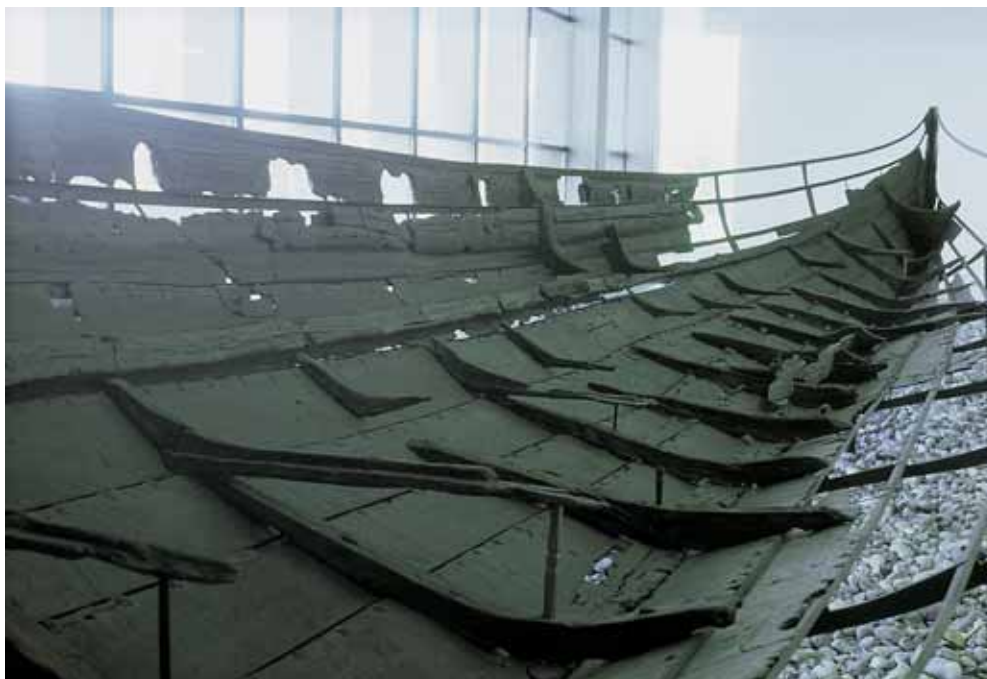
Fig. 29. Skuldelev 5. Interior of the hull, looking forward.

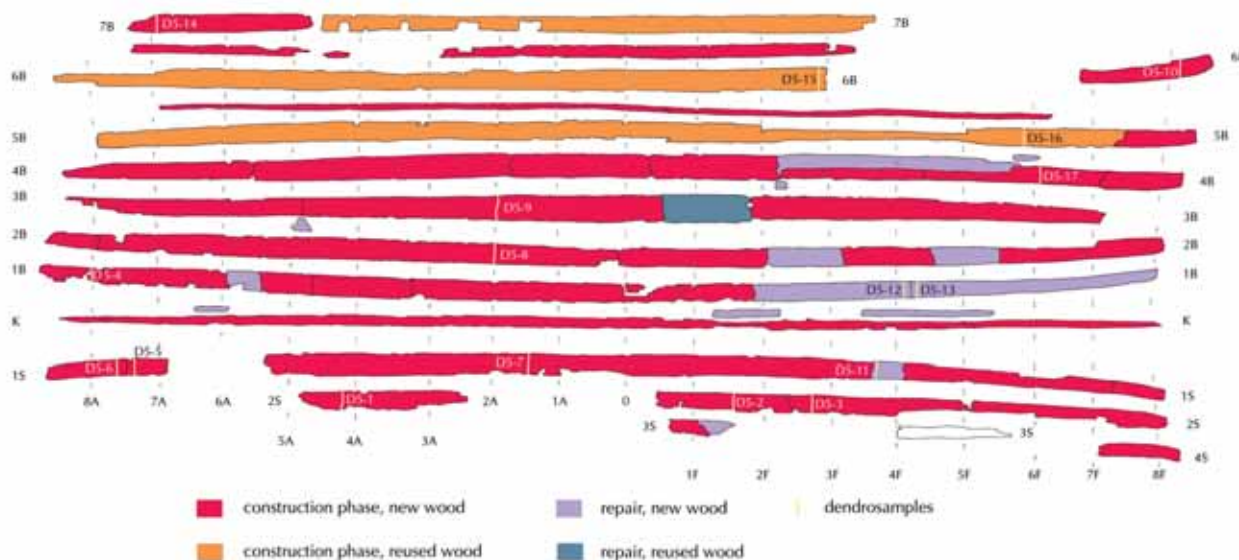
Fig. 33. The planking of Skuldelev 5 with colour codes for the use of new wood or reused wood during the construction phase and in repairs or alterations. Positions of dendro-samples are marked out.

In the bottom of the hull of Skuldelev 5, a clear pattern emerges (Figs 33-34). A broad, reused plank has been inserted in 3B at 1F to make up for a damaged part of this strake as well as the edges of the planks above and below. Most of the remaining repairs in the bottom are concentrated in the forward part of the hull, but in the course of this extensive repair, parts of the planks further aft were also replaced with short lengths of new planks.

A number of dendro samples have been extracted from this ship for examination and analysis (cf Chapter 3.3). A series of fourteen samples<sup>23</sup> were all taken from oak planks, nine of these from the construction phase and five from the late repair in the bottom. None of these samples included any sapwood, nor did any of these planks have features indicating that they were reused. They were evidently all new and cut specifically for use in this ship. In Fig. 33 the position of the samples are marked out.

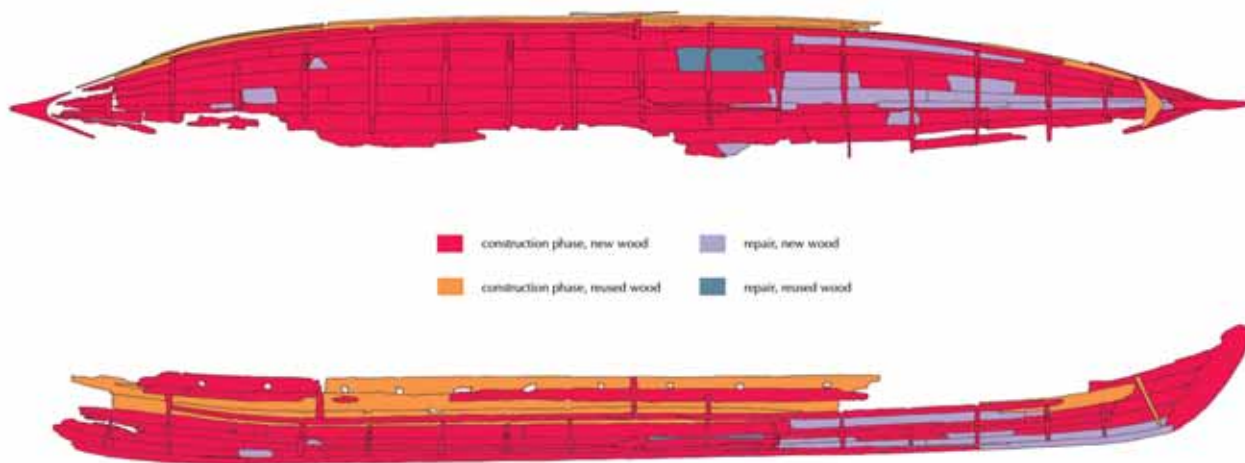
Fig. 34. Skuldelev 5. Torso-drawing with colour codes for the use of new wood or reused wood during the construction phase and at repairs or alterations.

(cf Figs 16 and 34). There are several fastening holes in this element, only some of which match holes in the planking of Skuldelev 5, strongly indicating this part's prior use in another ship.

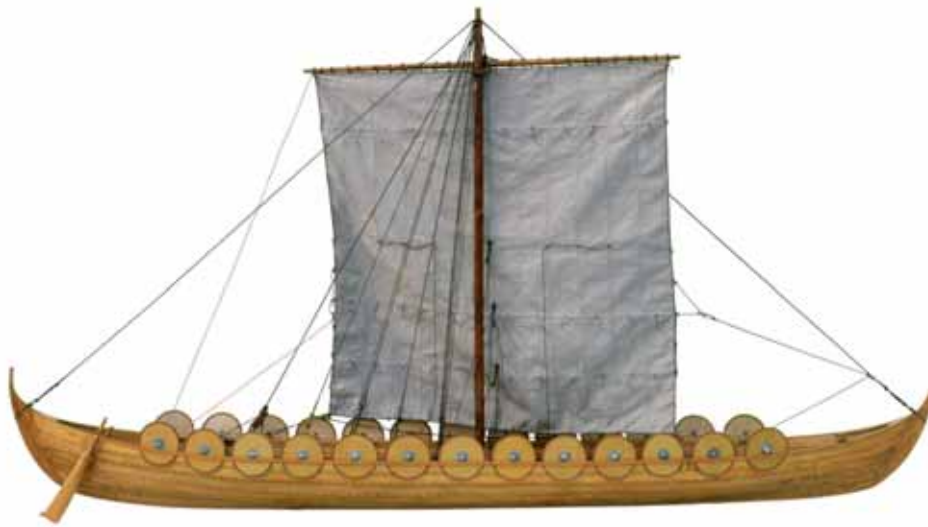
*Fig. 38. Skuldelev 5. Exhibition model at scale 1:10 of Skuldelev 5, built by Morten Grønbech with the rigging reconstructed by Erik Andersen and Vibeke Bischoff.*
