5.2 Skuldelev 2

5.2.2 Description of the preserved parts of the ship

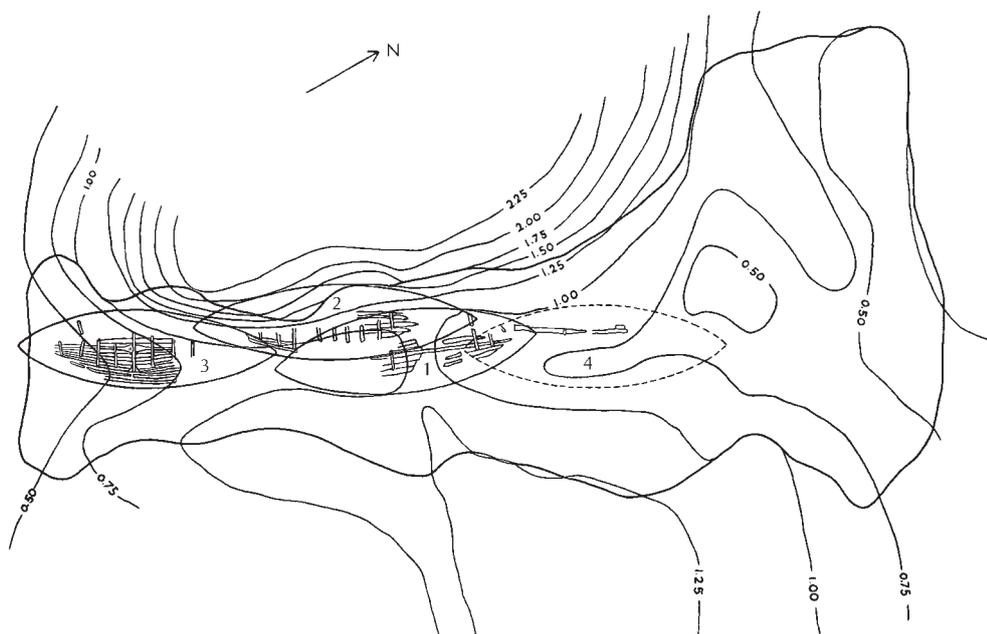
Fig. 1. This plan resulted from the underwater investigations of 1957-58; the ships are marked out as they were located, based on a very conservative estimate of their original size. The contour lines, based on elevation recordings taken on top of the stones in the barrier, clearly show how the narrow passage made by the fishermen through the middle of the barrier affected Wrecks 1, 2, and '4'.

The fishermen's establishment of a passage for their boats in the 1920s may also have affected this wreck, as the keel and planking of the central part of the wreck is missing in this area (cf Fig. 1). None of the ships' timbers recorded in 1924 by Kai Uldall are from this wreck, however, and the character of the pointed end of the keel of Skuldelev 2 here indicates that it may have juttied out from the protecting stone-heap for a longer period. Consequently, a considerable part of this northern end of the vessel, as well as the southern bow end, may have broken up and been dispersed shortly after deposition.

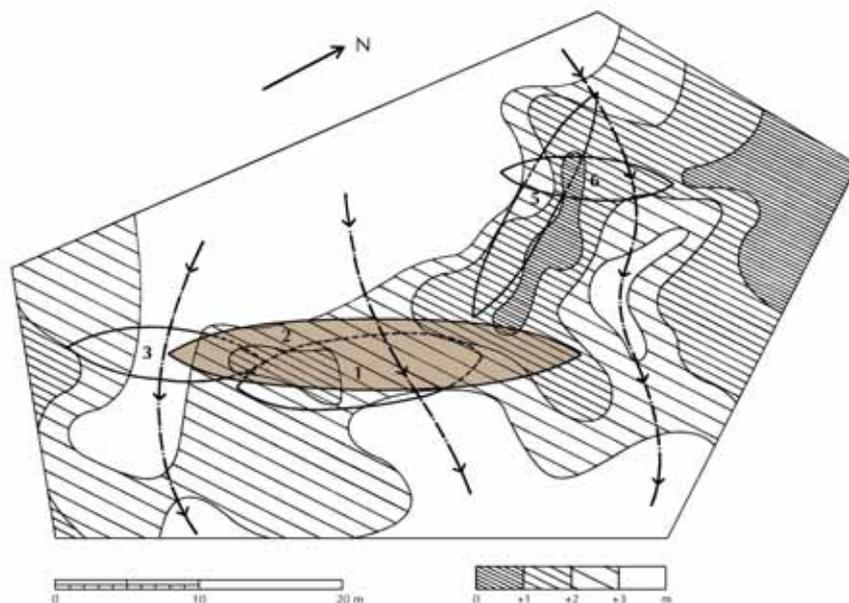
Fig. 2. The position of Skuldelev 2 (in brown) in relation to the natural barrier (the shaded areas) rising as a threshold from the bottom of the Peberrenden channel (the white area).

stones, and originally covered practically the full width of the natural passage over its threshold (Fig. 2). The ship was oriented northeast-southwest, with the bow pointing south-west. It was resting on top of Wrecks 1 and 3 and had evidently been positioned there some years after the scuttling of these ships (cf Section 5.2.2 of this chapter). The assumed identity of 'Wreck N' as part of Skuldelev 2 was later confirmed as a result of dendroanalysis.

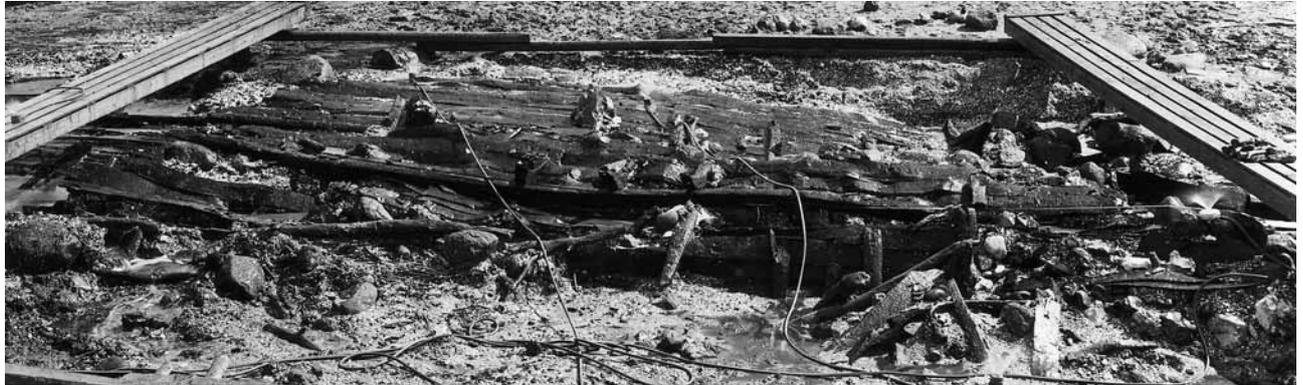
Fig. 3. Skuldelev 2 during excavation in 1962, seen from the west. The keel rides on top of the stones in Skuldelev 1 with the starboard planking pressed down along the side of the ship below.

The position of Skuldelev 2 on top of the pile of stones and ships' timbers of the first phase of the barrier, left the wreck unfavourably exposed. Whereas Skuldelev 1 had settled on the hard, curved but relatively even surface of the moraine ridge, the keel, planking, and frames of Skuldelev 2 were poorly supported and wedged in between the stones of Skuldelev 1, below, and its own load of stones. Parts of the planking and frames of Skuldelev 2 were found broken down and lying vertically over the western edge of Skuldelev 1 (Fig. 3).

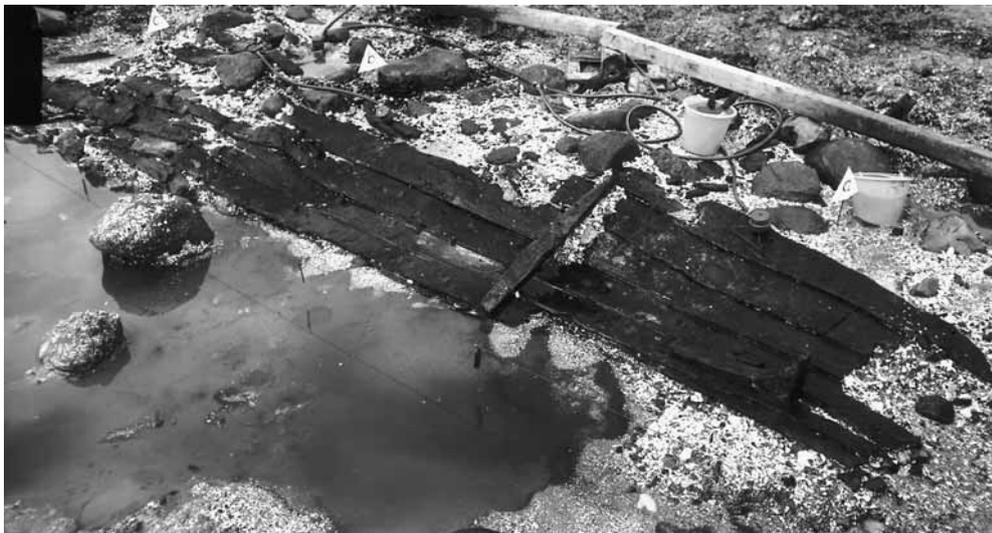
Fig. 4. Skuldelev 2 ('Wreck 4'). The port side aft after excavation.

The two separate parts of the wreck in the barrier were treated as independent units during the 1962 excavation. 'Wreck 4' was excavated during the period 12-20 July (Fig. 4),

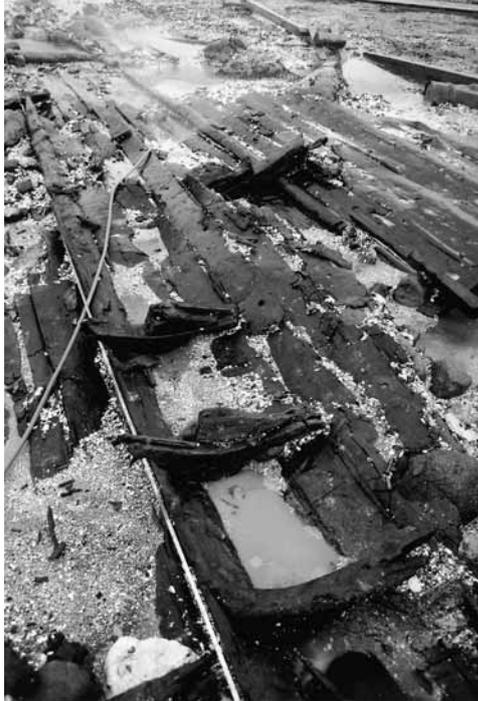
Fig. 5. Skuldelev 2. The northern section of the wreck (lower left) partly exposed on top of the stones and timbers in Skuldelev 1 (upper right). In the foreground the central parts of the floor timbers 2F-4F above the keel and two keelson knees.

and photogrammetrically surveyed on 19 July. It was taken up in two days and its fragments numbered from 1501 to 1570. The central part of the ship was excavated between 27 July and 7 August, recorded as 'Wreck 2' with the fragments numbered 501-599, and photogrammetrically surveyed on 9 August (Fig. 5). Lifting of the hull timbers started the next day and was concluded in the course of eight days. In the final phase of the 1962 fieldwork, the slope down to the deep pit west of the barrier was excavated in the period 1-14 October, and this yielded a considerable amount of wreckage, mainly from this ship (Fig. 6), numbered within the sequence of loose finds from P600 to P749 and from 1801 to 1819. Since we had not foreseen that the archaeo-

In this way, the greater part of the floor timbers from the central part of the ship could be placed correctly in relation to the keel and planking. Even two of the keelson knees had been found *in situ* in 1962 on top of their floor timber (cf Fig. 5), and several of the other floor timbers bore traces from the fastenings of the keelson knees, making possible the fitting of most of the loose knees into their original positions.

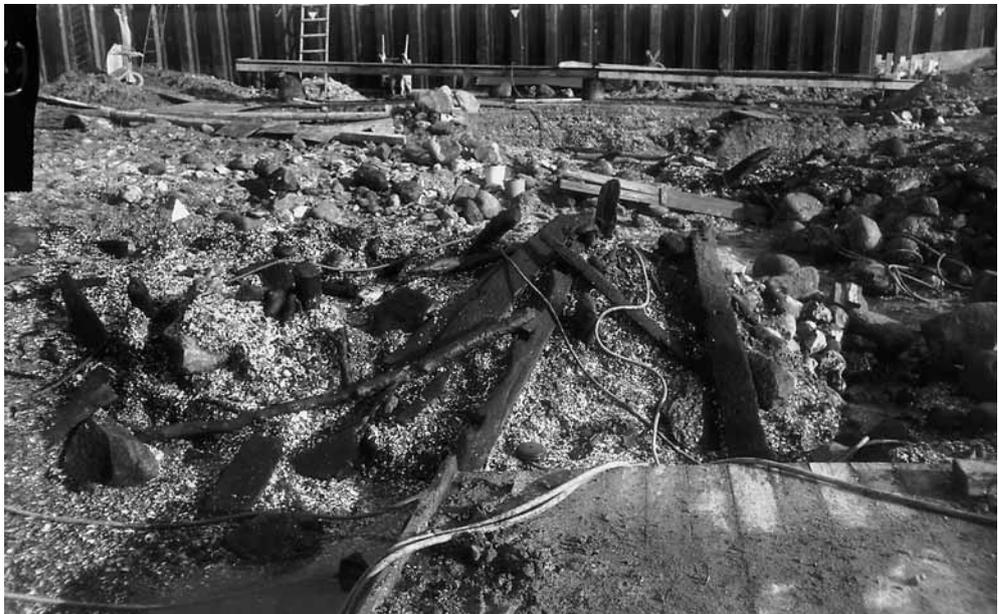
Fig. 6. Skuldelev 2. Dislodged parts on the western slope during excavation.

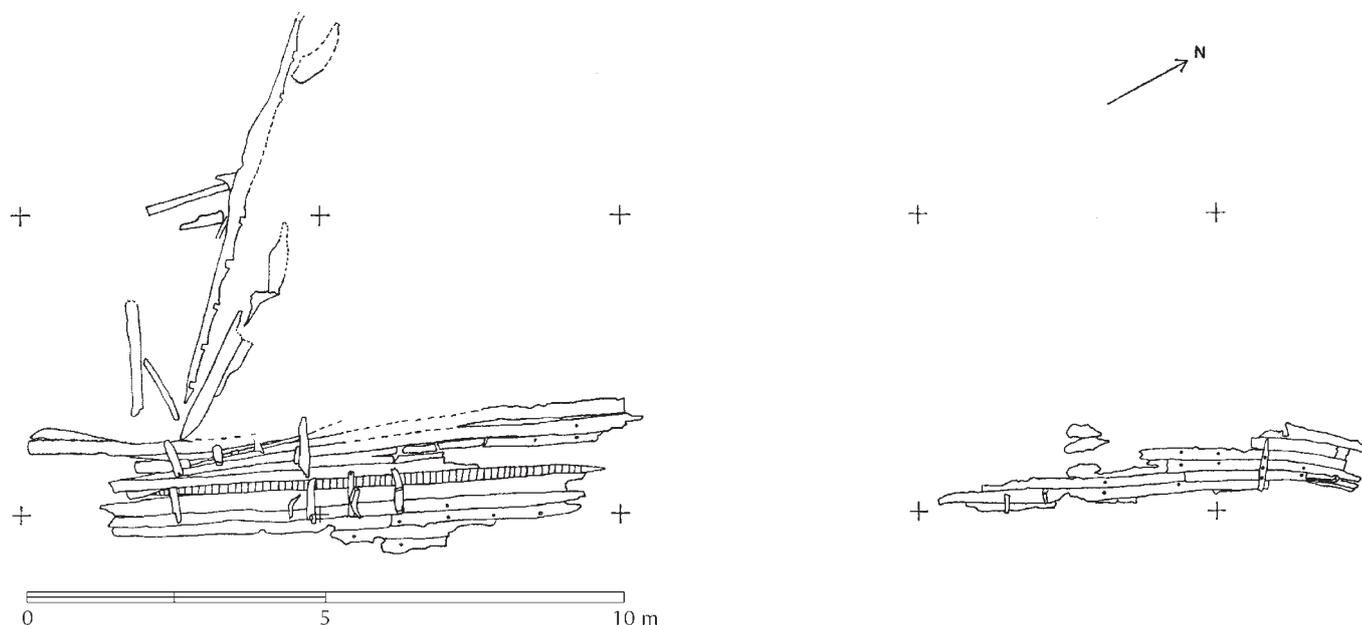
Fig. 7. Skuldelev 2. Plan based on the photogrammetrical survey 1962. Scale 1:100.

The difficult conditions for recording the various scattered parts of the Skuldelev 2 wreck *in situ* in the barrier meant that the overall plan of the wreck had to be pieced together from several localised recordings (Fig. 7) and an compassing photograph could not be taken at any time, except from the air (Fig. 8).

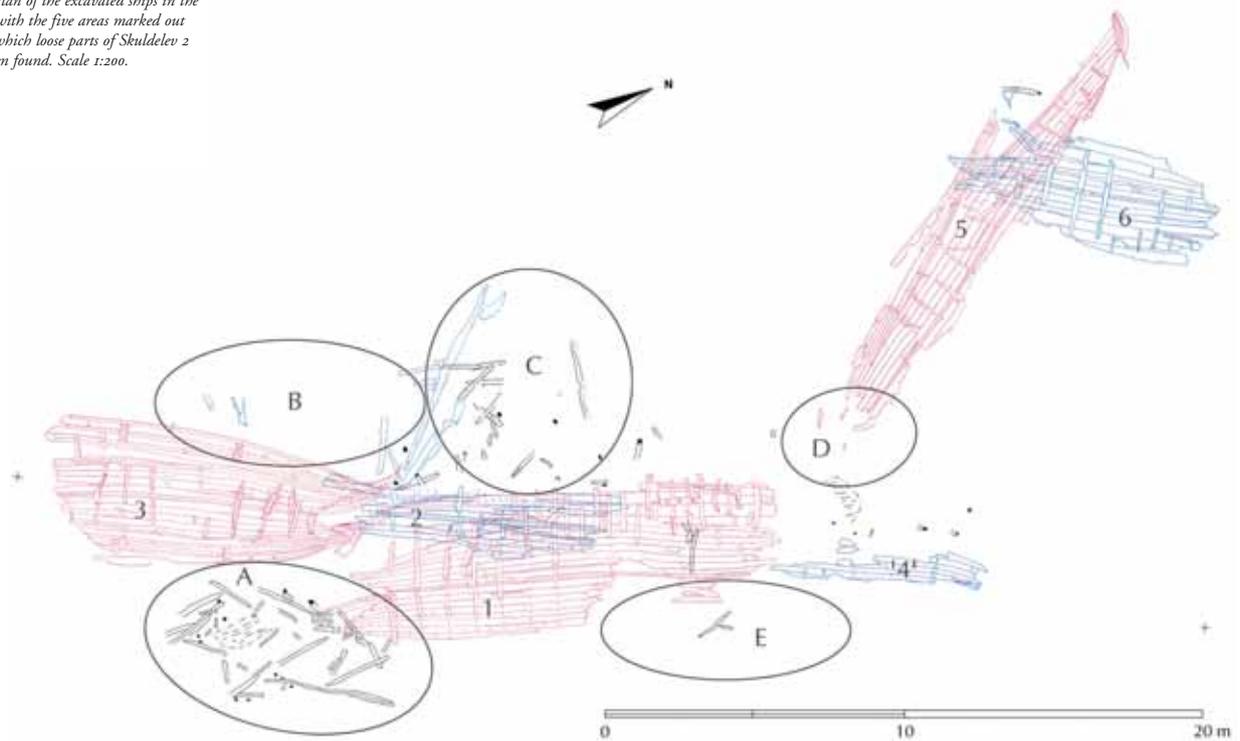
Fig. 9. Plan of the excavated ships in the barrier with the five areas marked out within which loose parts of Skuldelev 2 have been found. Scale 1:200.

Now the elements of the structure that had been identified as to their original position in the ship could be studied in relation to the five areas around the wreck from where these and other elements from Skuldelev 2 had come (Fig. 9). This study showed that structural members from the foremost part of the ship (forward of 5F) had been found in the areas A and B on both sides of Skuldelev 3, and only here. This corresponded with the fact that the forward part of Skuldelev 2 had originally been positioned on top of the stones in Skuldelev 3. Evidently, the ship's timbers had been completely removed here, except for a small number of individual elements deposited on the spot without further local scattering.

The loose elements that could be fitted into the middle and after part of the ship all came from area C (the western slope and the deep pit), area D (between Skuldelev 1 and 5) and area E (outside the starboard bow of Skuldelev 1). The after stem was found in area C at the deepest part of the pit, 20 m away from its original position, together with the large keelson and several other elements. Other midship elements had moved to the areas D and E.

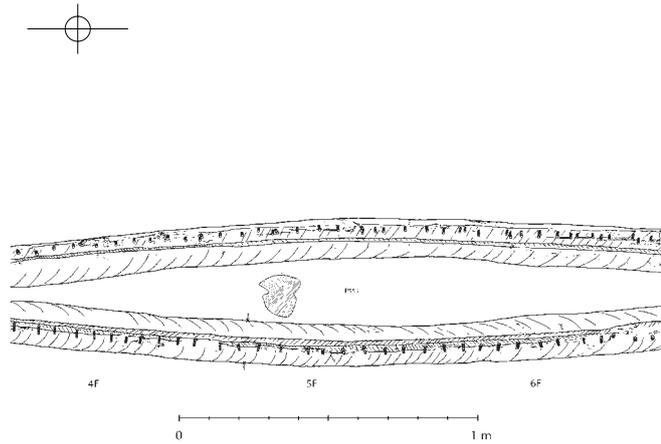
Fig. 10. Skuldelev 2. A section of the keel seen from starboard (above) and port (below). Scale 1:20.

A 7.6 m-long length of the midship part of the keel is preserved. The forward end is broken away between 7F and 8F, and the after end of the preserved part is worn down to a point between 2A and 3A (Fig. 10). The keel is of oak with a curved top surface in cross-section and has pronounced rabbets for the keel strakes (Fig. 11). The maximum width of the keel is 17 cm along the top and 9 cm at the underside, and the height is 14 cm. Originally the keel was slightly deeper, as it clearly shows signs of wear, as do the garboard strakes. Probably the original height was ca 16-17 cm over the midship length.

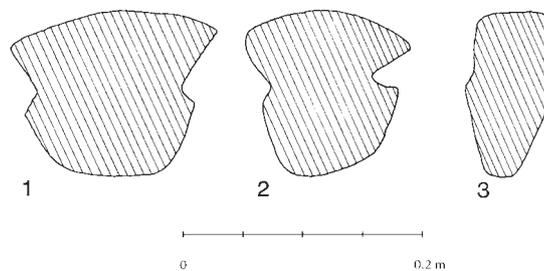
Fig. 11. Skuldelev 2. Cross sections of the keel. Scale 1:5.

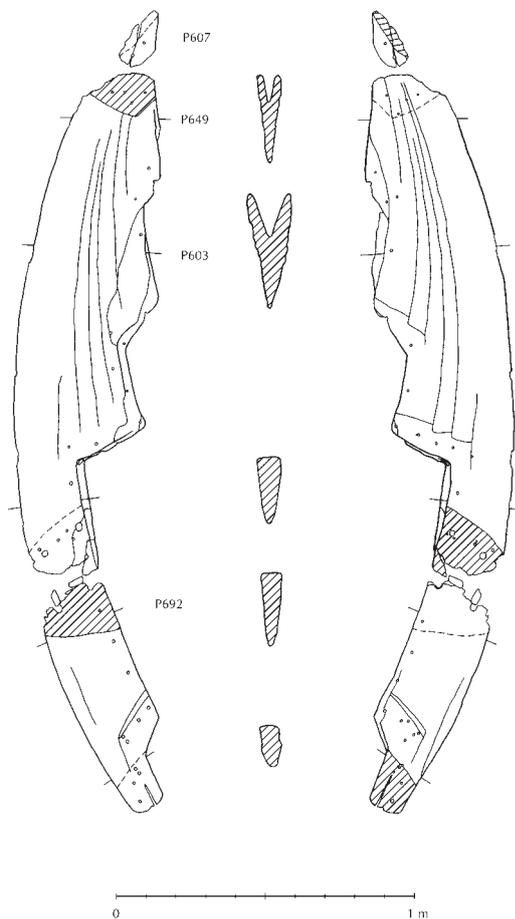
Fig. 13. Skuldelev 2. The stem aft. Scale 1:20.

The after stem (Fig. 13) is a composite structure of oak, originally comprised of three elements. The lower part is 0.80 m long, and has a scarf by which it was attached to the after part of the keel, or *lot*. There is a step for the first strake and a broad scarf to the central part of the stem, fastened with two treenails and a number of spikes or rivets.

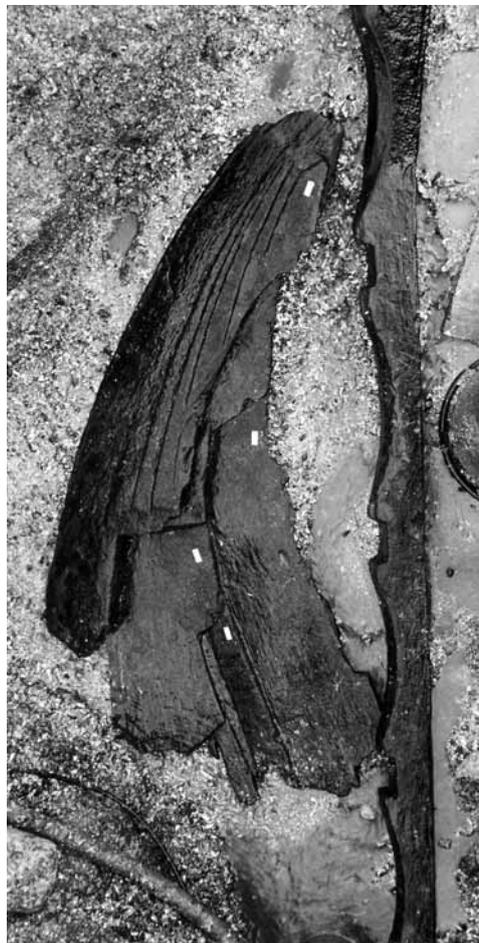
Fig. 14. Skuldelev 2. The stem aft as found in situ, seen from the starboard side with the port multiple-end planks in position.

The central part of the stem is 1.7 m long, with an open, V-shaped cross-section and sides carved with a continuation of the lines of the planking, similar to the found stems of Skuldelev 3 and 5 (Fig. 14). There are three steps for the multiple hooding end planks, the lower two of which are for the strakes 2B to 6B or 7B, which were found with the stem. The narrow top-most multiple hooding end plank,

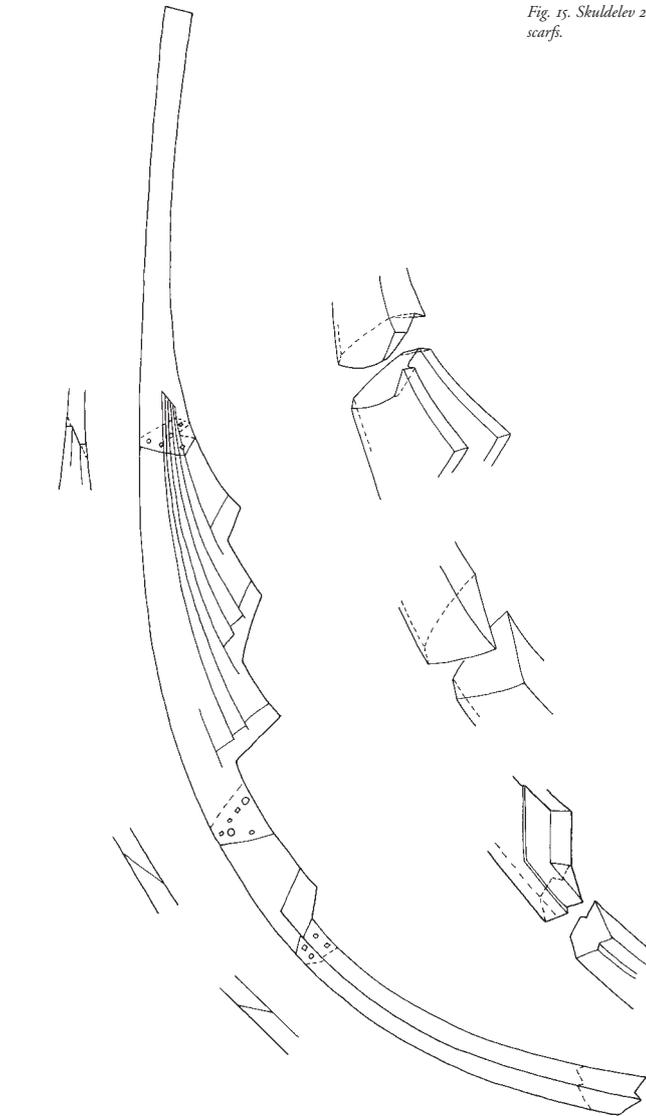
Fig. 15. Skuldelev 2. Details of the stem scarf.

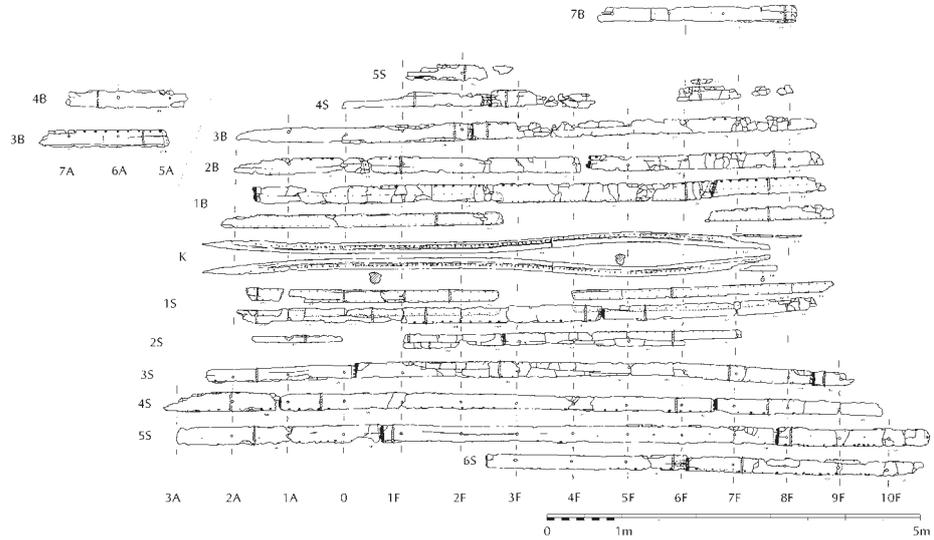
Fig. 16. Skuldelev 2. The keel and the coherent part of the planking from 10F to 3A found in situ and recorded as 'Wreck 2'. Scale 1:80.

In the forward and midship areas from 10F to 3A, the greater part of the strakes 3B to 5S were found together with a fragment of 6S and fragments of 4B and 5B. This section was recorded as 'Wreck 2' during the excavation (Fig. 16). These planks were severely damaged owing to their position between the stones in Skuldelev 1 below and those in Skuldelev 2 itself. Initially, as a result of the absence of continuous support for the planks, large portions of the edges of these had broken off and their remaining surfaces subjected to organic decay. However, sand and shells were eventually deposited between the stones, and they protected the planks against further decay. This panel of planking can be studied in context, and it gives a good impression of the bottom planking of the ship at the time it was scuttled, as these planks were found in their correct relative position. The holes for the treenails to the frames furthermore serve as a guide to the interrelationship of these elements in the damaged areas.

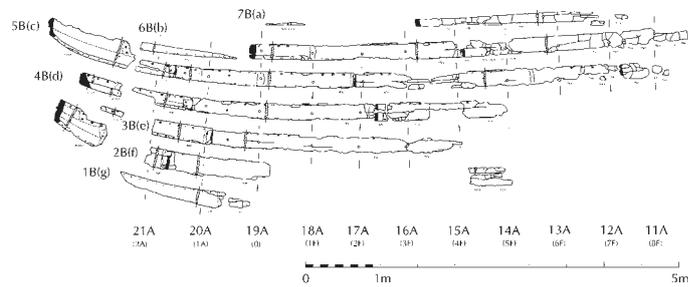
Fig. 17. Skuldelev 2. The planking from port side aft found in situ and recorded as 'Wreck 4', together with the multiple-end planks or stem-wings found together with the aft-stem. Scale 1:80.

From the port side aft, parts of strakes 1B to 7B between frame 11A and 21A were preserved *in situ* ('Wreck 4') (Fig. 17). This part of the planking rested directly on the relatively even sea floor to the north-east of the bow of Skuldelev 1. Consequently these planks are generally preserved in a better condition than those from midships, except for those at the southern end of this section, as the planks were exposed already in 1957, and those areas where a few large stones from the seabed had damaged the planks.

placing stem, keelson and several other parts of the wreck. The multiple hooding end planks found with the stem are shown in Fig. 17. They take up the ends of the strakes with a triple end plank for 2B-4B (Fig. 18) and a double end plank for 5B-6B which may, however, have been broader to take up strake 7B as well.

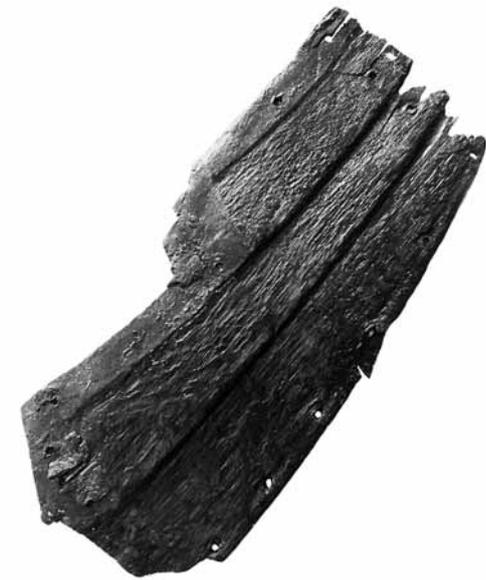
Fig. 18. (Left) Skuldelev 2. Triple-end plank for the strakes 2B, 3B and 4B.

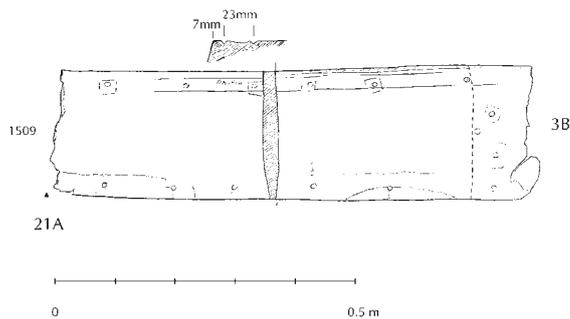
Fig. 20. Skuldelev 2. Strake 3B aft with details of fastenings, decorative moulding and cross-section of the plank. Scale 1:10.

Where the planking is best preserved, the fastenings could be studied in detail (Fig. 20). The rivets are spaced on average 11-14 cm apart without any evident pattern in the variations between the strakes or from amidships to aft. The rivets are made from iron nails with round heads and shafts, 6-7 mm^ø, riveted over rectangular roves, ca 25 x 30 mm. The rivets are placed in the middle of the *land*, the overlap between the edges of the planks. The upper, inner edge of the lower plank is usually decorated with mouldings, 25 mm and 28 mm wide, gouged into the wood with two v-shaped lines, spaced 20 mm and 21 mm apart and with a groove in between.

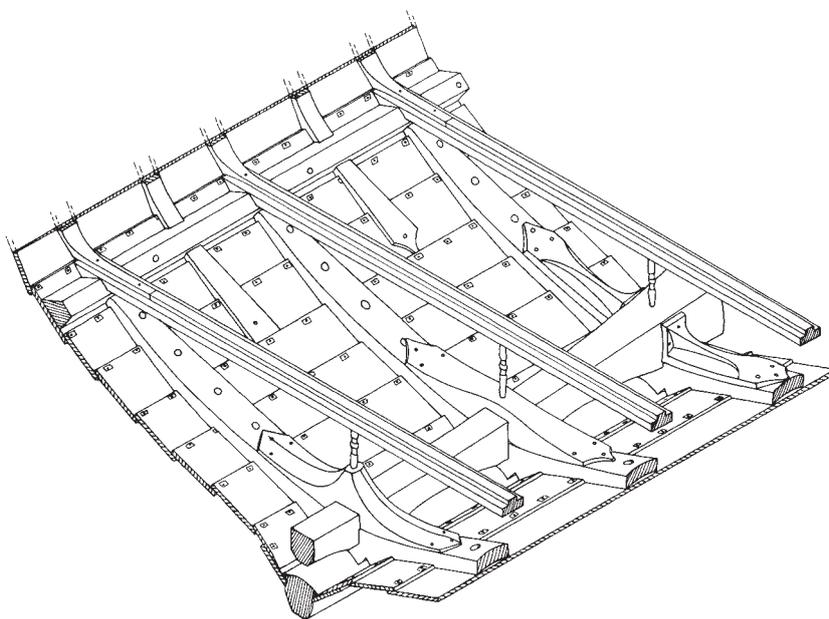
Fig. 21. Skuldelev 2. Reconstruction drawing of bottom section near amidships.

There is a strict system behind the layout of the framing system (cf Fig. 21), with the floor timbers spanning the lower seven strakes on each side and with an average spacing between the frame stations of 72 cm amidships and 67 cm aft. Halfway between the frame stations, slender side timbers span the fifth, sixth and seventh strakes. On the seventh strake, a stringer is joggled over the tops of the floor timbers and side timbers and it has notches on the upper side to accommodate a *biti*, the lower beam, over each floor timber. The *bitis* are supported from below by slender stanchions at their midpoint and they were originally fastened at each end with a slender knee. Only a few fragmentary parts of the framing system of the upper part of the ship are preserved. In this ship the keelson and its knees no doubt originally served as a longitudinal strengthening element fully integrated in the framing system that also maintained the ship's systematic structure, and is fully detailed below.

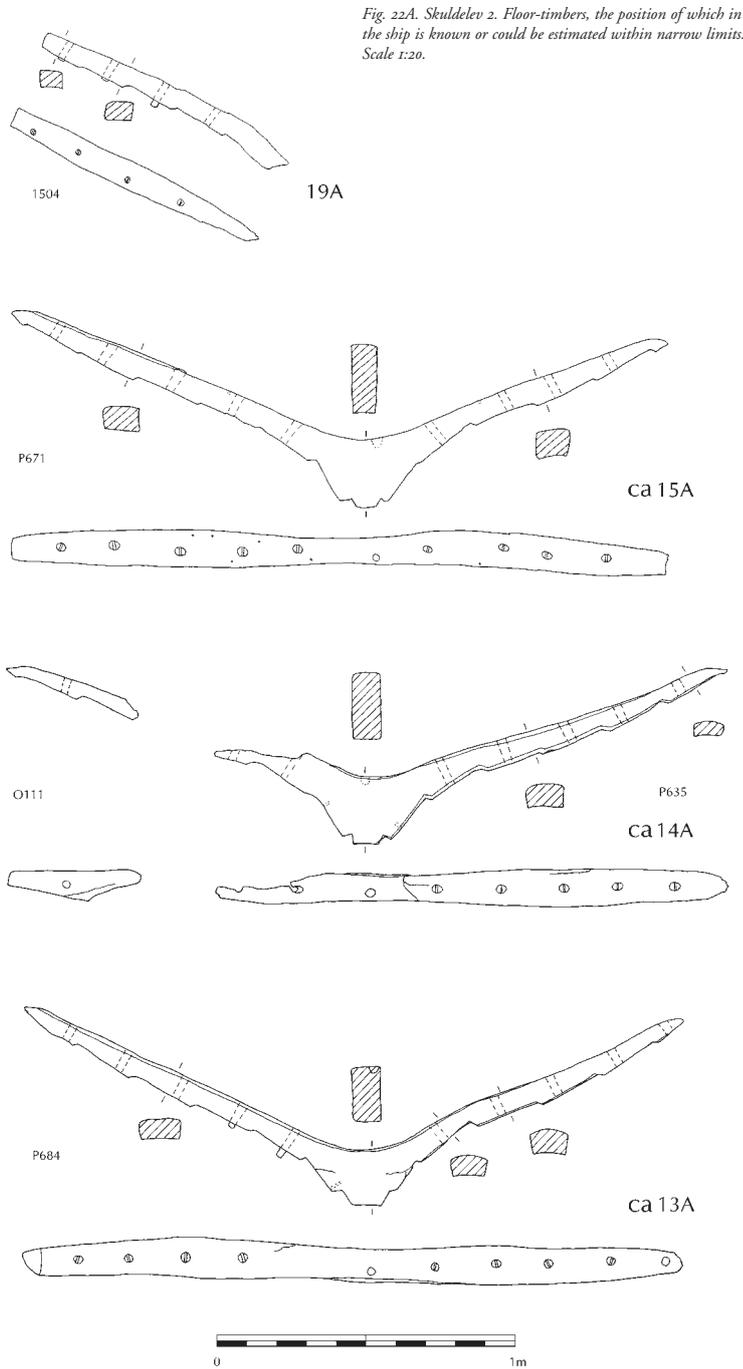
Fig. 22A. Skuldelev 2. Floor-timbers, the position of which in the ship is known or could be estimated within narrow limits. Scale 1:20.

Completely or partially preserved floor timbers were recorded from a total of eleven known frame stations amidships and aft (cf Table 2 and Fig. 22). These timbers have been identified as to their positions, even those that were found loose, on the basis of the nail hole patterns.

This feature is a clue to the relative positioning of the best-preserved floor timbers found out of context around the wreck and evidently coming from areas in the ship from which little or no planking has been found to indicate their original positions (Fig. 22A-C). Initially, these floor timbers were categorised on the basis of two other criteria: 1) Those from areas A and B (cf Fig. 9) were taken to be from the forward end of the ship, and those from areas C, D and E were attributed to amidships or aft in the ship. 2) Those floor timbers which had not been covered over by the keelson had a shallow hole drilled on the top in the centre-line as a socket for the lower end of a vertical *bitti*-stanchion (cf the description below), whereas no such holes were found on the floor timbers from 10F to 8A as these were fitted into the notches of the keelson.

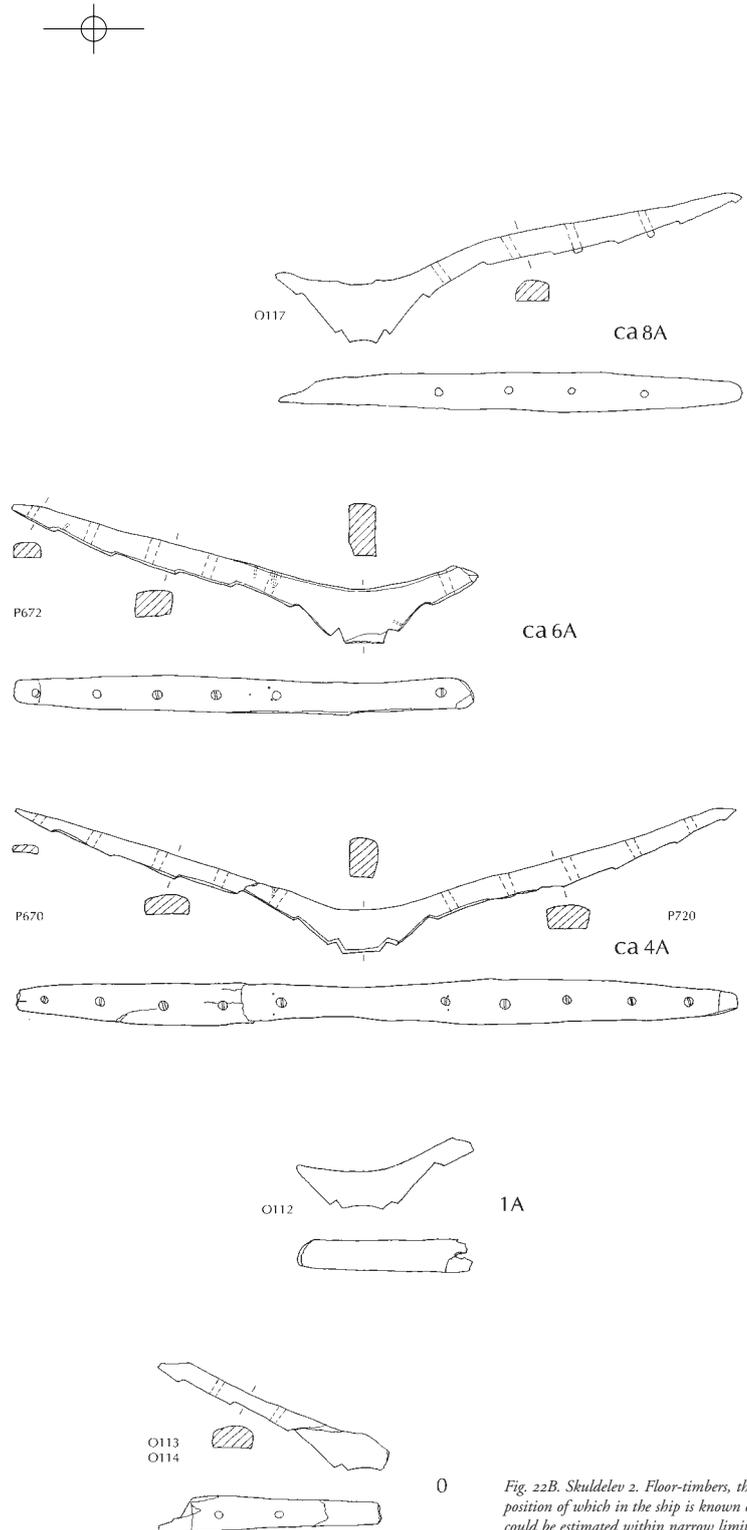
Fig. 22B. Skuldelev 2. Floor-timbers, the position of which in the ship is known or could be estimated within narrow limits. Scale 1:20.

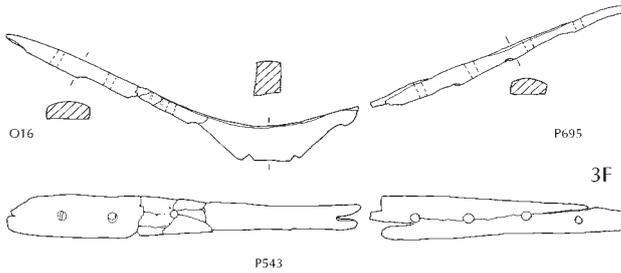
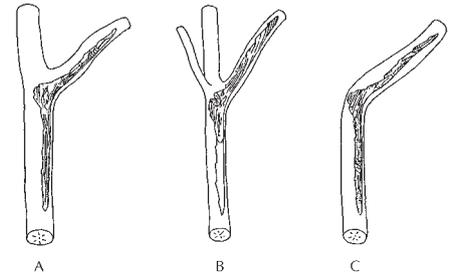
Fig. 23. Skuldelev 2. The position of the floor-timbers aft in the parent trees.

The floor timbers have been cut from oak trees, in five cases at the junction from the trunk with a thick branch and in one case from a curved tree (Fig. 23). In most cases (4 out of 5), the floor timber was distorted or broken on the side which was cut from the branch, the weaker of the two parts of the timber. In Table 4 the deviation angles between port and starboard are given for the strakes 2 and 3, with reference to Fig. 23 for the orientation of the floor timbers in the parent tree.

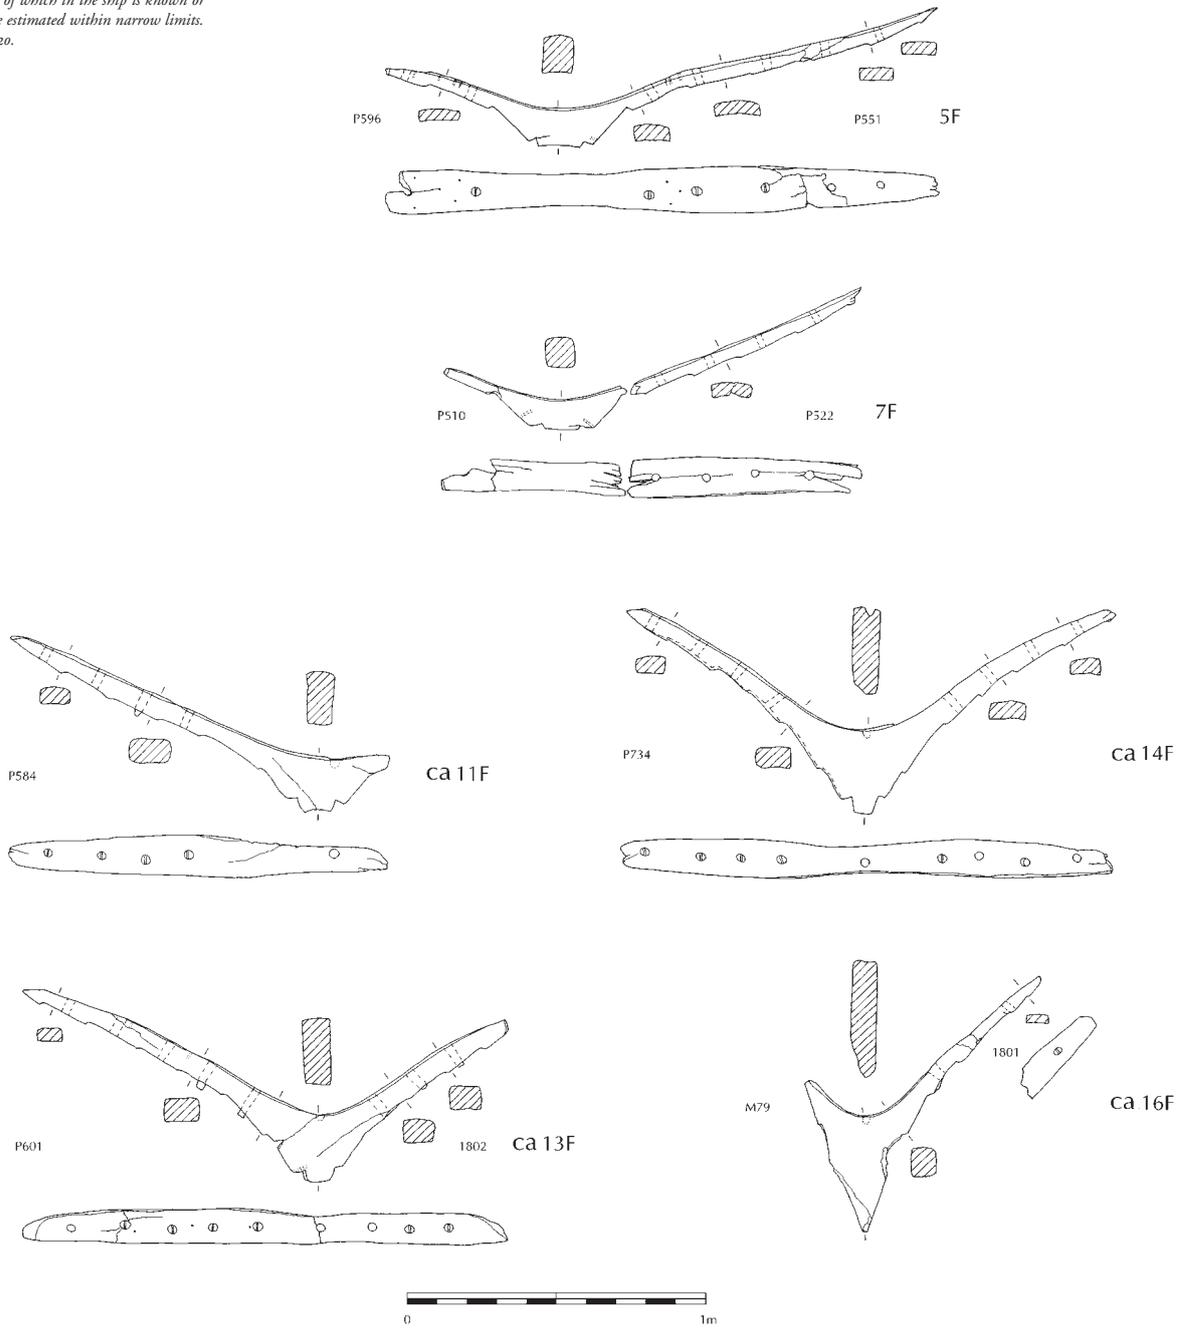
Fig. 22C. Skuldelev 2. Floor-timbers, the position of which in the ship is known or could be estimated within narrow limits. Scale 1:20.

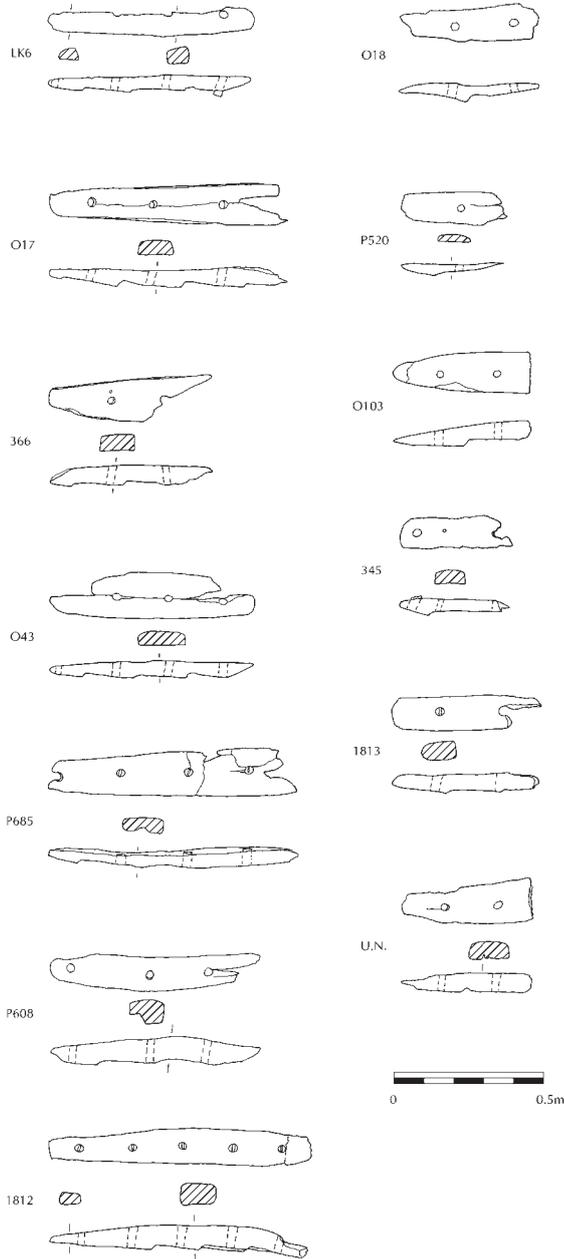
Fig. 24. Skuldelev 2. Fragments of floor-timbers of unknown position in the ship. Scale 1:20.

Once the precise or approximate original position of most of the floor timbers was determined there were still a limited number of floor timber fragments that could not be specifically placed except very generally (Table 5 and Fig. 24). None of these fragments displays characteristics unknown from the floor timbers described above.

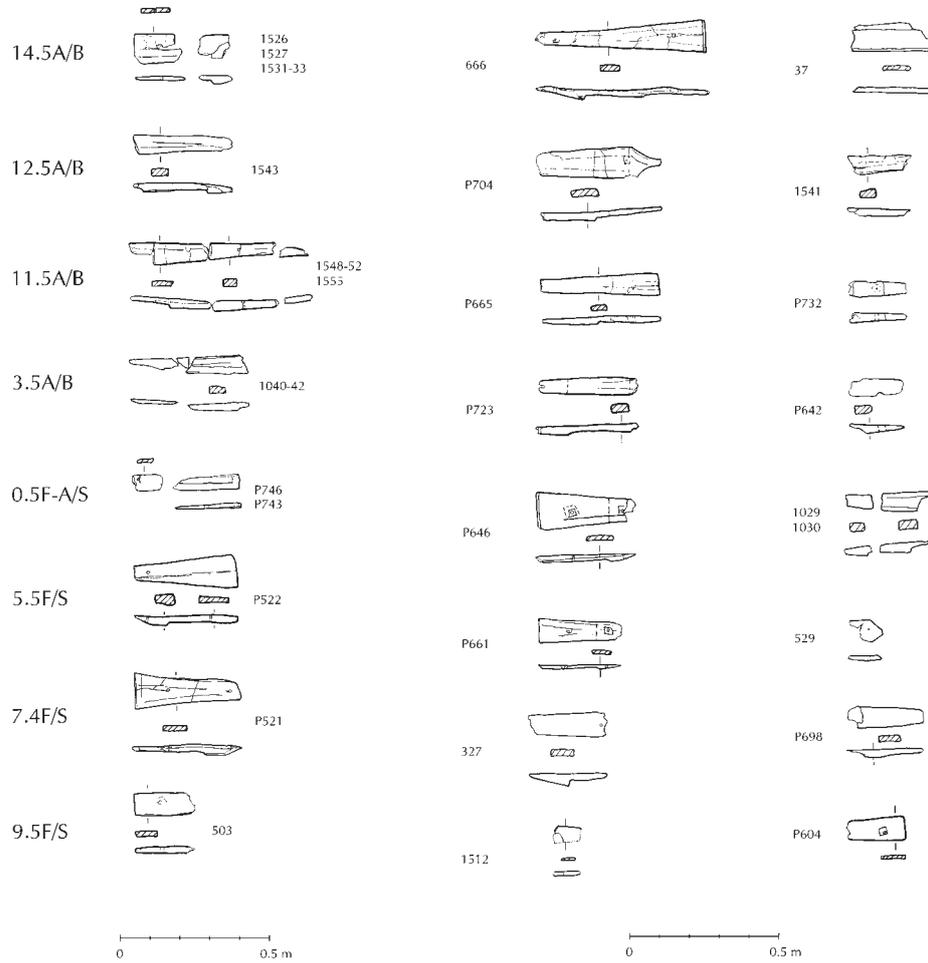
Fig. 26. Skuldelev 2. Side-timbers and fragments of these found loose. Scale 1:20

The side timbers (Figs 25-26) are the only structural elements in Skuldelev 2 that are not all made of oak, as some of these are of willow. They were originally elegant and slender, and placed equidistant between every frame station, except aft of 15A or 16A. They rest against the upper edge of the fourth strake with a broad, flat end or a nicely pointed shape. Originally, they were fastened to the fifth strake with an iron rivet and continued upwards over the sixth strake and under the stringer on the seventh one, being fastened here with a rivet. In some cases a short scarf for a continuation of the element upwards is found in the sixth strake, secured with a rivet (Fig. 27). None of these slender side timbers is preserved beyond the seventh strake, but the fact that some of them were scarfed at the sixth strake is a strong indication that they originally extended well beyond that strake.

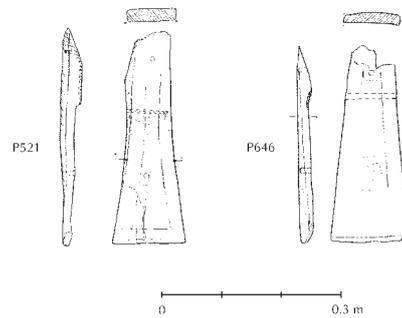
Fig. 27. Skuldelev 2. Lower part of side-timbers P521 and P646 with scarf at the upper end for a continuation. Scale 1:10.

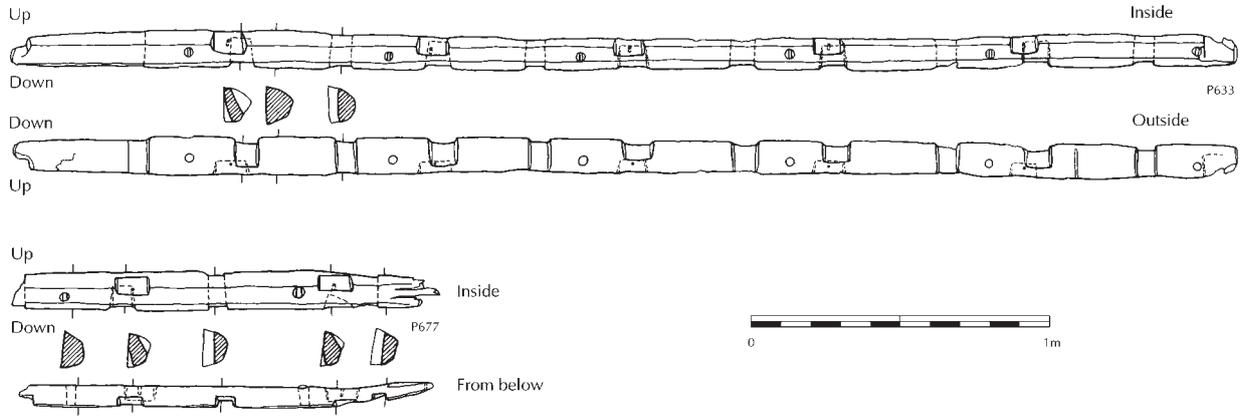
Fig. 28. Skuldelev 2. Two lengths of a stringer, originally mounted on the inside of the seventh strake with notches for the tops of the floor-timbers, the side-timbers and the bitis. Scale 1:20.

Among the loose parts of Skuldelev 2 were two fragmentary lengths of a stringer of oak. This longitudinal strengthening element was originally fastened with treenails to the inside of strake seven. Here the contact face was notched to receive the top ends of the floor timbers, which were fastened neither to the strake nor to the stringer, but wedged in behind the stringer. Notches were also cut in the stringer for the side timbers and the rivets fastening these to strake seven. On top of the stringers notches had been cut for the ends of the *bitis* which were fastened here with a spike (Fig. 28, see also Fig. 21).

The longer stringer fragment, P633, was found in area D and is therefore most likely to be from the midship or after part of the ship. It is 4.10 m long, broken at both ends and has notches for five floor timber tops and *bitis*, and for six side timbers. The average distance between frames here is 68 cm, with variations between 66 cm and 70 cm, but overall corresponding to the average frame distance measured on the planking aft.

The shorter stringer fragment, P 677, is 1.39 m long and has notches for two sets of floor timbers, *bitis*, and side timbers. The distance between frames here is 71 cm, and this fragment is broken at one end and has a hooked scarf at the other end. It was found between areas B and C and is therefore likely to have come from the forward or midship part of the ship. The average frame distance of 72 cm recorded for the planking here is in accordance with that of the fragment. There is a perfect match between P519, a length of the seventh strake port which was found in area C, and this fragment of the stringer.

The precise position of the two lengths of the stringer in relation to the known frame positions can only be loosely determined by comparing the spacing of the notches in the stringers for the upper ends of the floor timbers with the spacing of the notches in the keelson for the lower part of these timbers. These two sets of distances, however, will deviate if the frames are not positioned strictly at right angles to the centreline. In several places the notches for the *bitis*-ends are slightly off-set from the notches for the top-ends of the floor timbers. This feature shows that the positions of the *bitis* in some cases were adjusted to compensate for slight irregularities below.

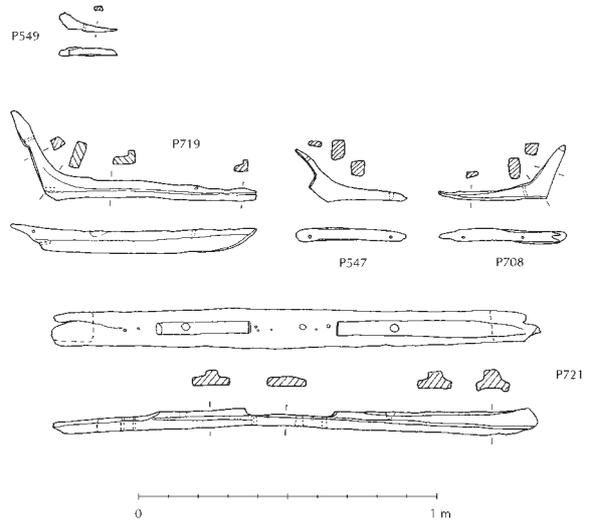
Fig. 29. Skuldelev 2. Bitis and *biti*-knees. Scale 1:20.

The notches for a *bitis* over the floor timbers in each of the two fragments of the stringer are 8-11 cm wide, and they show that such *bitis* were present over the entire midship length of the ship. Most of these are now lost, but among the loose parts of the ship found in area C to the west of Skuldelev 2 are two *bitis* fragments from this ship (Fig. 29).

The best preserved of these, P721, is a 1.64 m-long *bitis* that served as a deck beam. It is 10-11 cm wide at the ends, 13 cm in the middle, and cut into a \perp -shaped cross-section to receive the deck boards along both sides. Originally, this

Among the knees found loose in and around Skuldelev 2, there are three which may have served as knees for *bitis* or for upper beams/thwarts in this ship, to judge from their narrow width and overall characteristics (Fig. 29 and Table 8). Two of these knees, P547 and P549, were found amidships, whereas P708 is from area C. In the preserved sections of the hull amidships, the angles between horizontal and the eighth strake is ca 130°-144° for the knees. For knee P708, the angle is 111°, corresponding to the angle of *biti* P719, and so both are from aft in of the ship according to the above-mentioned criteria. The knee P547 is joggled for a stringer. Such a feature does not show up on the other *biti*-knees and it is therefore most likely that P547 had a different function in Skuldelev 2, such as a knee for a thwart above the *biti*.

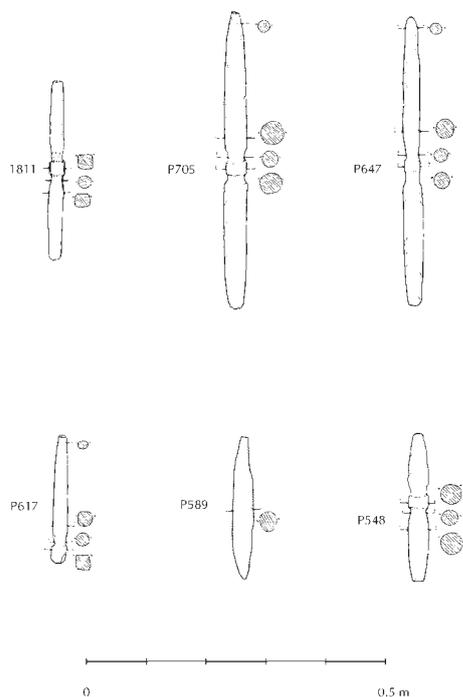
Fig. 30. Skuldelev 2. Stanchions to support bitis and beams. Scale 1:10.

In Table 9 and Fig. 30, the six stanchions found in and around Skuldelev 2 are presented. Two of these, P647 and P705, seem to be fully preserved with a length of 35 cm, whereas P548 and 1811 are both 18 cm long. The stanchions are cut with a decorative ring around the middle and slightly tapered ends that fit into the sockets at both ends.

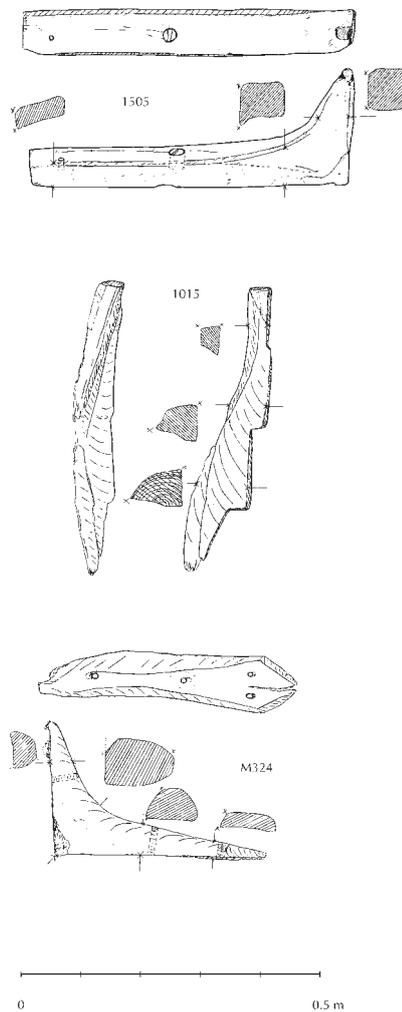
Fig. 31. Skuldelev 2. Horizontal knee (1505) found *in situ* aft in the ship, a fragment of a side-timber (1015) with notches for the upper strakes, and a knee (M324), both found in the bow area. Scale 1:10

In contrast, practically all parts of the external hull of the ship above the waterline are missing except the after stem and the aftermost section of port planking. The internal strengthening system for the upper part of the ship is represented only by the horizontal knee (no. 1505), found *in situ* between the frame stations 20A and 21A on strake 5B, and a strong frame-member, (side timber no. 1015), that is joggled for planking, and split lengthways. This second element evidently came from the bow region, as it was found in area A (Fig. 31). These two elements provide some important clues as to the character of the sides and the internal structure of the ship above the level of the *bitis*, even if they only represent the two ends of the ship. In the same area, the knee M324 was found, which may belong either to Skuldelev 2 or 3.

The strong side timber, no. 1015, is an important clue as to the character of the upper part of the planking of Skuldelev 2. Similar side timbers were also mounted in Skuldelev 3 over the top-strakes, strengthening these and in some cases also serving as a base for rigging cleats (cf Chapter 5.3.2). The fragment from Skuldelev 2 is decorated with a curved moulding along the inner face and joggled for the planking on the outside face. The upper notches have almost the same orientation and they probably represent the two uppermost strakes in the forward part of the ship. From these notches, the measurements of these upper strakes can be determined: The width is 17 cm for the top-strake, which has had a thicker upper part, and 9 cm for the strake below. These strakes were probably almost vertical in their original position and the oarports would probably

have been cut in the lower one of these. The notch for the third strake from above is oriented inwards at an angle of 25° to the upper planks. This notch is deeper than normal notches for the planking, and it may have been cut to accommodate a stringer on the inside of this plank. This important element is preserved as a fragment since the original side timber was cleaved lengthways and only one half is preserved.
