5.2 Skuldelev 2

5.2.2 Description of the preserved parts of the ship

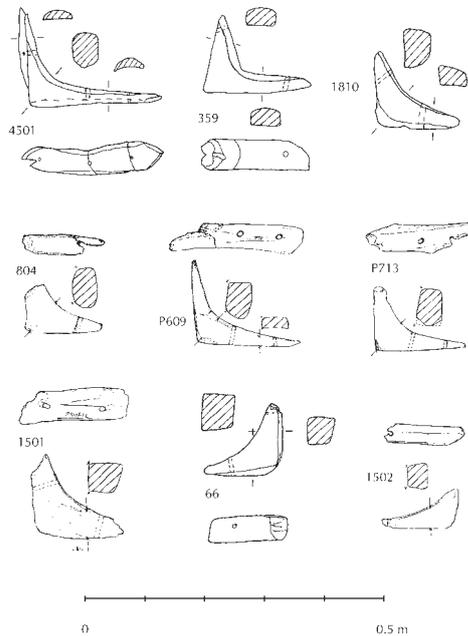
Fig. 32. Skuldelev 2. Small knees of unknown function. Scale 1:10.

There are a few structural elements found in and around Skuldelev 2 which seem to belong to this ship but which have not been mentioned yet as their original function has not been identified. Such is the case with a group of small knees of oak (Fig. 32) that have angles of 75°-98° between the two arms. Two possible functions for these have been considered: They might be horizontal keelson knees, or standing knees to connect the upper beams or thwarts and the side of the ship, probably fixed on a stringer, which would explain their steep angles. The former explanation will be discussed below in relation to the keelson. Their small size and the range of variations in the angle of the knees, however, argue against the possible use of these knees to fasten the thwarts (cf Table 10).

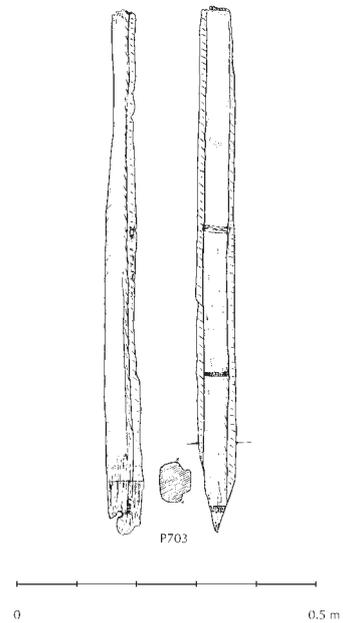
Fig. 33. Beam with rabbets and scarf, found west of Skuldelev 2. Scale 1:10.

In area C, an 0.89 m long slender beam of oak, P703, which is worn and broken at one end and cut off at the other end was found (Fig. 33). The beam has a ridge running along its length, flanked by a rabbet on both sides and originally pierced by horizontal iron nails spaced 34-38 cm apart. The original function of this element is not known, and it is not certain that it comes from Skuldelev 2.

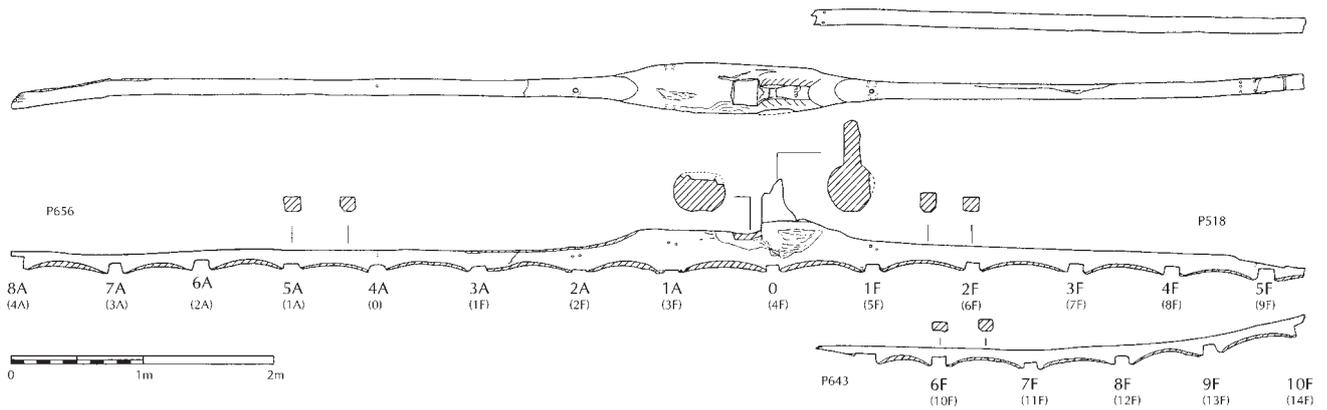
Fig. 34. Skuldelev 2. The keelson.

Fig. 35. Skuldelev 2. The keelson knees. Scale 1:20.

The keelson (Fig. 34) consists of two parts, of which the main element is 9.85 m long. They are joined by a hooked scarf, and so give the keelson a total length of 14.1 m. The keelson is 11 cm wide, except in the area of the mast step, where the width increases to ca 38 cm. The mast step is ca 18 x 18 cm; its present depth is ca 5 cm, and its original depth could not have exceeded 8 cm. Immediately in front of the mast step is a vertical branch of considerable thickness which is broken off at a height of 45 cm above the bottom of the mast step. The keelson did not rest directly on the keel but on top of the floor timbers, and was notched to a depth of 2-8 cm for these on the underside with arches in between these notches. There are no direct fastenings between the keelson and the floor timbers.

The keelson was held firmly in position in the ship, partly by its own weight and the notches for the floor timbers, but mainly by the upright branch and a series of elements riding over the keelson or supporting it from the sides around the mast step. These elements (Fig. 35 and Table 11) fall in two groups. At the frames 1F to 2A, one knee from each side supported the keelson. Each of these was shaped to fit the side of the keelson and the top of a floor timber and was fastened with spikes into both parts. The knees on both sides at 1F and 2A have been found and they are very elegantly shaped to combine strength and minimal weight.

Outside the central part of the keelson, the keelson supports are shaped as double-knees or chocks, cut to a roughly triangular shape that bridges over the keelson. They are spiked to the floor timbers on both sides, whereas there are no fastenings directly to the keelson. In one case, P516, the central part of the chock rises up to a peak with a boring for a stanchion for the *biti* above. Similar borings are found on the best preserved of the other chocks and most likely all the double-knees were originally similar chocks. This is supported by the fact that there are borings on top of the keelson for stanchions only at 1F and 2A. At all the other frame stations, except o and 1A, these holes were made in the double-knees over the keelson and in the floor timbers fore and aft of the ends of the keelson.
