5.5 Skuldelev 5

5.5.1 Excavation

5.5.2 Description of the preserved parts of the ship

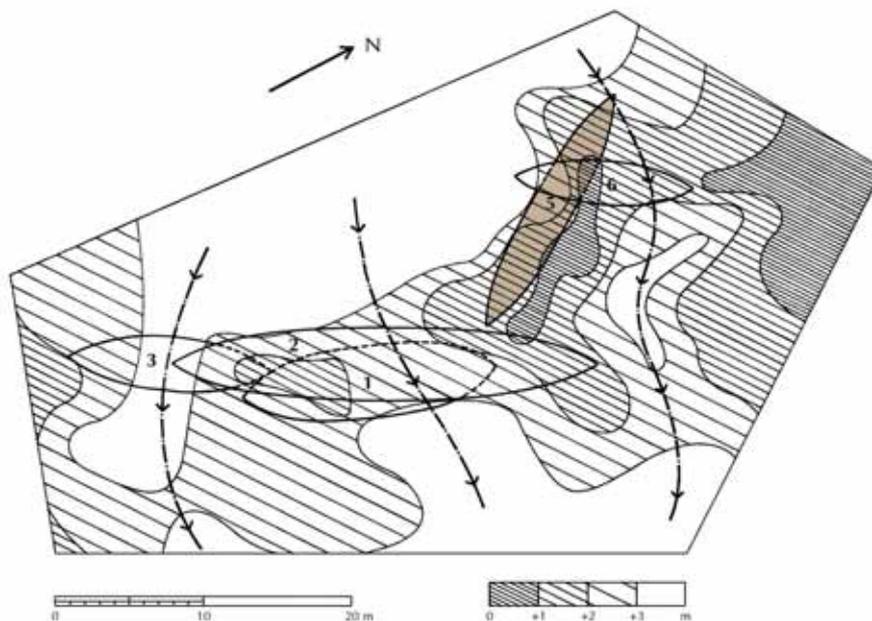
Fig. 1. The position of Skuldelev 5 in relation to the natural barrier (the shaded areas) rising as a threshold from the bottom of the Peberrenden channel (the white area).

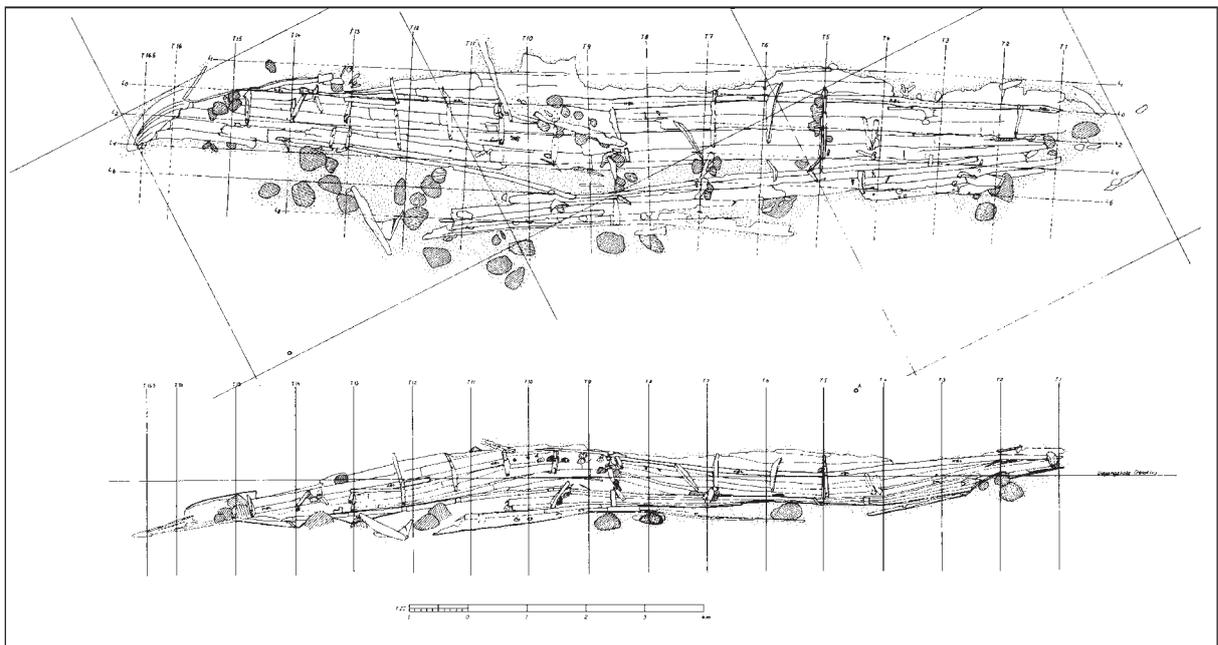
Fig. 2. Skuldelev 5. Photogrammetrically recorded plan of the excavated ship seen from above and from the channel-side

The complete excavation of Skuldelev 5 began on 18 July and was completed on 25 August, 1962. During this period the wreck of Skuldelev 6, lying on top of Skuldelev 5, also had to be excavated and partly removed in order for the hull below to be fully exposed (cf Fig. 3). The photogrammetrical survey was then made on 25 August. Starting on 30 August, all parts of the ship were removed in seven working days, after they had been numbered from 2001 to 2124 and from 3001 to 3146. Several of the pieces were in many fragments and 270 units were collected in total.

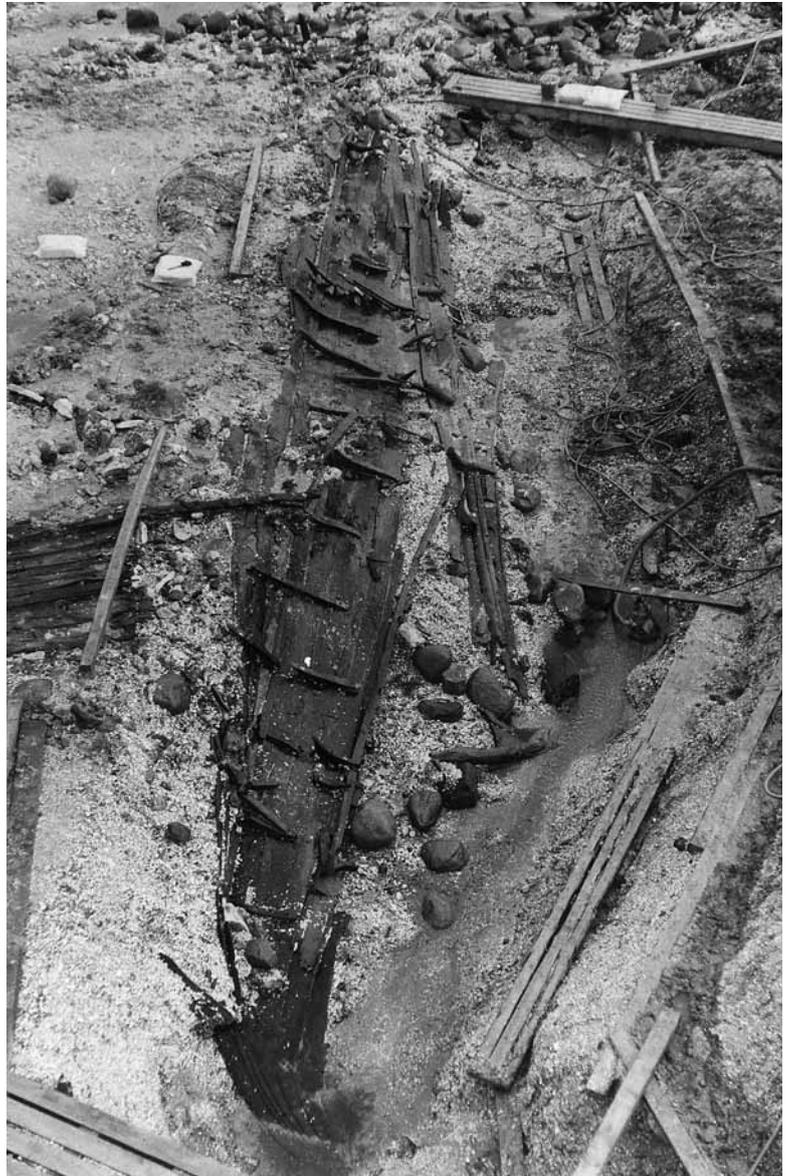
Fig. 3. Skuldelev 5. The wreck fully exposed, seen from the north-west. The deepest part of the wreck (right) is the port gunwale. A segment of Skuldelev 6 is seen to the left with the keel still in position on top of Skuldelev 5.

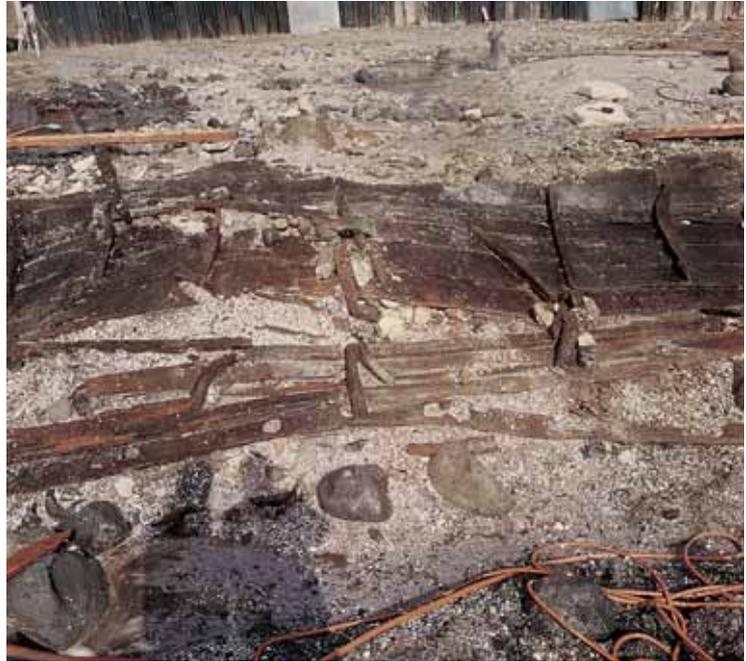
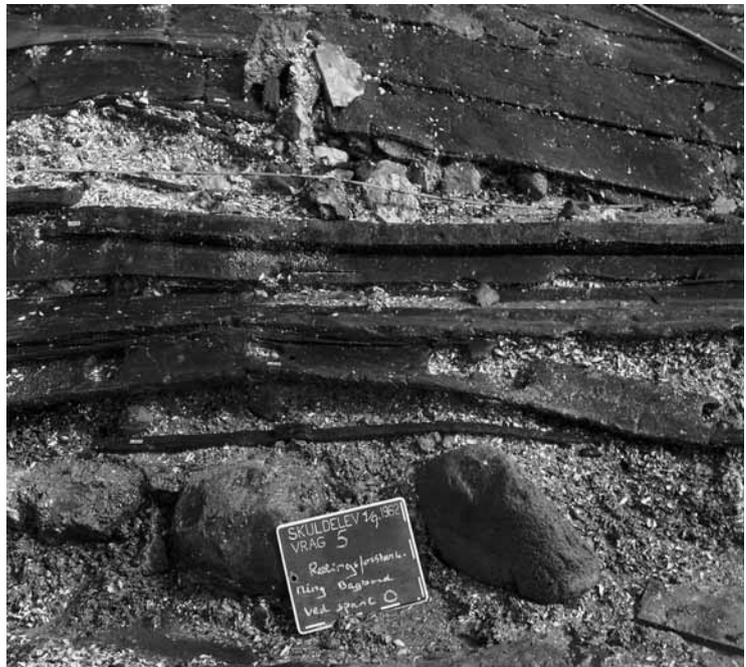
Fig. 4. Skuldelev 5. Section of the midship part of the ship during excavation.

Fig. 5. Skuldelev 5. The midship section of the upper strakes in situ. The planking is lying upside down on the slope with the sheerstrake and its shield-rack in the bottom of the picture, followed by the sixth and fifth strakes with their stringers.

possible salvaging activities, leading to their disintegration or removal at an early stage. Afterwards, sediments started building up in the lower part of the hull, leaving the remaining starboard planks and frames as well as the keelson protruding along the upper edge of the slope, exposed to biological decay and erosion (Fig. 4).

covered by sediments (Fig. 5). Before the iron fastenings corroded, the beams and knees were exposed to decay and they eventually also settled in the sediments collecting inside the wreck.

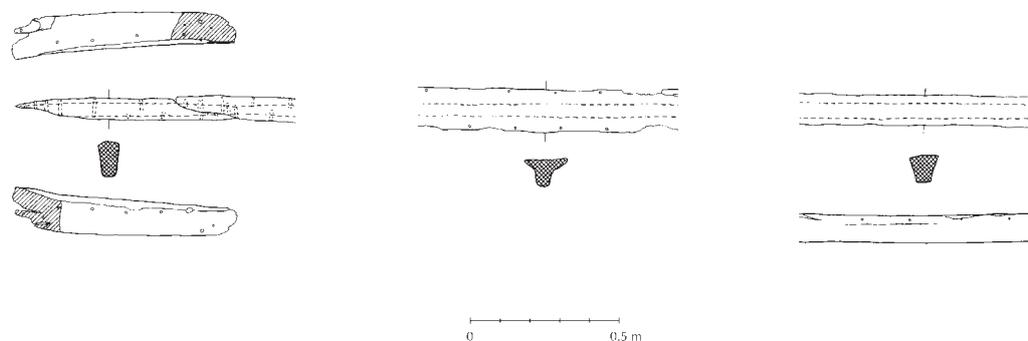
Fig. 6. Skuldelev 5. The lot aft and two sections of other parts of the keel seen from above and from the side. Scale 1:20.

The keel is of oak and consists of three sections: an 11.87 m-long proper keel along the greater part of the length of the vessel, a 0.78 m-long *lot*, a curved intermediate piece to the after stem, and a 2.71 m-long combined keel-length and *lot* forward with scarf to the fore stem. The three lengths of keel are joined with vertical scarfs, 20-24 cm long, and the scarfs at the *lot* aft have slightly curved contact surfaces (Figs 6 and 10). When assembled, the total length of these three elements is 14.92 m.

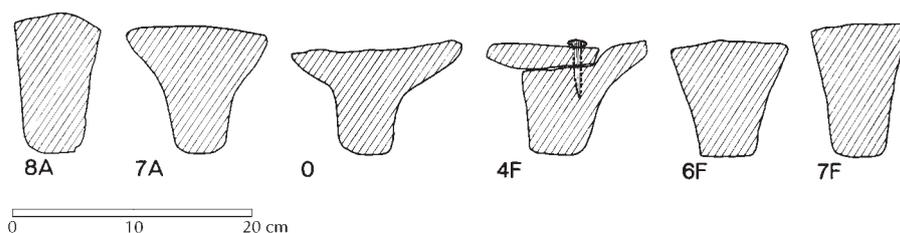
Fig. 7. Skuldelev 5. Cross-sections of the keel. Scale 1:5.

The keel has no rabbet, and its cross-section is almost rectangular at each end but changes gradually over a Y-shape to a T-shape amidships with marked wings for fastening the garboard strakes (Fig. 7). The depth of the keel amidships is now ca 8 cm but was probably originally ca 10 cm, increasing towards the ends to 11-12 cm. The bottom of the

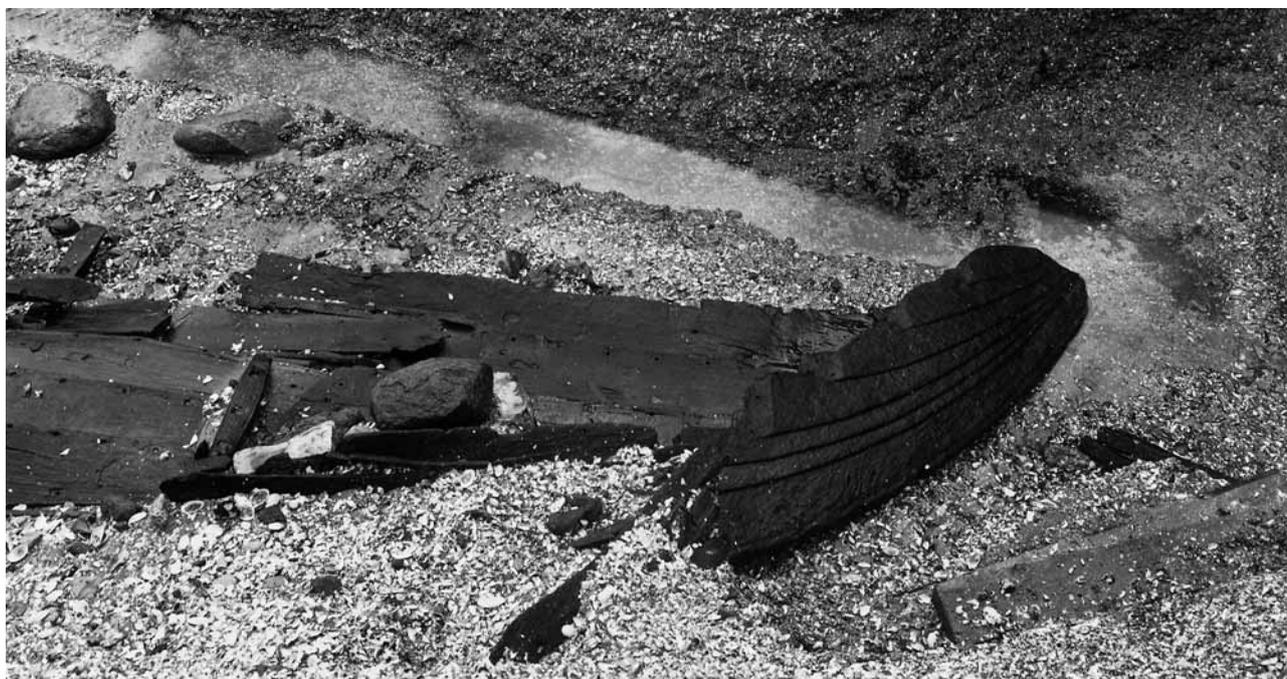
Fig. 8. Skuldelev 5. The stem in situ.

Nothing is left of the after stem, but the after scarf at the *lot* reveals that it had been connected to the keel in a similar manner as was the fore stem. Found *in situ* (Fig. 8), the fore stem was in contact with the keel and most of the hooding ends of starboard planking.

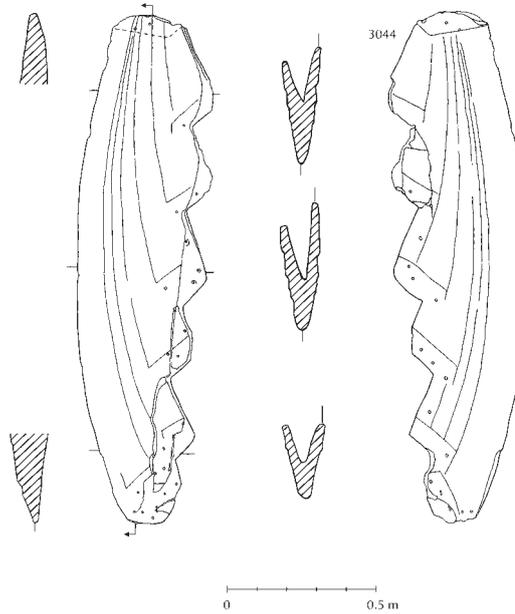
Fig. 9 Skuldelev 5. The stem. Scale 1:20.

The stem (Fig. 9) is of oak with a V-shaped cross-section that is deeply hollowed out, and its general characteristics are similar to those of the stems found in Skuldelev 2 and 3. The stem is preserved to a length of 1.73 m and has a maximum breadth of 0.44 m. Six steps for the planking were cut along the inner edge, and the run of the strake edges is carried onto and carved into the sides of the stem. The lines converge towards the vertical top of the stem which is now missing but originally was fastened by a number of nails or rivets at a scarf. Mounted at the keel, the stem projects ca 1.2 m beyond the keel-scarf.

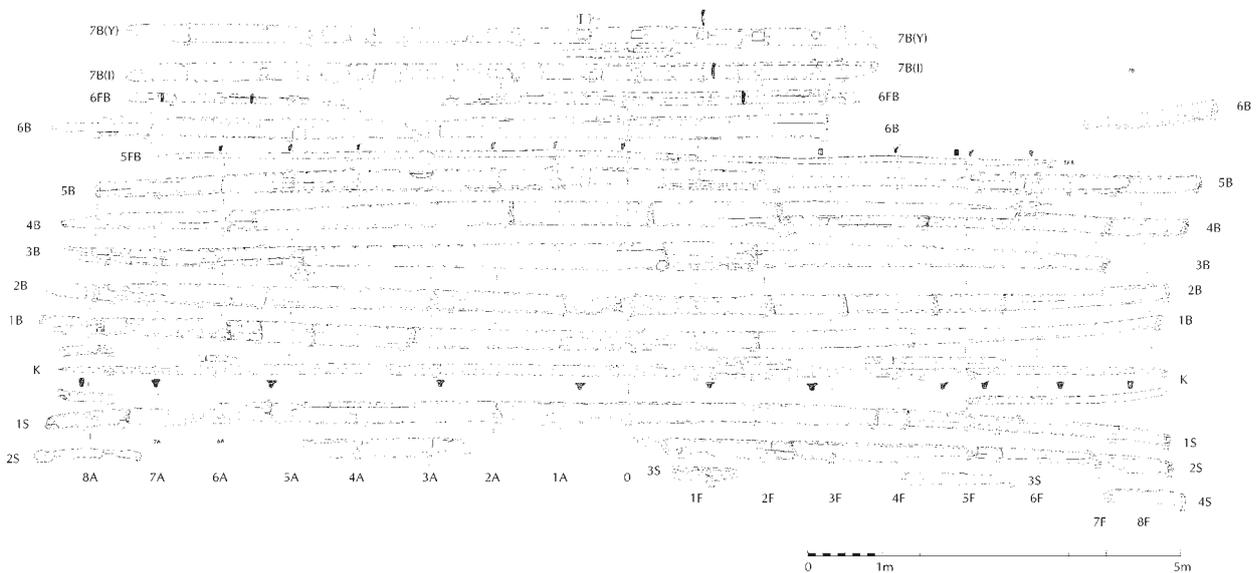
Fig. 10. Skuldelev 5. Plan of all preserved parts of the keel, planking and stringers. The following parts have been drawn from two sides: the uppermost strake (7B) with its shield rack, and the forward and aftermost parts of the keel. Scale 1:80.

to the keel, the garboard strake, is preserved almost completely between the scarfs fore and aft, and fragments of the next two strakes also survive. The port-side planking is almost entirely preserved, except for the aftermost plank-ends that connect to the after stem and parts of the three upper strakes forward, as already mentioned (Fig. 10).

The stringer on the fifth strake (5FB in Fig. 10) has a roughly rectangular cross-section of 5-6 x 8-9 cm amidships, decreasing slightly towards both ends. It is made of two slender laths of oak, scarfed between 0 and 1F, and at every frame station fastened with a treenail, 2.5 cm in diameter, and notched from above and below to accommodate the top ends of the *biti*-knees and serve as a saddle for the beams. Owing to these notches and nail holes, this stringer could only make a very limited contribution to the strength

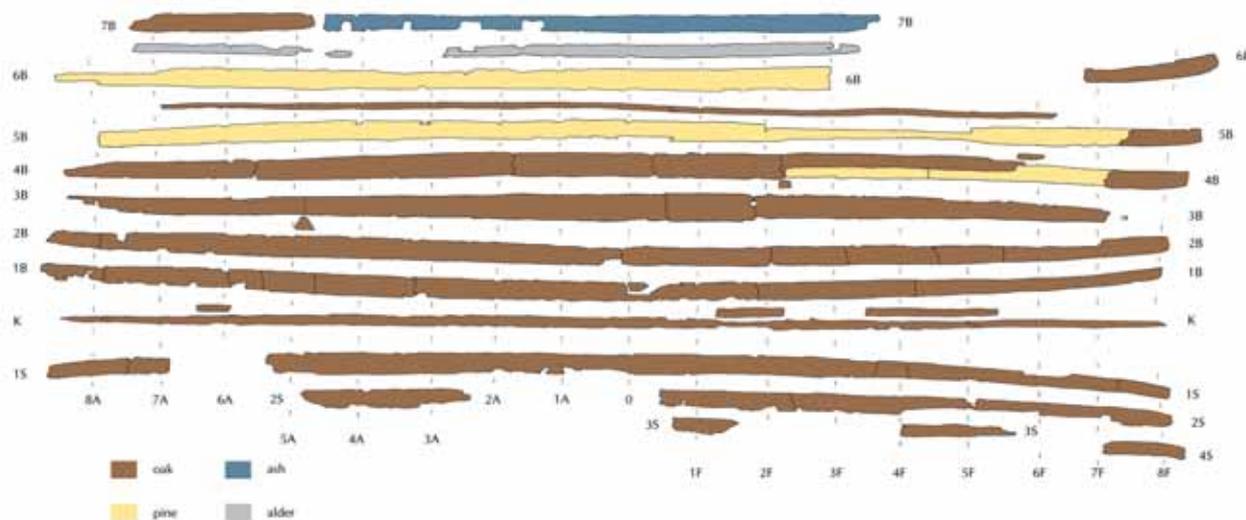
Fig. 11. Skuldelev 5. Wood species used in the planking and stringers.

The transitional fourth strake between the bottom and the side, as well as the fifth to seventh strakes forming the ship's side in Skuldelev 5, are only represented on the port side, and here they display a remarkable mixture of wood species: oak planks between 1.2 m and 3.6 m long, pine planks¹ between 2 m and 14 m long, and a single plank of ash, 7.7 m long (Fig. 11).

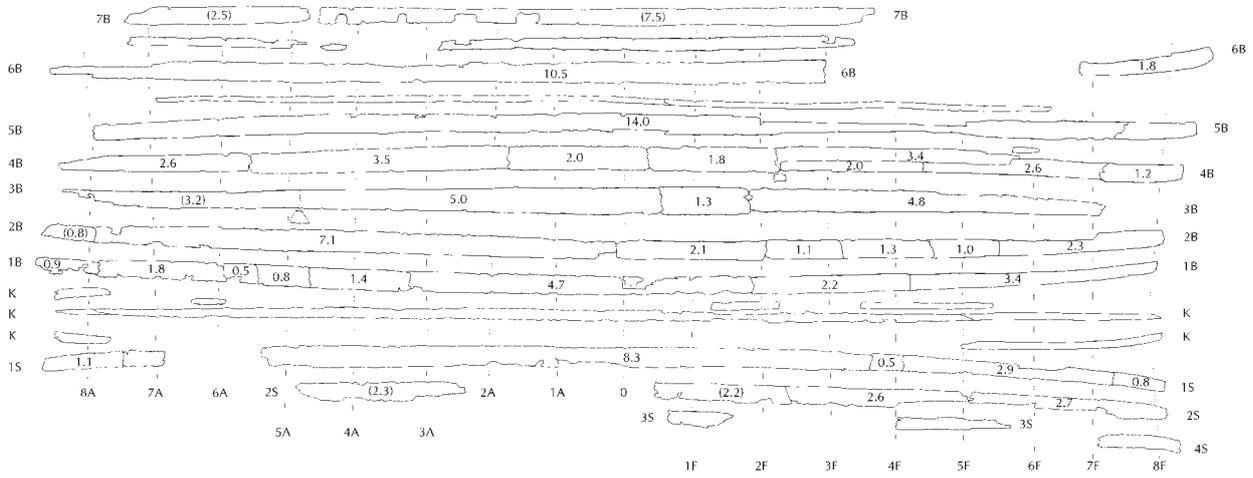
Fig. 12. Skuldelev 5. The individual plank lengths as found.

Amidships the first two strakes are 25-28 cm broad, while the third strake is as much as 35 cm broad, with an inserted repair plank that is up to 38 cm wide. The fourth, fifth, and sixth strakes measure 30-32 cm and the seventh strake 27 cm in width amidships. The oak planks are almost rectangular in cross-section with a slight increase in thickness towards the middle. Most of the bottom planks are very worn, but they appear originally to have been 2.0-2.5 cm thick at the centre, decreasing to 1.5-2.0 cm at the edges. The long pine planks are 3.5 cm thick at the middle, flat on the inside and convex on the outside (Fig. 12). The sheerstrake plank of ash has a similar character, but a thickness of

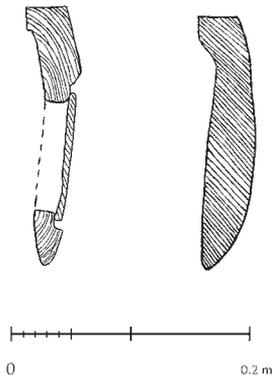
Fig. 13. Cross-sections of the sheerstrake (seventh strake) through a covered-over oarport at 1F and in the solid wood 17 cm further forward. The lower edge of the plank is worn away in this area. Scale 1:5.

4.0 cm in the middle and a 3.5 cm-wide upper edge with a characteristic cross-section (Fig. 13).

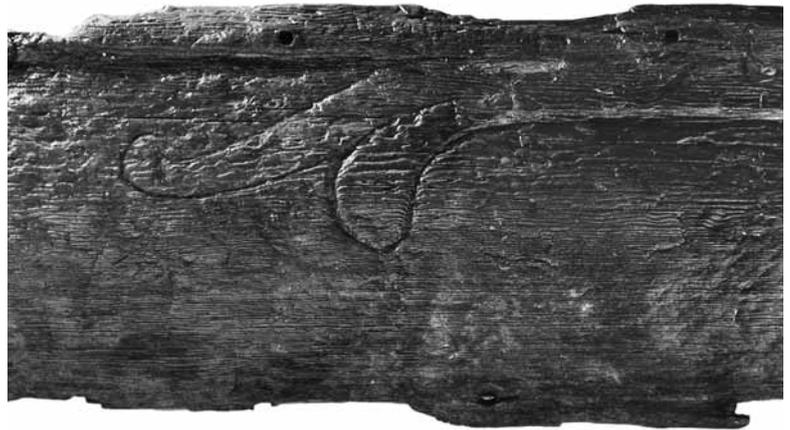
Fig. 14. Skuldelev 5. Carved acanthus tendril in the Ringerike style, found on the outside of the sixth strake aft to port.

When the outside of the sixth strake was exposed during the cleaning process after the excavation, a carved acanthus tendril in the *Ringerike* style was revealed in the area

between frames 5A and 6A (Fig. 14). No similar decoration has been found on any other piece belonging to this or any of the other ships of the Skuldelev find.

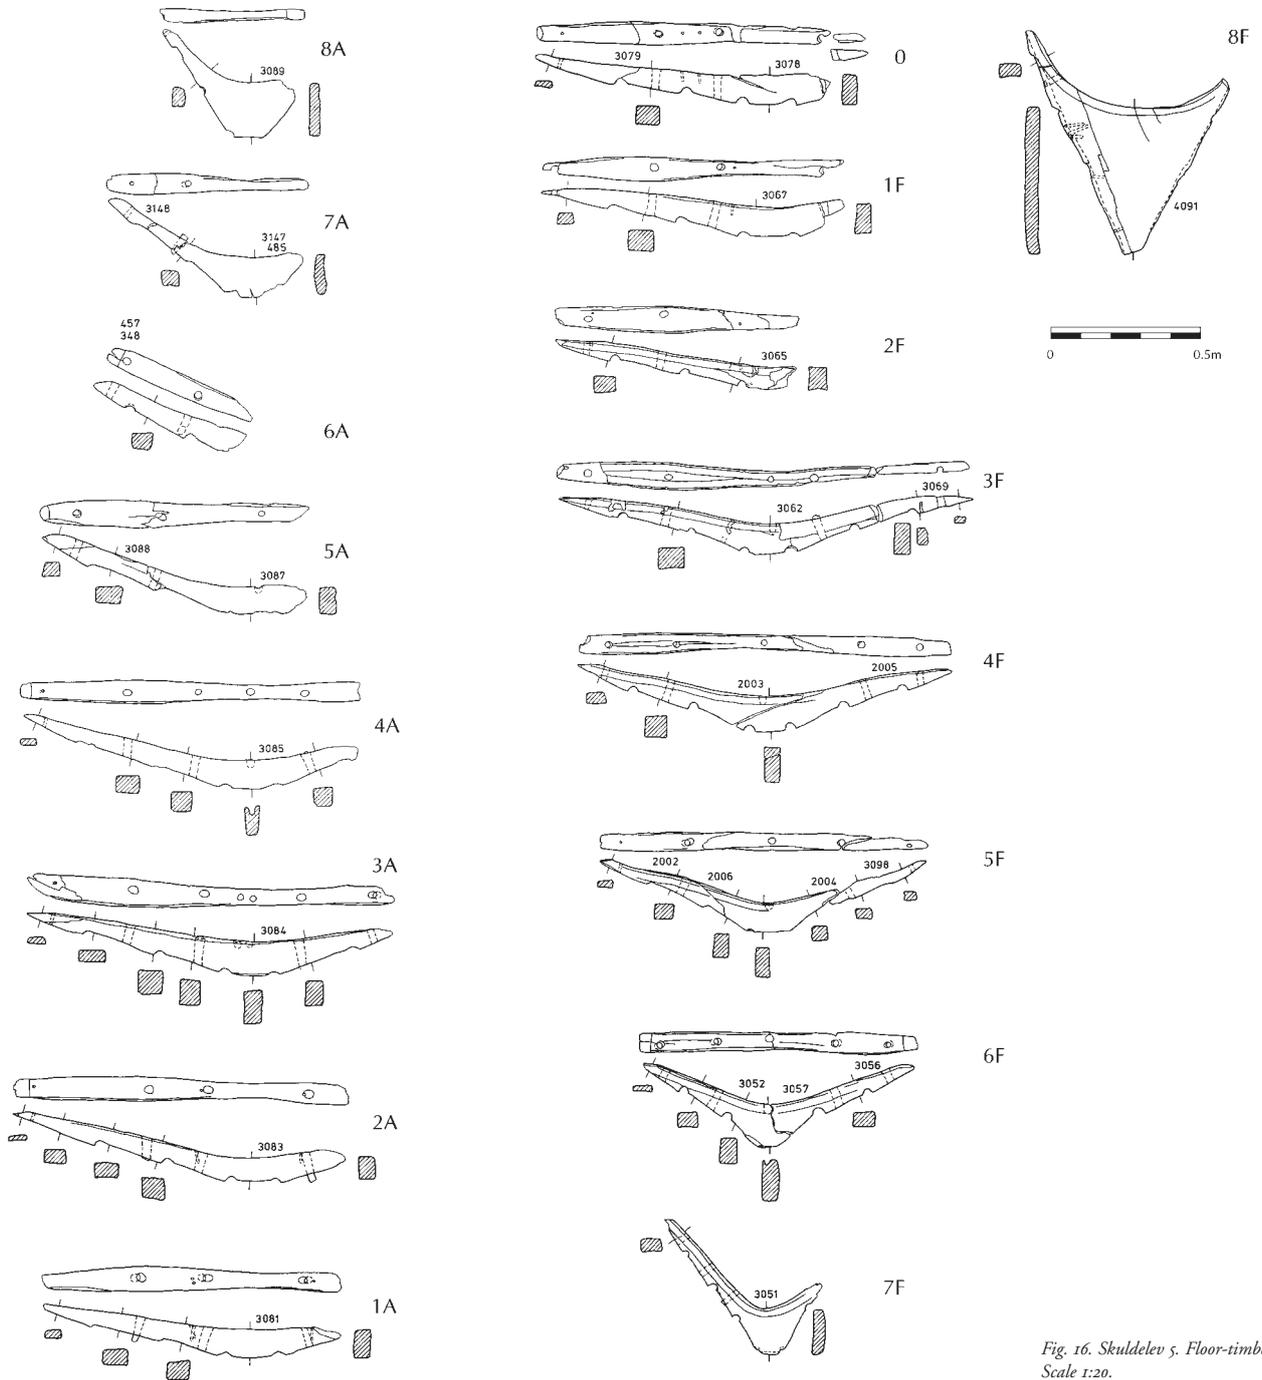
Fig. 16. Skuldelev 5. Floor-timbers. Scale 1:20.

The floor timbers are of oak, as are the other parts of the framing system, with the exception of the V-shaped *rong* at 8F, which is of pine. They span the keel and the three lower strakes on each side (Fig. 16). They have the same characteristic shape as those found in Skuldelev 3, with a high part over the keel, only ca 5 cm wide, that widens to 7-9 cm over the next strakes and narrows again to 4-5 cm towards the wedge-shaped end. At the point of contact with the second strake, the height is 5-7 cm. The height of the floor timbers

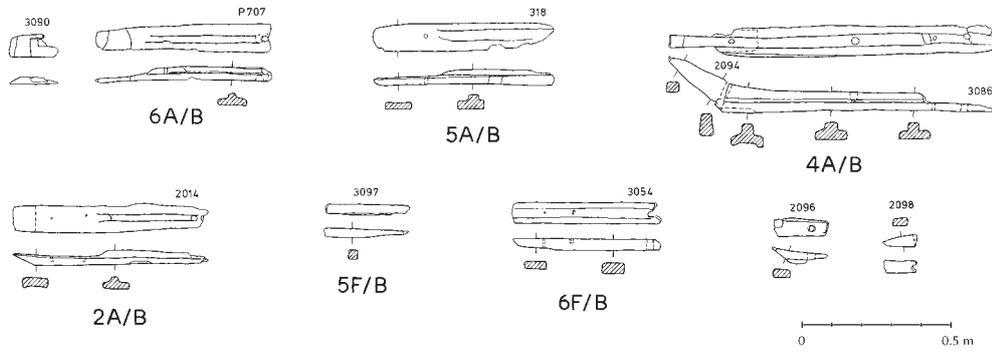
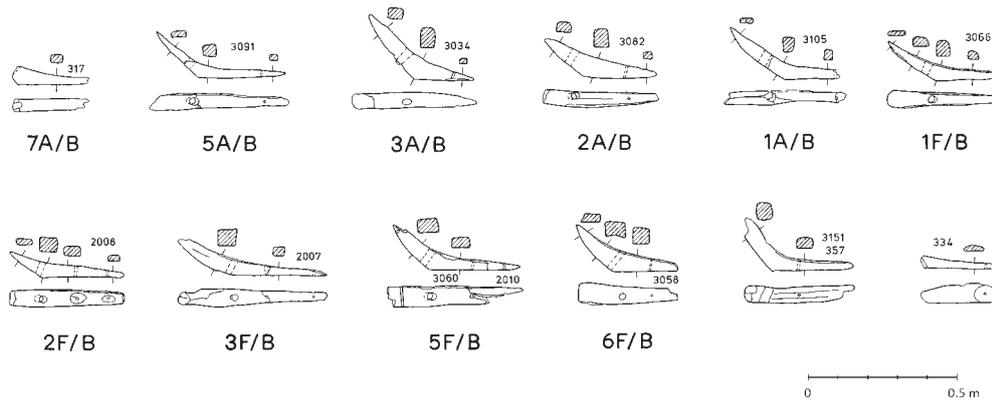
Fig. 17. Skuldelev 5. Bitis, biti-knees and stanchions. Scale 1:20.

All preserved *bitis* have a ⊥-shaped cross-section, in order for them to serve as deck beams for a through-deck of loose planks. The *bitis* that were found are all partially eroded so that their dimensions have been reduced, but the most extant parts measure 9-10 cm in width and 2.5-3 cm in thickness with an extra ca 3 x 3 cm ridge in the middle. This allowed a space of ca 3 cm as support for the deck planks, which were evidently ca 3 cm thick along the edges. None of these was found, however, as they were most likely removed before the sinking of the ship.

The *biti*-knees are all cut with a narrow, horizontal part, corresponding in size to the ridge on top of the *bitis* and replacing this ridge near its ends. This feature is a clear indication that even those *bitis* that are not preserved but are represented by their knees would have been similar in shape to the deck beams found, and consequently that a flush deck had been present along the length of the ship from 6F to 7A, following the upper edge of the third strake.

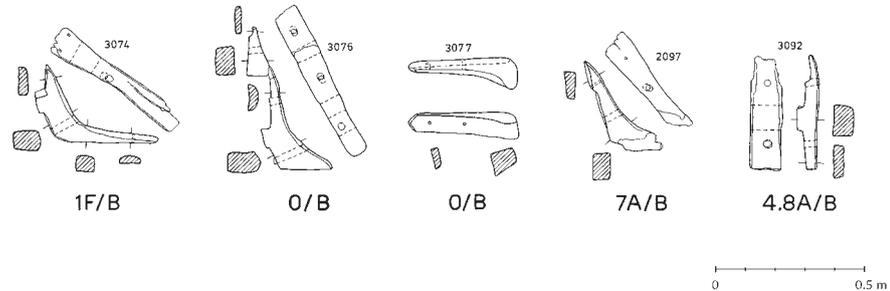
Fig. 18. Skuldelev 5. Beam-knees from 1F, 0 and 7A, and a side timber from port side at 4.8A. Scale 1:20.

There are no regular side timbers in this ship positioned halfway between the frame-stations like those found in Skuldelev 1 and 2. However, just as in Skuldelev 2 and 3, there are a few sturdy side timbers positioned across the top-strakes outside the strict frame-module system that are undoubtedly primarily related to the handling of the rigging. In the present ship, they are represented by the timber at 4.8A (cf Fig. 18) which may have been fitted with a cleat for the rigging as are similar ones in Skuldelev 3.

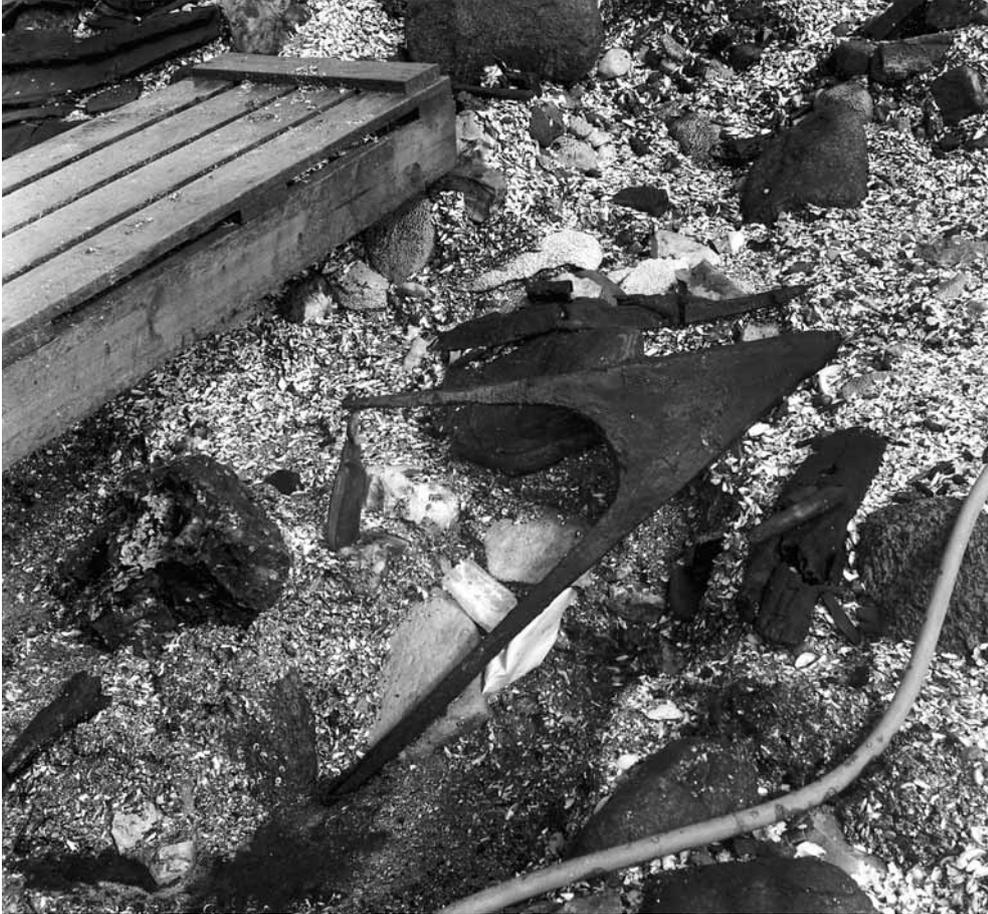
Fig. 20. Skuldelev 5. The breast-hook in situ outside the after end of Skuldelev 5.

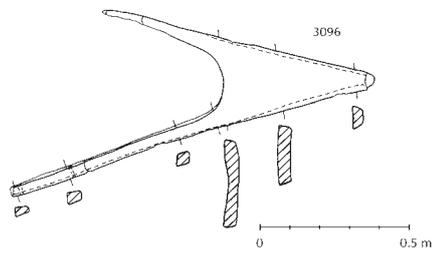
Fig. 21. Skuldelev 5. The breast-hook aft. Scale 1:20.

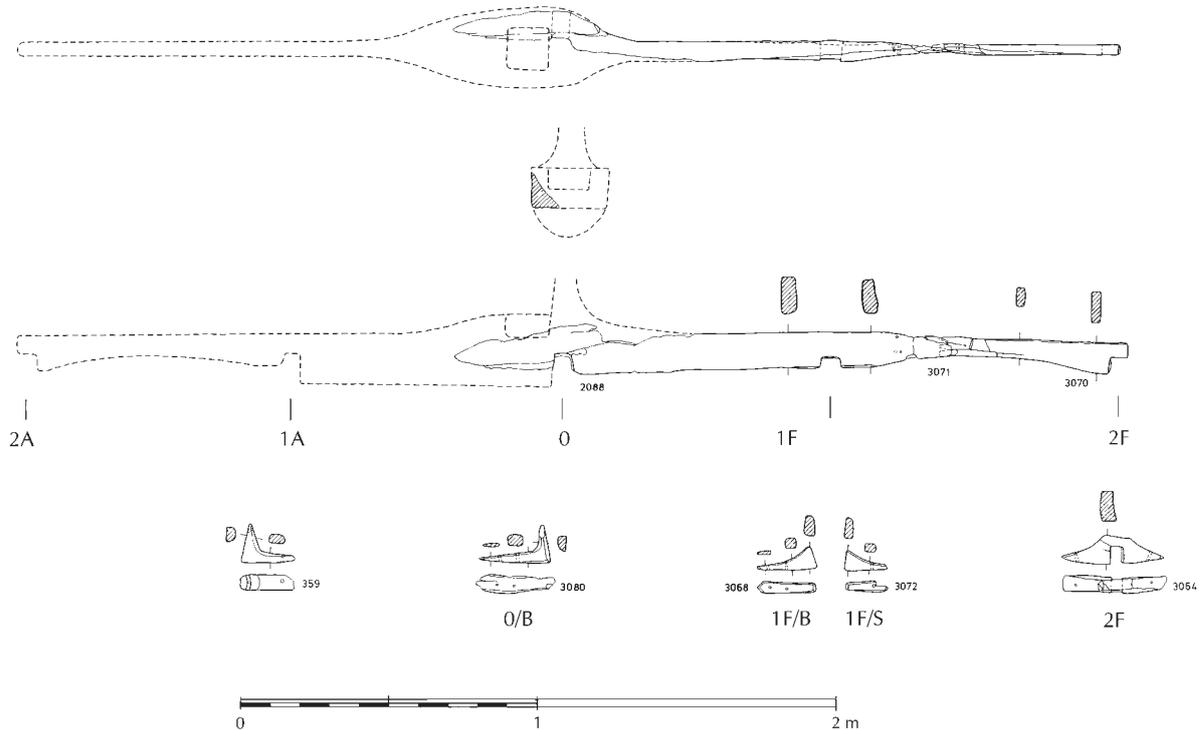
Fig. 22. Skuldelev 5. The preserved part of the keelson with an indication of the likely shape of the missing part, as well as the keelson-knees which have been found. Scale 1:20.

The lower end of the mast was safely anchored in the middle of the keelson. The forward half of the keelson is preserved from 2F to 0, incorporating a section that has been added with a scarf over the first 0.6 m from 2F. The middle part of the keelson is partly eroded away and the after part is completely lost (Fig. 22, see also Fig. 4).
