NORD STREAM 2 PIPELINE –  
SOUTH-EASTERN ROUTE  
Cultural heritage target assessment  
and exclusion zone recommendations

***NORD STREAM 2 PIPELINE – SOUTH-EASTERN ROUTE***  
***Cultural heritage target assessment***  
***and exclusion zone recommendations***

***VIR 2740***

August 2019

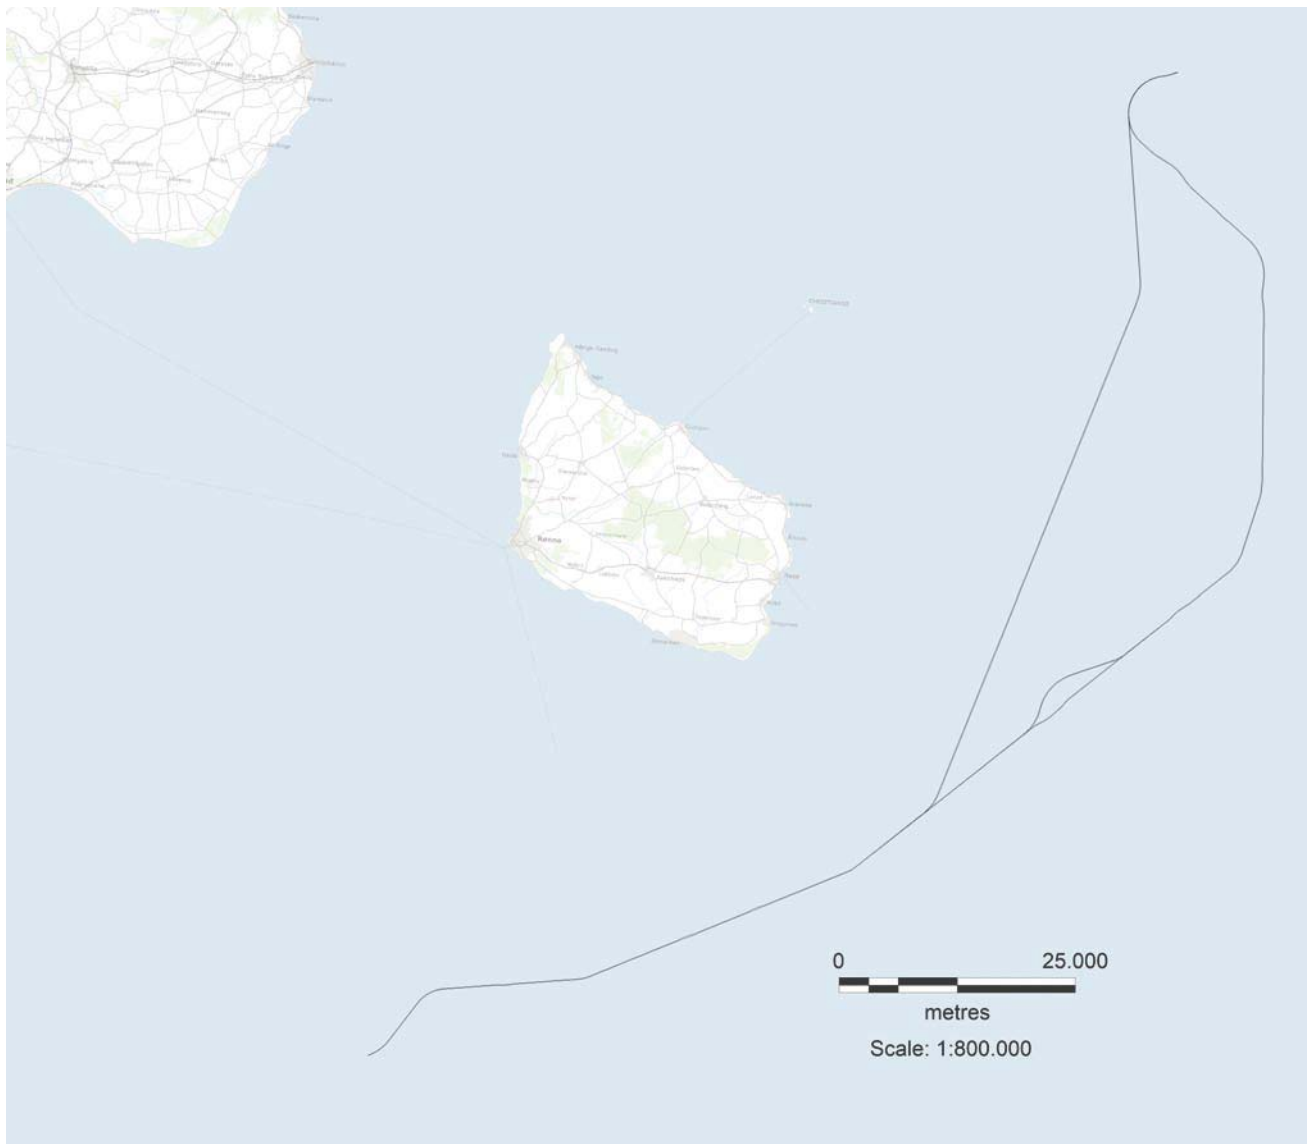
**Fig. 1. Nord Stream 2 Pipeline, Danish sector. Route design D6\_09, D6\_10, and D7\_05 South-east of Bornholm, DK. Drawing: Mikkel H. Thomsen © Vikingskibsmuseet. Base map: Styrelsen for Dataforsyning og Effektivisering (Skærmkort, dæmpet).**

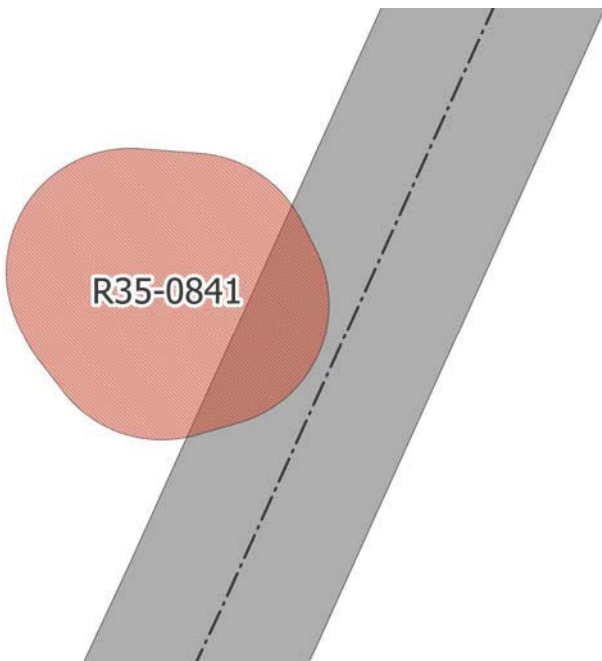
Fig. 2A. Marginally conflicting exclusion zone.

Examples from Base Case route. Drawing: Frederik D. Hyttel © Vikingskibsmuseet.

A target is said to be *marginally conflicting* if the target exclusion zone intersects with the design pipelay corridor of +/- 8,25 m (or, eventually, intervention work areas), but does not intersect the design route centre line. Minor pipelay re-routing within the lay corridor is feasible so that the 'as-laid' position of the pipeline does not intersect with the exclusion zone (Figure 2A). In this case the pipelay contractor must manoeuvre away, maintaining a minimum of half the lay corridor from any target exclusion zone; the so-called *lay-avoid* procedure. If this should prove impossible (for example because of proximity of another object on the opposite side of the lay corridor), further mitigation may be required by the Danish Agency for Culture and Palaces (Slots- og Kulturstyrelsen, SLKS), e.g. further investigation, rerouting the pipeline, removing the object, or securing it *in situ*.

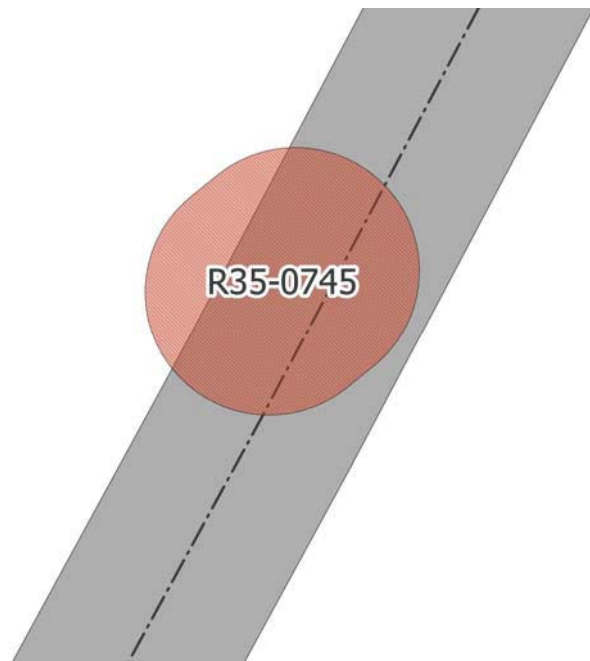
Fig. 2B. Conflicting exclusion zone.

Conversely, a target is said to be *conflicting* if its final exclusion zone intersects with design route centre line (Figure 2B).
